Accident Report

Drowning

Unnamed Kayak

1 November 2006

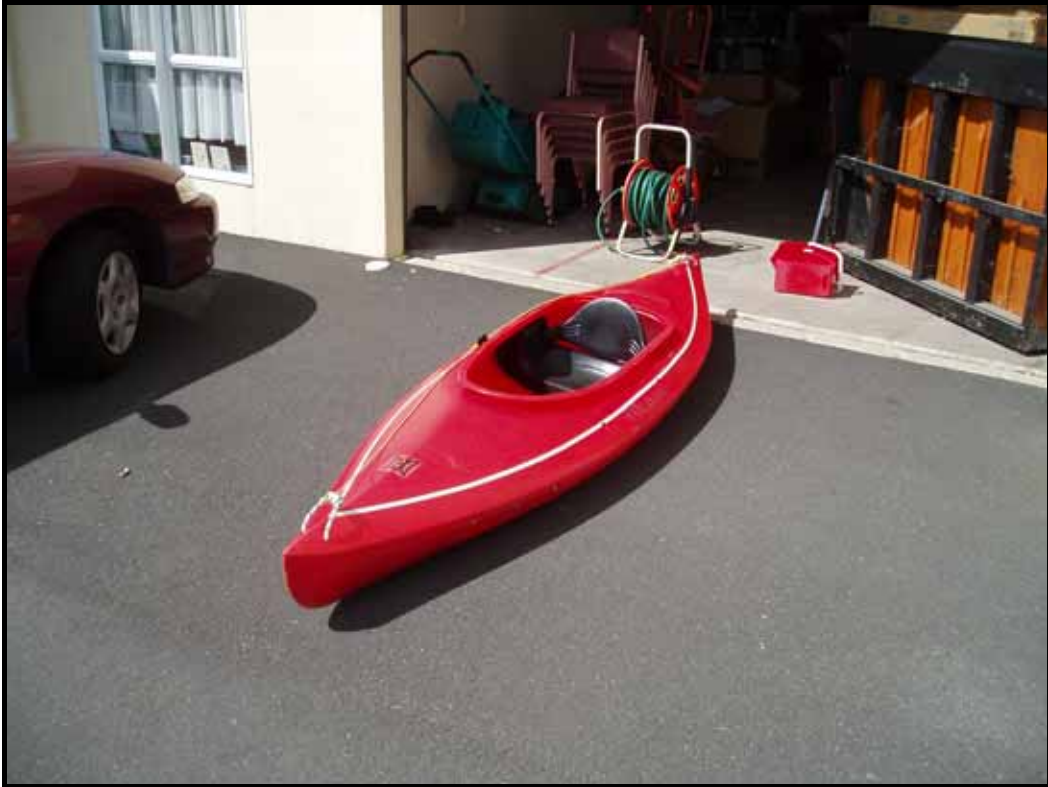
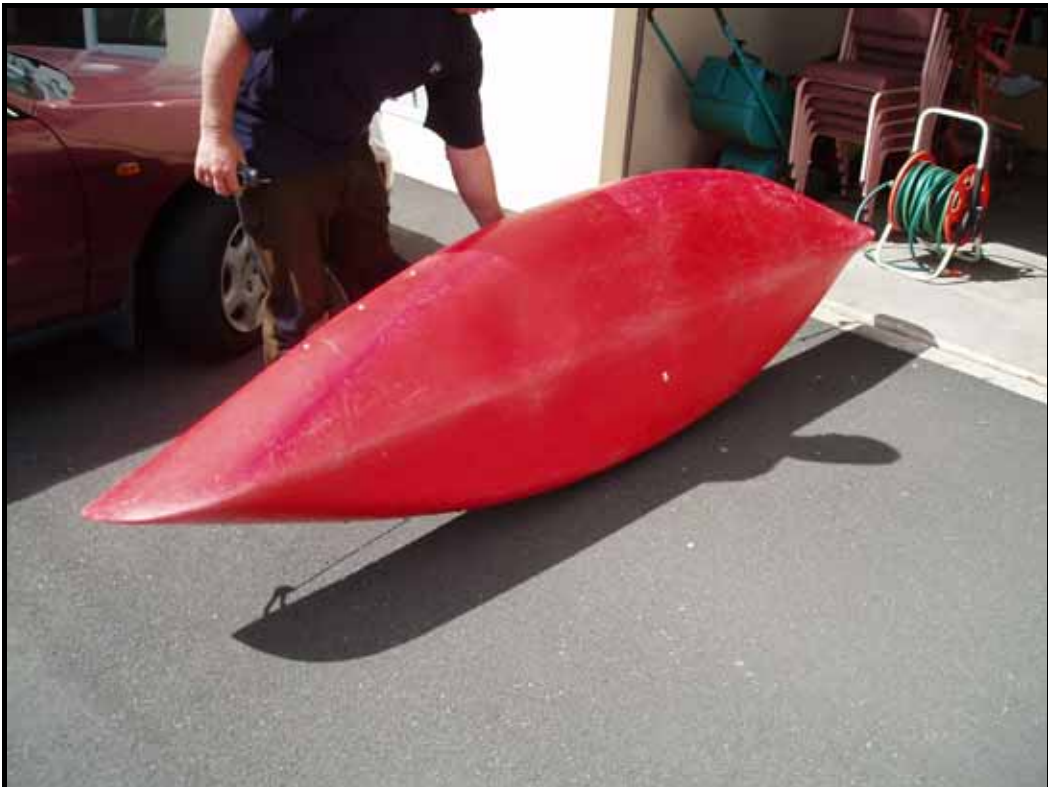
Photographs of the Perception Minnow kayak

The kayak was a Perception Minnow

Length:	2.90m
Breadth:	0.74m
Mass:	17kg

The vessel was intact and in a satisfactory condition. Moulded internal buoyancy was fitted in its bow and stern.

The kayak was a small sit-in type of vessel.

The kayak was not suitable for use on the open sea.

- Always ensure that the craft you use is suitable, both in its design and its construction, for the conditions.
 - Preferably do not go out alone. If you do go alone, do not venture too far out as you may need to swim ashore.
