# Accident Report

## *Free Spirit*

Injury from Improper use of a Flare  
Viaduct Basin, Auckland Harbour  
on 6 November 2004

REPORT NO.: 04 1148

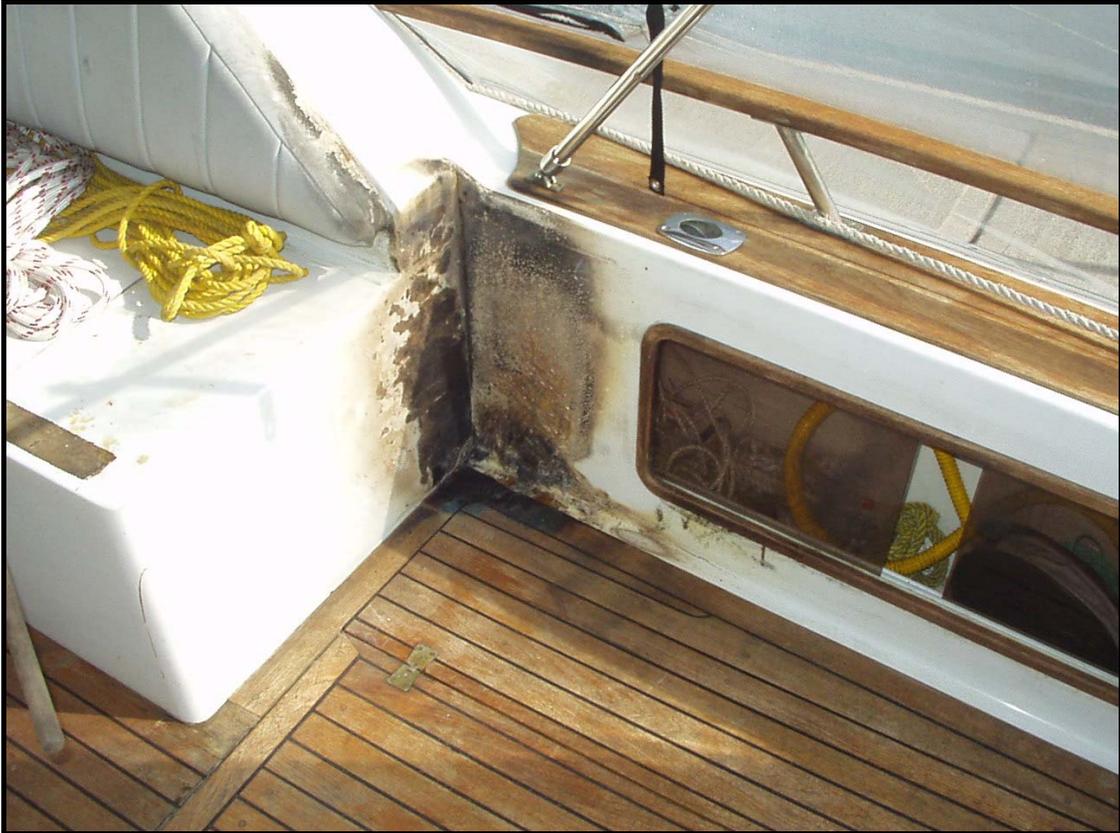
Photograph 1 – Showing aft of vessel and damaged area

At approximately 2145 hours, a heavily intoxicated crewman on board **Free Spirit** discharged a hand flare in the cockpit of the vessel. He dropped the flare on the cockpit deck. The flare burned the leg of a female crew member and burned a section of a fibreglass locker, deck and squabs. Ineffectual efforts were made to extinguish the flare by the Skipper.

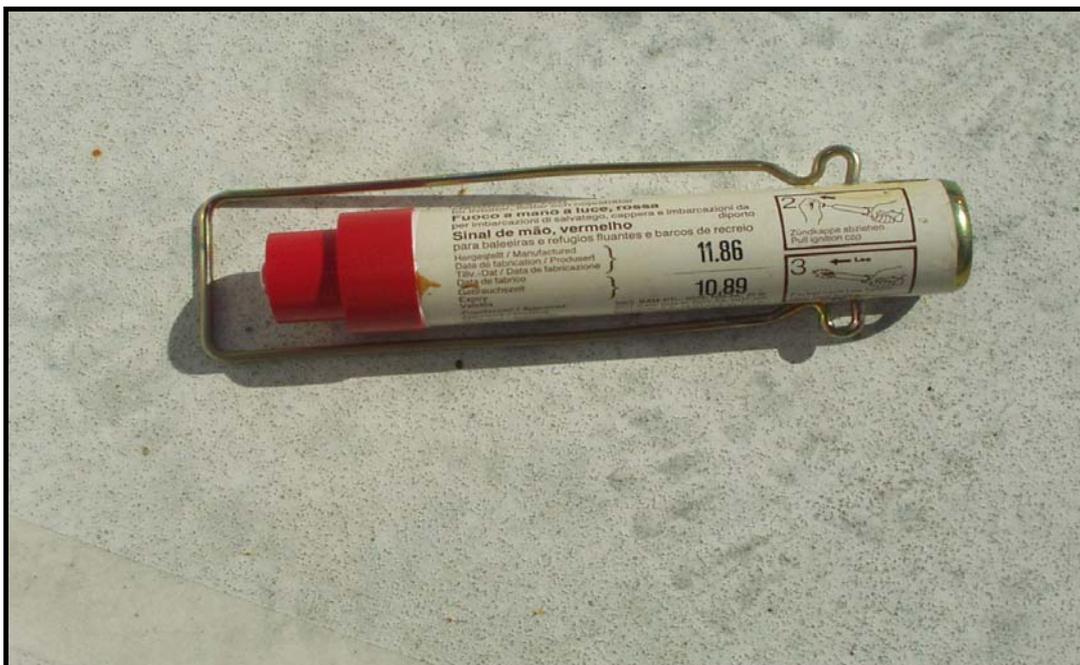
Photograph 3 - Flare

The flare that was found in front of the steering station by the Investigator, was a comet brand red hand flare that had expired in 1989. The manufacturers specify a burning time of 60 seconds. A pull wire ignitor ignites the flare. Under Fire and Explosion data are the words:

- "Special Fire Fighting Procedure: Once ignited the device cannot be extinguished"

There is evidence the flare burnt for approximately 60 seconds and consequently may have expired after the contents had burnt out (See *Photograoh 3 - Flare*).

It is common practice for recreational mariners to keep out of date flares on board vessels. Chemical components used in flares degrade over time and variations in temperature and humidity accelerate this process. Out of date flares can burn at a lower brightness (candela) and the colour can fade. In some cases burn time can be lengthened which can be a fire hazard.
