Accident Report
Amaltal Enterprise
Serious Harm Injury
East Coast of New Zealand on
10 February 2005
Class A

REPORT NO.: 96 367

VESSEL NAME: *AMALTAL ENTERPRISE*

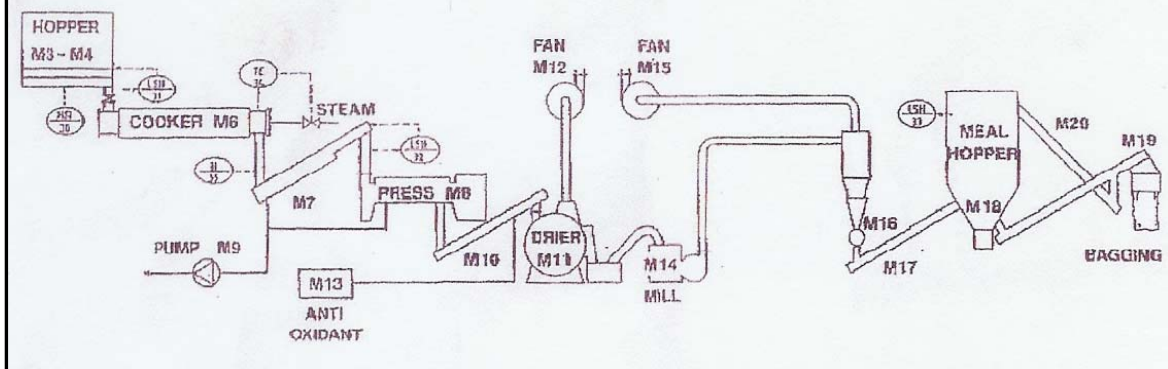
Diagram1- Fish meal Plant

The product then goes from the press into a fish meal dryer, a mill, a cyclone and then to a silo. The finished product is then bagged for export.
