Accident Report

Aquilo

Person Overboard/Fatality

REPORT NO.: 04 1155

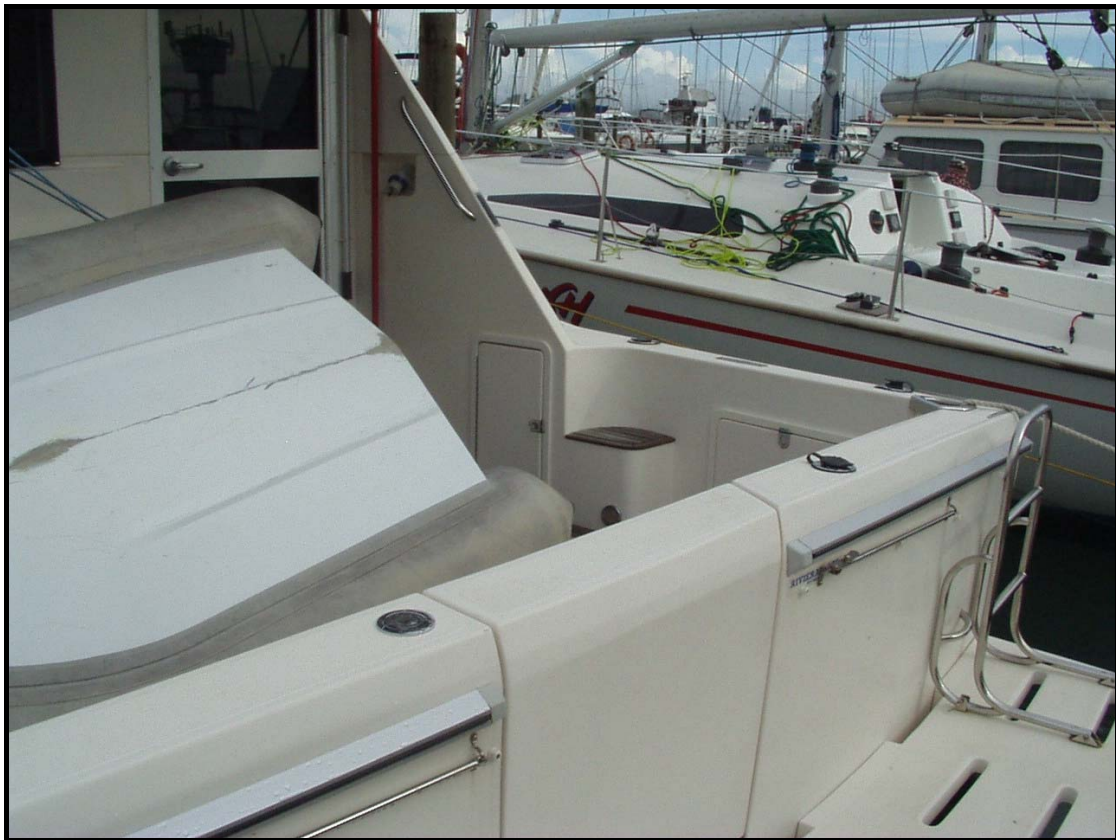
At about 1700 hours **Aquilo** moved further into the bay and anchored in the area with about 10 other vessels, including the yachts **Redeeder** and **Entourage** (See Figure 1). There was a light northwest wind.
