Accident Report
Arahura
Mechanical Failure in Tory
Channel on 14 December 2004
Class B

REPORT NO.: 04 3626

ARAHURA – MECHANICAL FAILURE

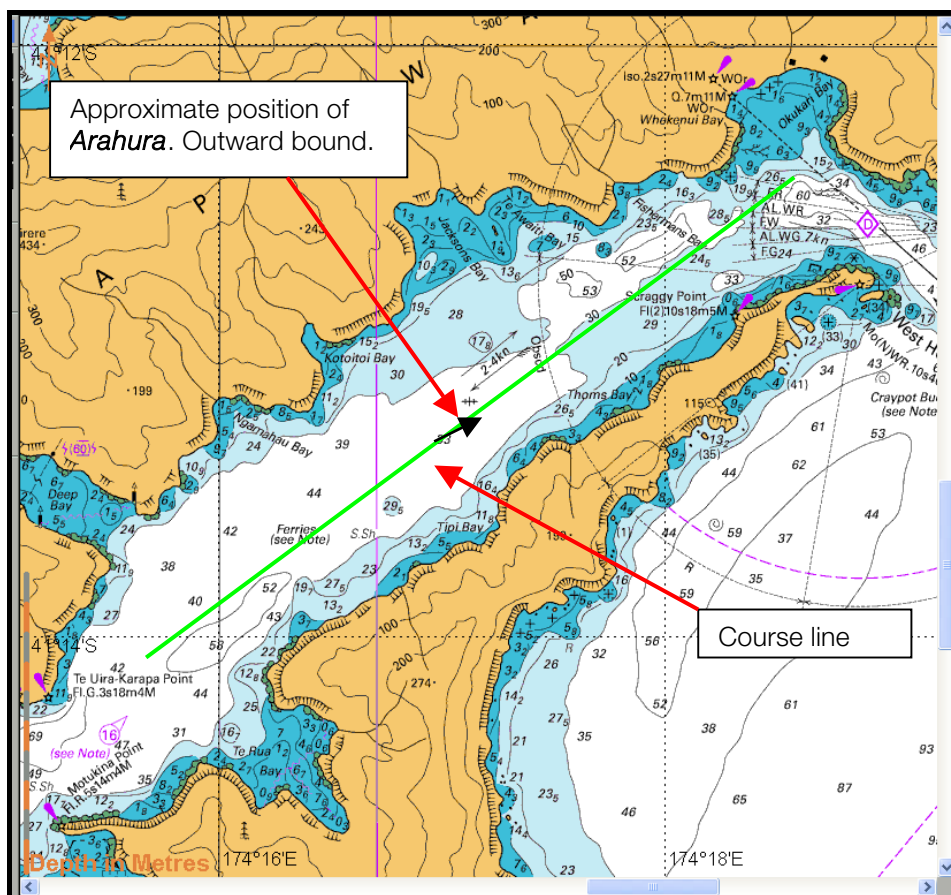
Figure 1

Whilst *Arahura* was transiting Tory Channel (Figure 1), a shore based Electrical Contractor was tracing/eliminating earth faults in the vessel's main engine room. These faults had been the cause of previous spurious alarms on the CSI alarm and monitoring system. The function of the system was to monitor the sensor outputs from the four diesel driven alternators (PE's – Figure 2). The PE's provided electrical power to four electric propulsion motors (PM's – Figure 2).
