# Accident report

Blue Dolphin

Collision resulting in one fatality  
and two persons missing,  
presumed drowned

**21 October 2009**

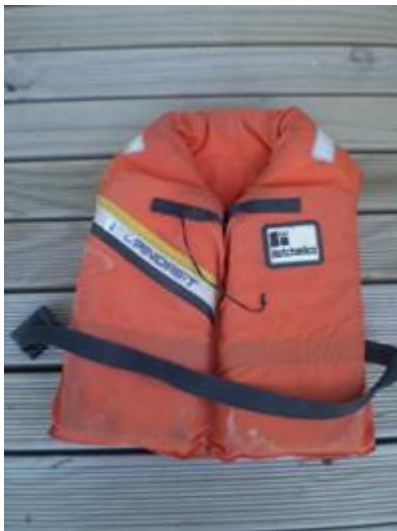
**Figure A2.1** \$5

The examples on the following page show PFDs that, at the time of writing, were advertised as lifejackets and were all for sale for \$5 or less. Although better than nothing, these items are not in good order and have passed their usefulness.

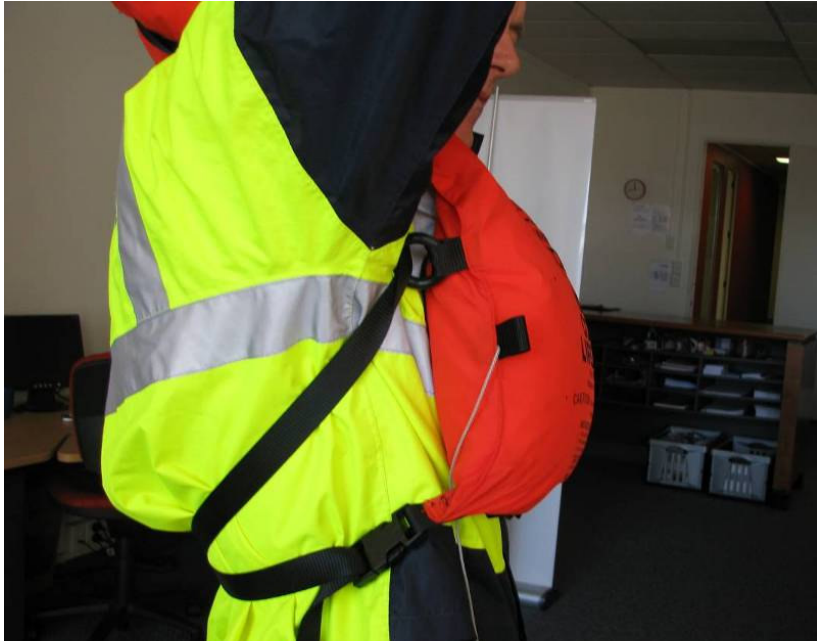
**Figure A2.6** An incorrectly fitted 401 lifejacket

To provide an example of this, MNZ investigators tested this 401 lifejacket when it was incorrectly fitted. It was found that the front section came loose from the chest, with the strap going under the wearer's chin. The wearer remained face down in the water, allowing the airways to be submerged (see Figure 7).

Lifejackets have a tendency to 'ride up' if they are not fitted correctly, and this makes staying afloat difficult. It is recommended that you test a new lifejacket under safe conditions to ensure it performs as you expect it to and that it fits.

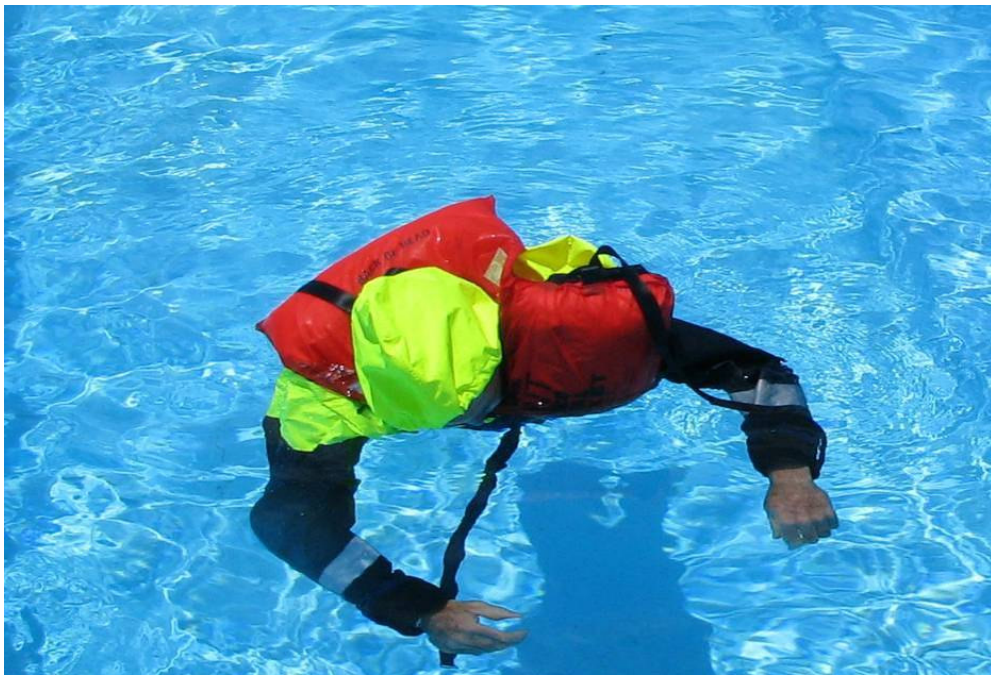
**Figure A2.7** The incorrectly fitted lifejacket turned the wearer face down
