Accident Report

Sinking (1 fatality)

Hard Out

23 February 2008

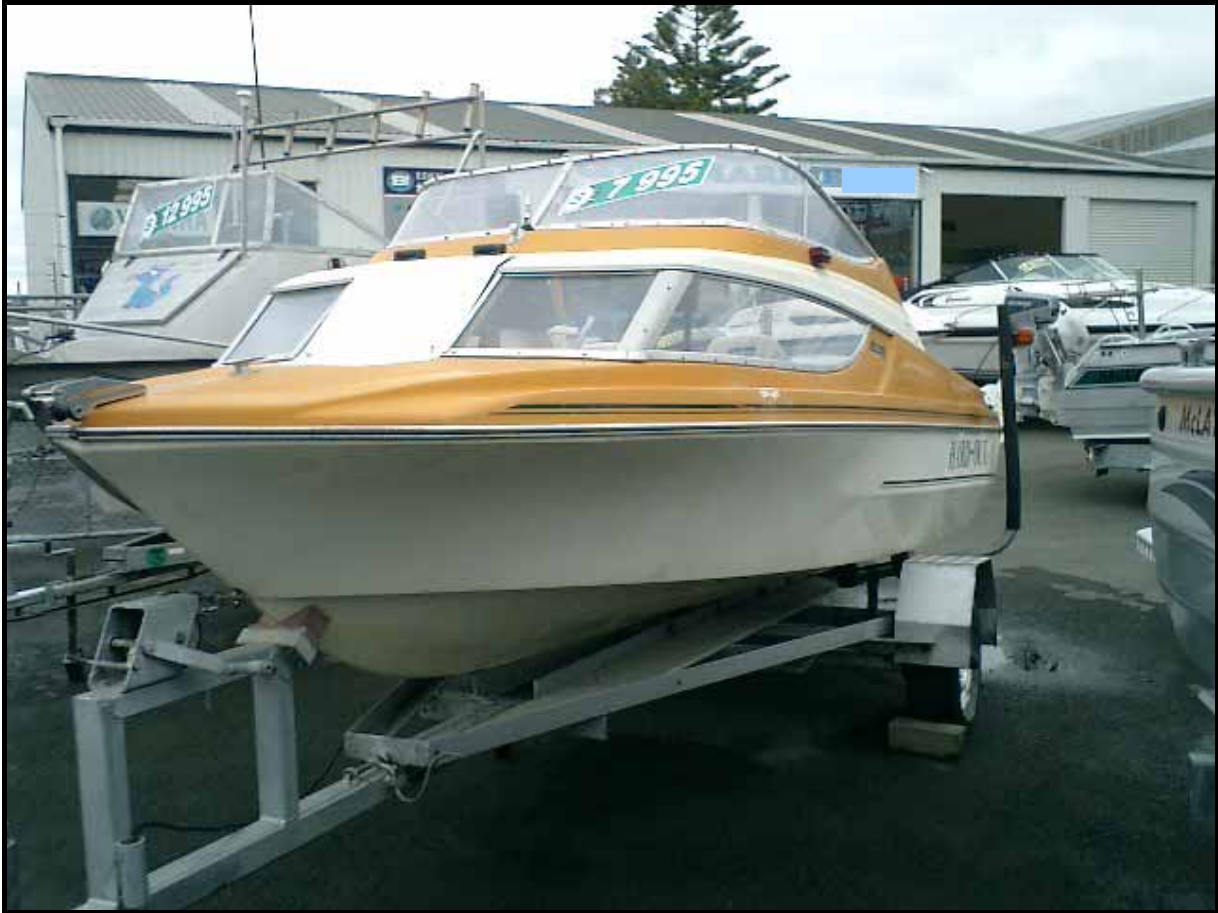
Photograph 1
Photograph of *Hard Out*.

- 2.13 The skipper noted that **Hard Out** appeared to be *“sitting very low with his back in the water like when you try to get on a plane, not full throttling it, you know, that kind of thing that just lifts the nose and it was sitting like that for at least I would say two, three hundred metres, before it actually got up onto the plane. So the back was hanging quite low down...”*.

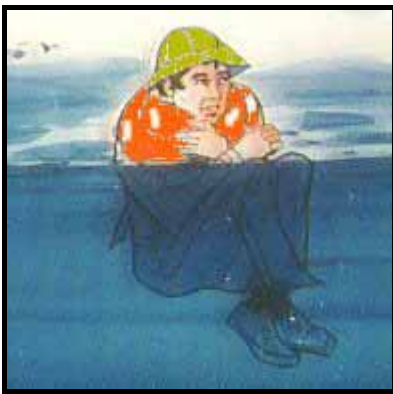
Figure 3
Showing HELP

- 3.84 It is not clear what sea survival techniques, if any, were employed by the persons in the water.
- 3.85 It does appear that all three of them made, understandably, a considerable effort to swim to shore.
- 3.86 During an in-water sea survival period conservation of body heat and energy is paramount to ensure that the person in the water has the maximum possible survival time.
- 3.87 For conservation of body heat several methods can be used depending on the number of persons in the water. For a single person the Heat Escape Lessening Posture (HELP) can be used. This is achieved by placing the arms across the chest to protect the axillae (armpits), and flexing the legs to protect the groin area. If present, wear headgear and remain still in the water. The HELP position will result in a 50% increase in survival time *(See Figure 3 – HELP position)*.

- 3.89 It appears that once the occupants of *Hard Out* found themselves in the water they were not prepared for an extended in-water survival situation.

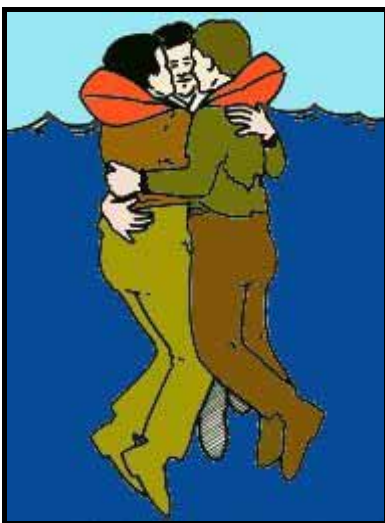
Figure 4
Showing HUDDLE position

- 3.88 If there are two or more the "HUDDLE" position is recommended to conserve heat loss. This again results in a 50% increase in survival time *(See Figure 4 - HUDDLE position)*.

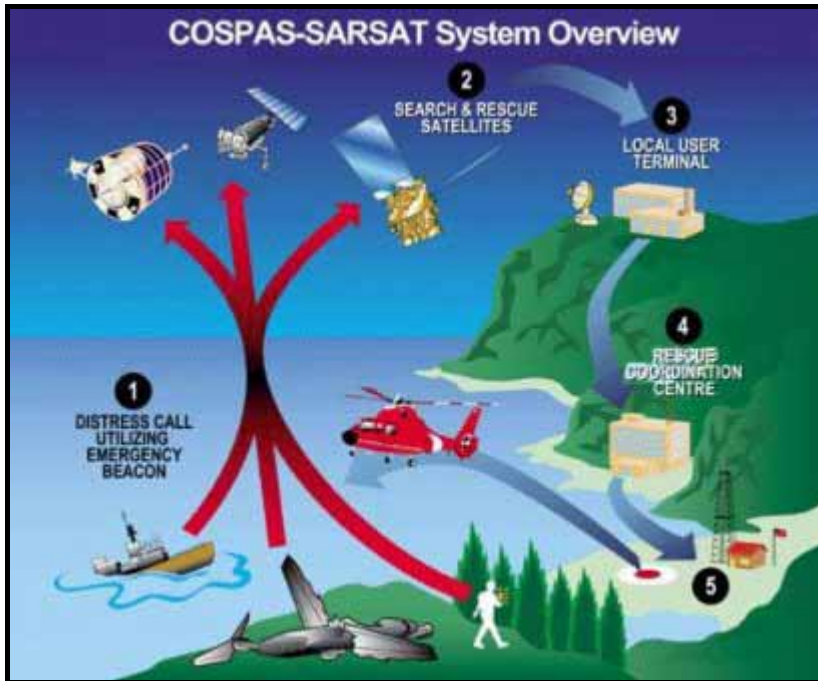
Figure 5
Diagram showing how the system works.

- 3.94 If, however, an EPIRB/PLB has the GPS input, RCCNZ will receive notice of activation and the position within approximately 10 minutes of it being activated (*See Figure 5 – Diagram of COSPAS-SARSAT System Overview*).

- 3.95 The satellites process 406 MHz signals only, and will detect a transmission, if it is not shielded by terrain or other medium, the instant a 406 MHz EPIRB is activated. RCCNZ will receive processed information within approximately four minutes of activation. If no position is available, RCCNZ may have to wait until a LEOSAT satellite transits the area before positional information is obtained.
