Accident Report

Serious Harm
Kawau Kat III

16 September 2005

Kawau Kat III

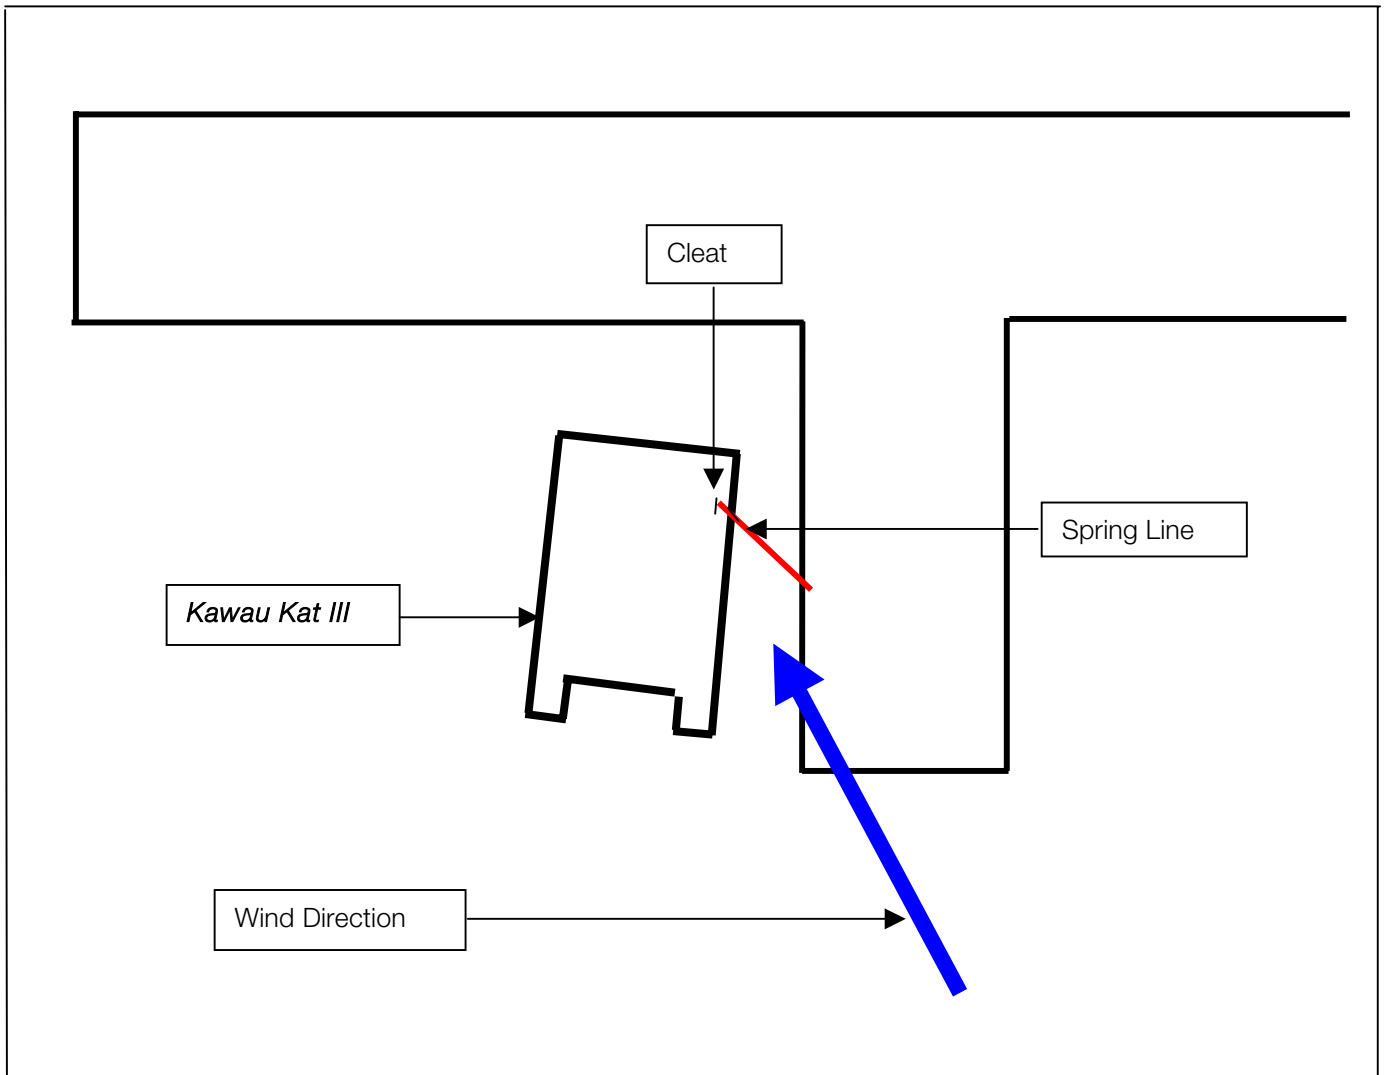
Figure 1
Diagram of Berth (not to scale)

On Friday 16 September 2005 at approximately 1055 hours NZST (New Zealand Standard Time), the commercial passenger vessel ***Kawau Kat III*** was approaching the commercial vessel berthing wharf known as Z Pier in Gulf Harbour Marina. The vessel had unloaded passengers at Tiri Tiri Matangi Island and was returning with the Master and Crewmember on board. A strong southerly was blowing. This caused the vessel to be blown off the face of the wharf during berthing (*See Figure 1 - Berth and approach (not to scale)*).
