Class B Non Serious Harm Accident Report

# **Lady Marie**

# **Injury**

## **REPORT NO: 96 323**

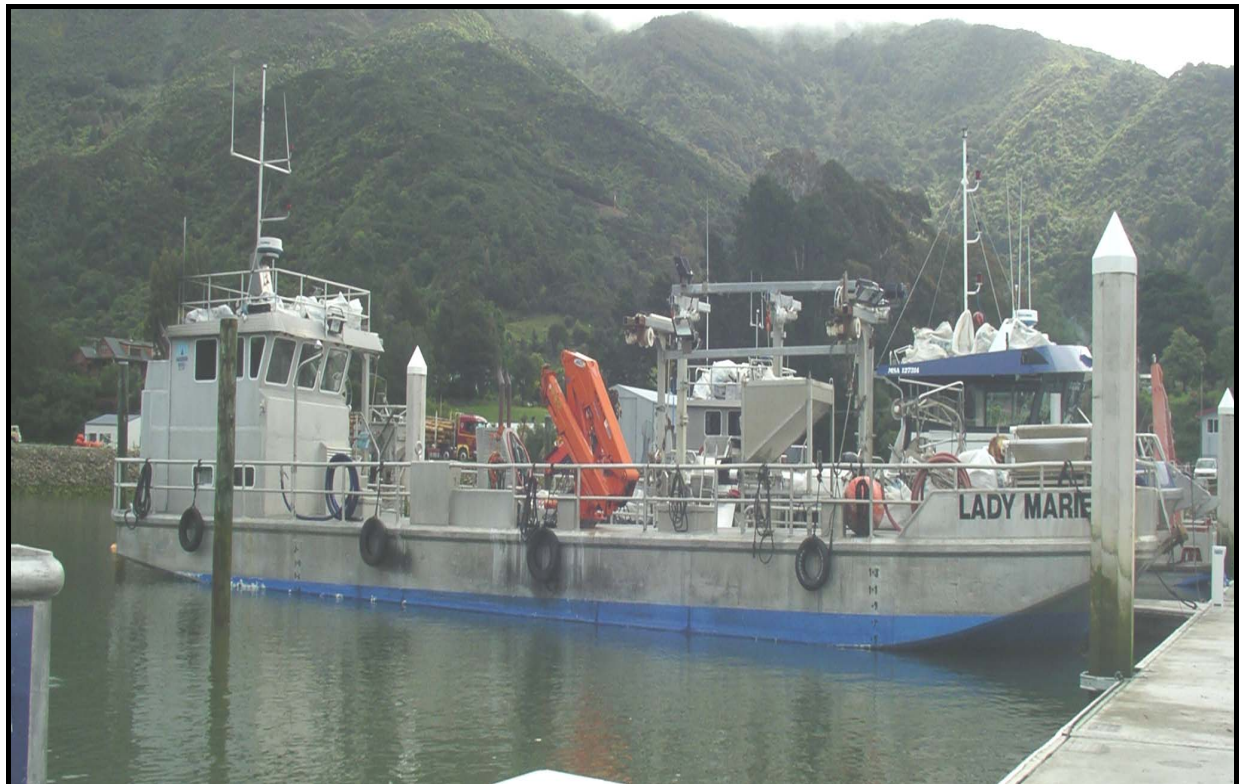
While berthing *Lady Marie* at Havelock, Marlborough, a crewman's fingers were caught in the stern gantry cleat when a gust of wind caught the vessel and swung the stern out. This caused the rope to tighten quickly and unexpectedly. Two of the crewman's fingers were severed and later re-attached in hospital.

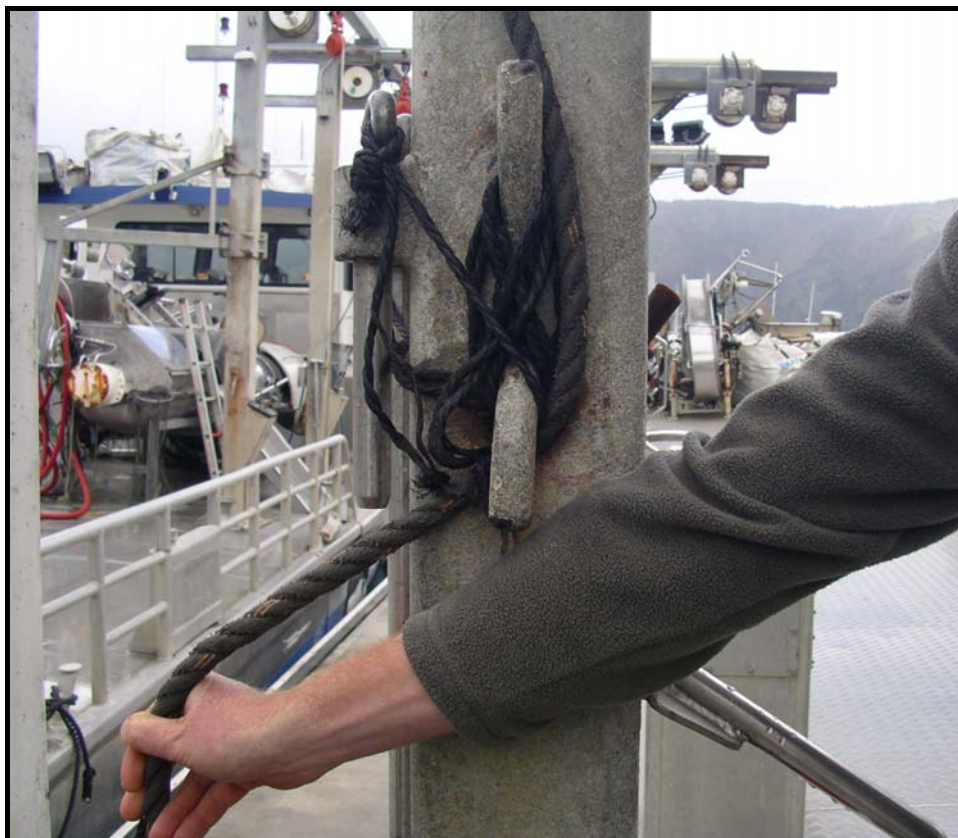
At the same time as he activated the winch to take up the slack, a gust of wind hit the vessel and moved it away from the wharf. Deckhand One had not removed his fingers from the vicinity of the cleat and they got caught between the line and the cleat as the wind pushed the vessel away from the wharf and the winch took up the slack. He cried out and then pulled his fingers clear of the cleat.

*Photo showing where Deckhand One was holding the line before the accident  
(note: at the time Deckhand One was holding the line with his left hand)*

The Marlborough Mussel Company is currently putting together new working procedures and guidelines for their vessels. It is recommended that these procedures be completed as a matter of priority and promulgated to all vessels by the end of January 2005.

It is recommended the Marlborough Mussel Company ensure that all Skippers make sure that new crew are aware of the correct procedures with regard to all equipment and operations onboard their vessels, including berthing and slipping.
