Accident Report

Matakana

Capsize

Totaranui Beach, Abel Tasman National
Park on 1 September 2004

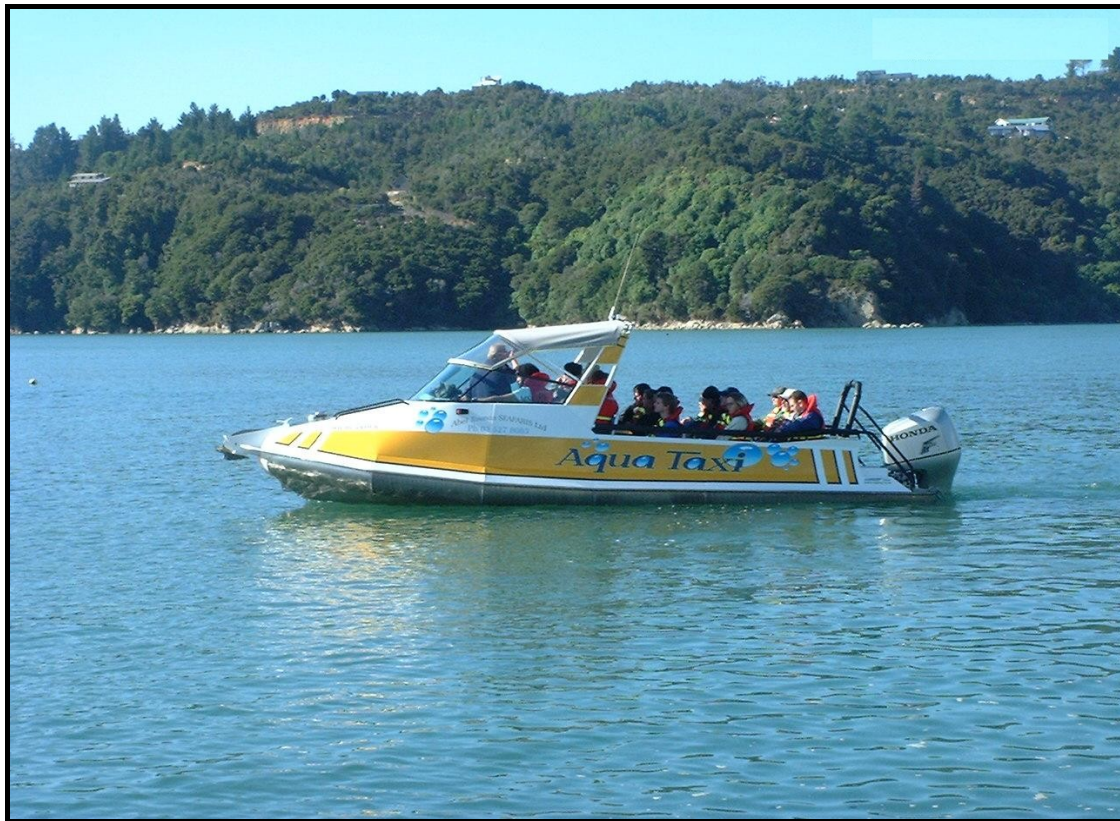
PHOTO 1 – VESSEL OF SAME DESIGN & LENGTH

- 2.1.1 *Matakana* is an aluminium rigid pontoon designed vessel of 7.4 metres in length. She was designed by Osprey Boats and constructed by Alloyd Engineering. The vessel was powered by a 225 hp Honda outboard motor.
- 2.1.2 Abel Tasman Seafaris, trading as Aqua Taxi, owns *Matakana*. They, in turn, are owned by Shotover Jet Limited, Queenstown. Abel Tasman Seafaris own six other water taxis of the same design and length as *Matakana* (See Photo 1 - Photograph of vessel of same design and length).
