Accident Report

Foundering & Loss of life

Mi Jay

Report Issued on 4 June 2008

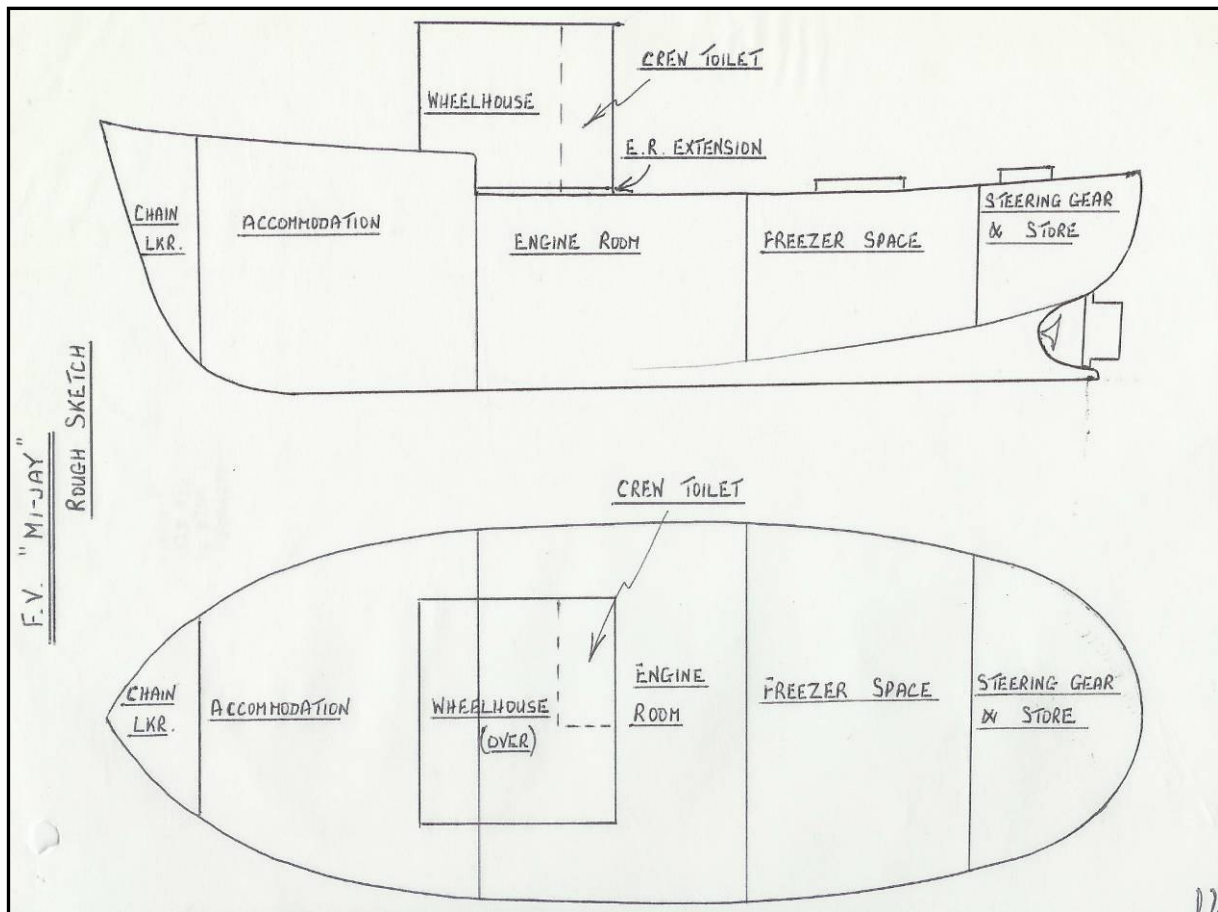
Figure 1
Sketch of *Mi Jay* obtained from the Ministry of Transport file.

Extending approximately three quarters the length of the working deck, were several freeing ports that were permanently open to the sea. The previous Skipper of the vessel stated that the freeing ports enabled any water that shipped on board to escape easily over the sides of the vessel. A small length of handrail situated immediately abaft the long line gear on top of the bulwarks at the stern had been cut away.

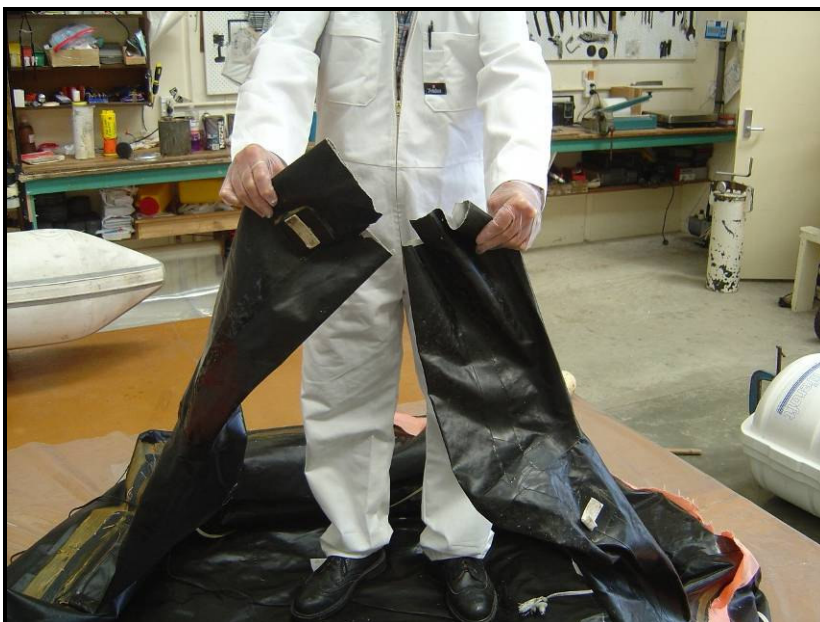
RFD Report Photograph 2

On inspection, both buoyancy chambers were found to be partially inflated with no sign of damage to either (Photo 1). The firing head was in the fully activated position, with the cylinder valve open, and subsequent weight checks proved the cylinder to be empty. This showed that the liferaft had been deployed and had inflated successfully on deployment. The subsequent loss of gas from the buoyancy chambers would be due to two main factors. Firstly, the arch tube had been severed relatively cleanly almost in its centre, (Photo 2) allowing gas to escape from the arch and then from the top buoyancy chamber via the non return transfer valve. Secondly the lower buoyancy top-up valve plug had become detached from its retaining cord and was lying in the bottom of the raft. This may have allowed gas to leak back through the top-up valve allowing the lower chamber to deflate gradually. (This process would have been very slow and adds weight to the liferaft having been afloat for some considerable time.) In addition to these two factors neither of the relief valves had been plugged, and the plugs were not in the raft, though they were recorded as present in the equipment pack at the raft's last survey (Appendix 1). All external life lines were intact, but the internal line had been severed in two places. Both lighting batteries were still attached to the raft body.

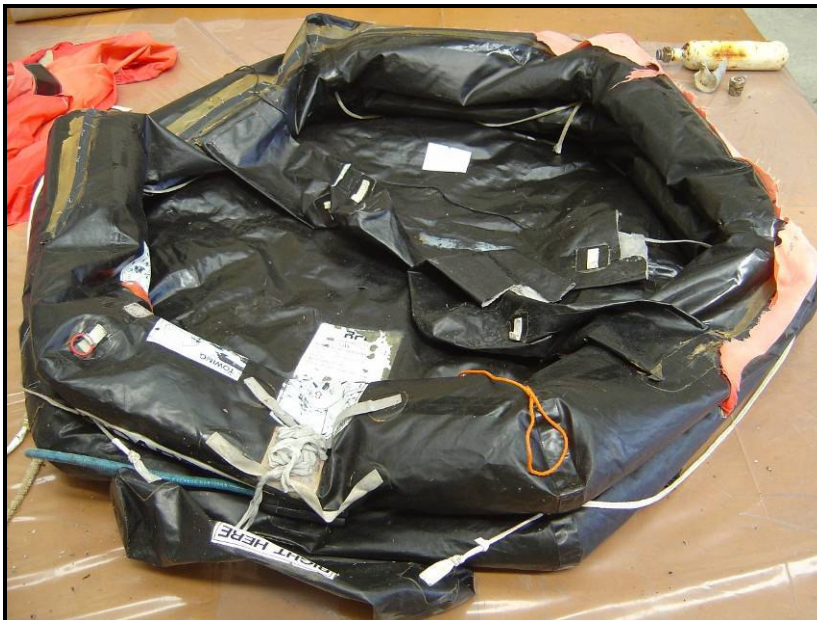
RFD Report Photograph 5

The canopy had been removed from the raft completely (Photo 4). The material appeared to have been cut initially for approximately half the canopy circumference, and then subsequently torn from the raft. This assumption was reached due to the canopy material still attached to the raft on one half, the other half had pulled off cleanly with the glued strip still in place on the canopy (Photo 5). The wires for the lights had been severed and both lights were missing.
