Accident Report

Grounding

Milford Mariner

18 September 2005

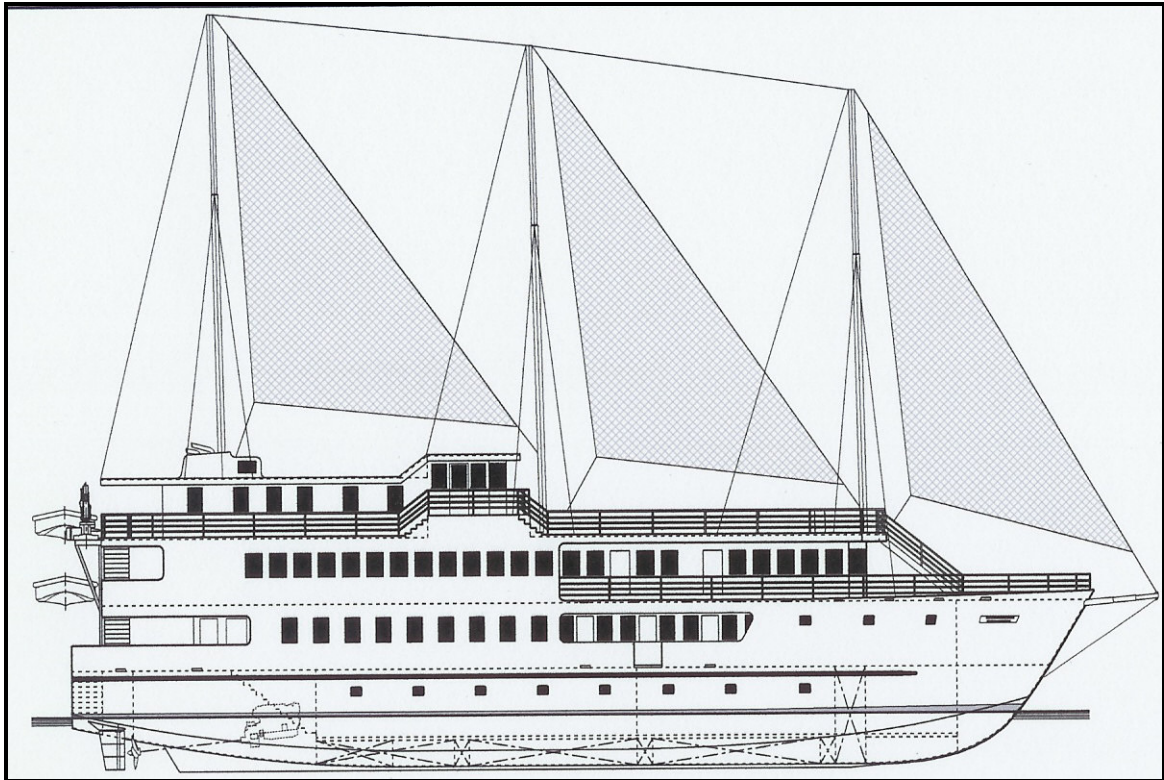
Figure 1

The above illustrates the effect the wind had on the stern when the main engines stalled. The wind was acting on the starboard side of the vessel; this caused the port bow to move to port as speed fell away after the stall.

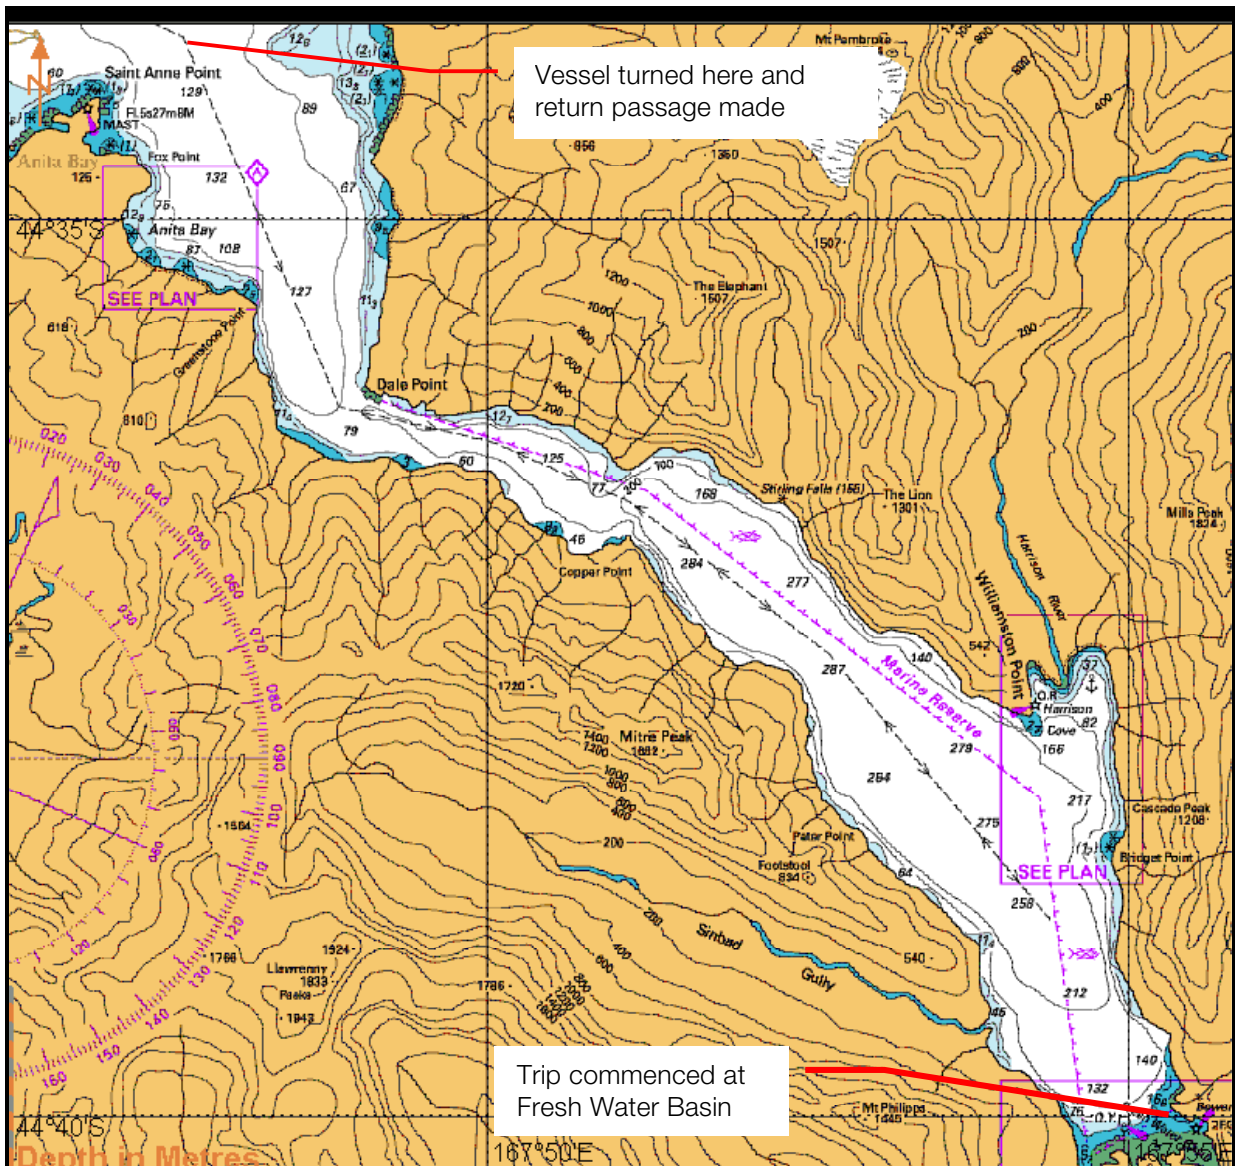
Figure 3
Milford Sound

The trip commenced at the berth in Fresh Water Basin, then passage made along the southern side of the Sound. The vessel stopped and looked at various points of interest along the way. The Master turned the vessel in the vicinity of St. Anne Point and headed along the northern side, back into the Sound, continuing the scenic cruise.
