Safety Investigation
Paihia High-Speed Passenger
Boats
27 June 2009

Maritime New Zealand

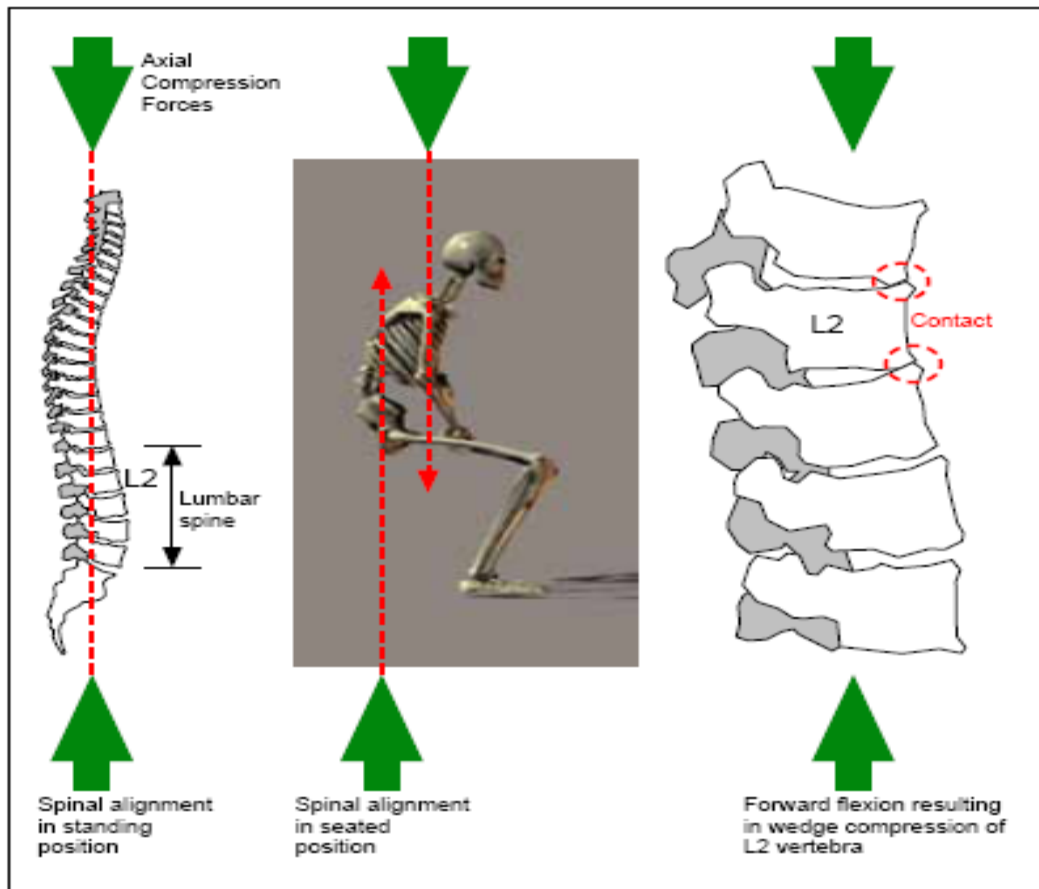
Figure 4 Spinal alignments

23. During axial loading the body's centre of gravity moves forward, increasing the risk of the spine bending forward (forward flexion). It is the combination of the flexion of the spine and the axial forces applied that causes contact between the vertebrae and results in fractures due to the wedging effect.

24. If a twist or bend is introduced to the lower back region the risk of this type of injury is further increased. Research indicates that the introduction of a twist can reduce the mechanical strength of the vertebra/intervertebral disc unit by about one third.

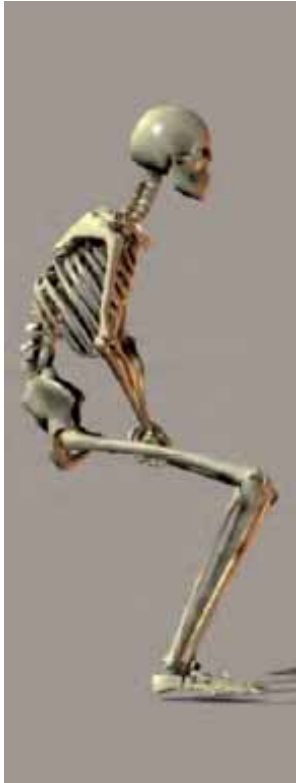
44. Handle position can be critical for the continuing safe posture of the passenger's back. By being too low it may provide no support to stop the individual from being thrown forward as the boat impacts with the water. By being too narrow it provides little lateral support to the individual when the boat impacts with the water or during cornering.
45. This again contributes to increased lumbar instability.
46. Both vessels in Paihia have differing handle setups that vary in their ability to provide the seated stability required for the passengers.

Figure 16 An example of what happens when the seat handles are too low
Courtesy of STRResearch

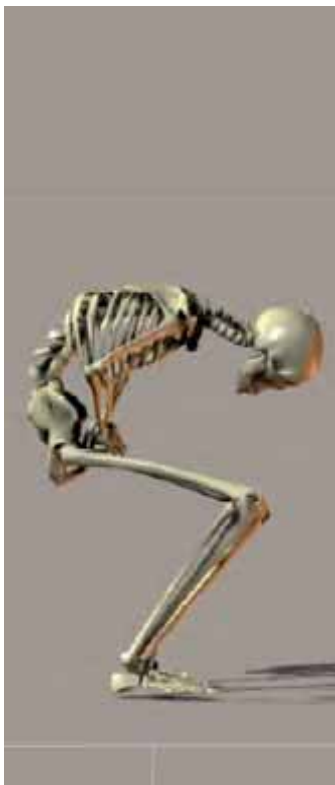
Figure 17 An example of what happens when the seat handles are too low
Courtesy of STRResearch

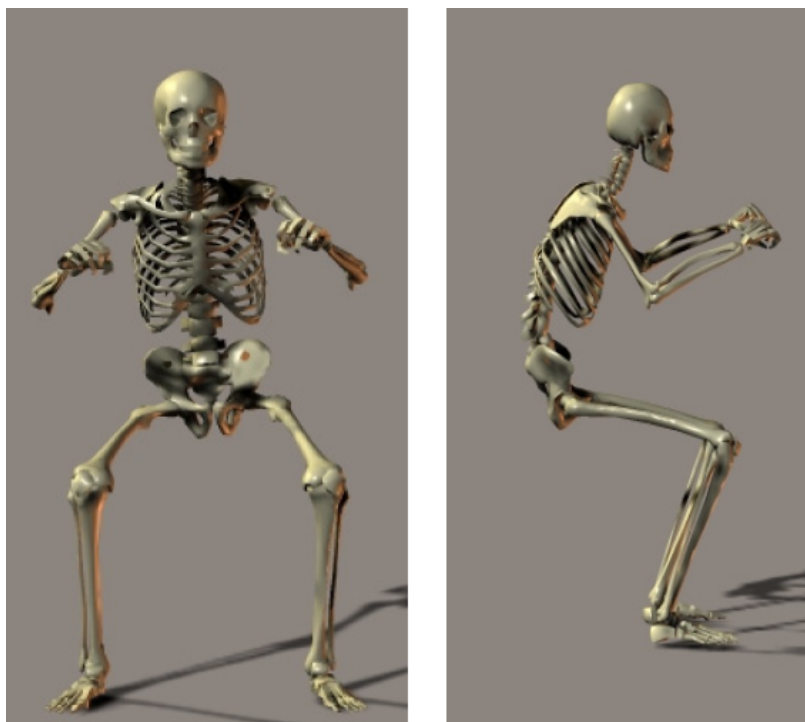
Figure 18 Example of a more supportive wide and high hand rail grip
Courtesy of STRResearch
