Summary Report

Serious Harm Injury

Patea Explorer

21 September 2006

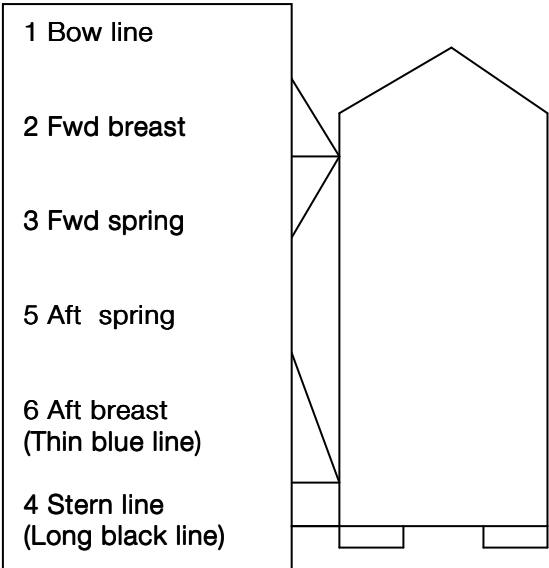
Real Journeys are currently reassessing the mooring arrangements of *Patea Explorer*. They have approached Incat Crowther in Australia, the builders of the vessel, to prepare drawings for the modification of the mooring bits at the stern and the fitment of a single Samson post at the bow on the outside of the coaming about a metre above the deck to allow easier and safer mooring/unmooring.

In the meantime the mooring procedures for this vessel have been re-assessed and the new procedure is as follows:

All work areas are to be cordoned off when crew are working with the lines.
