Incident Report
Close Quarters
Pegasus II & Distraction
26 April 2006
Class B

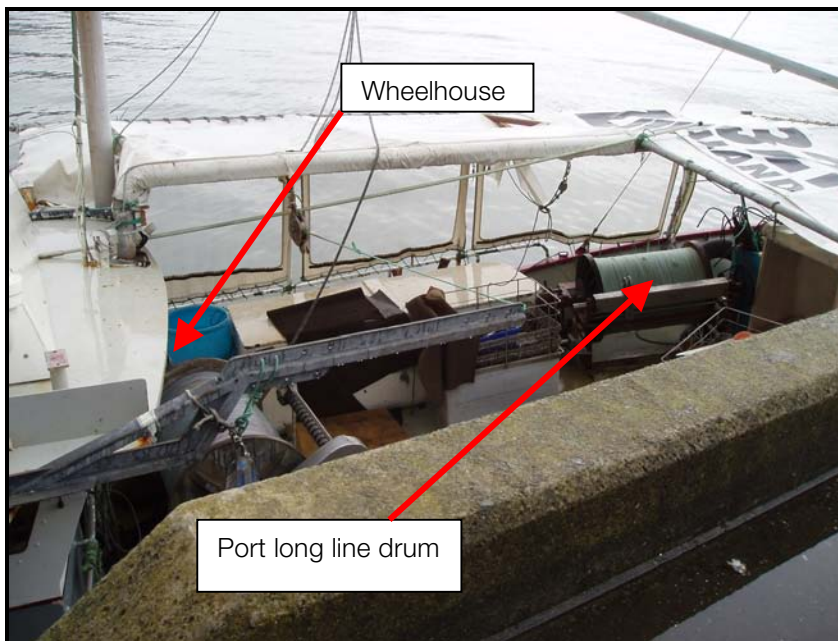
Photograph 3

Pegasus II departed Opuia wharf at approximately 1400 hours. The vessel travelled north from Opuia and then altered course to the north east on entering the sector light area north of No.1 and No.2 channel marks. The Skipper noted *Distraction* 20° to 30° on his port bow at an approximate distance of between one quarter and half a mile. As *Pegasus II* closed on *Distraction* the Skipper stated he gained the "impression" that *Distraction* was underway and bearing 20° on his port bow. At this stage *Pegasus II* was travelling at 6 knots. The Skipper then left *Pegasus II* on autopilot and commenced greasing bearings on a surface long line drum on the port side in front of the wheelhouse. After approximately 30 seconds the Skipper went to the port rail to urinate and saw an anchor warp on the surface dead ahead running across his course. He ran to the wheelhouse and took the engine out of gear and coasted over the warp. He observed a small vessel off his starboard side at a distance of approximately 15 to 20 metres. Prior to the close quarters the Deckhand was working on the aft deck and did not observe *Distraction* until she was abeam of *Pegasus II*.
