Accident Report

Predator

Capsize & Fatality

REPORT NO.: 05 1166

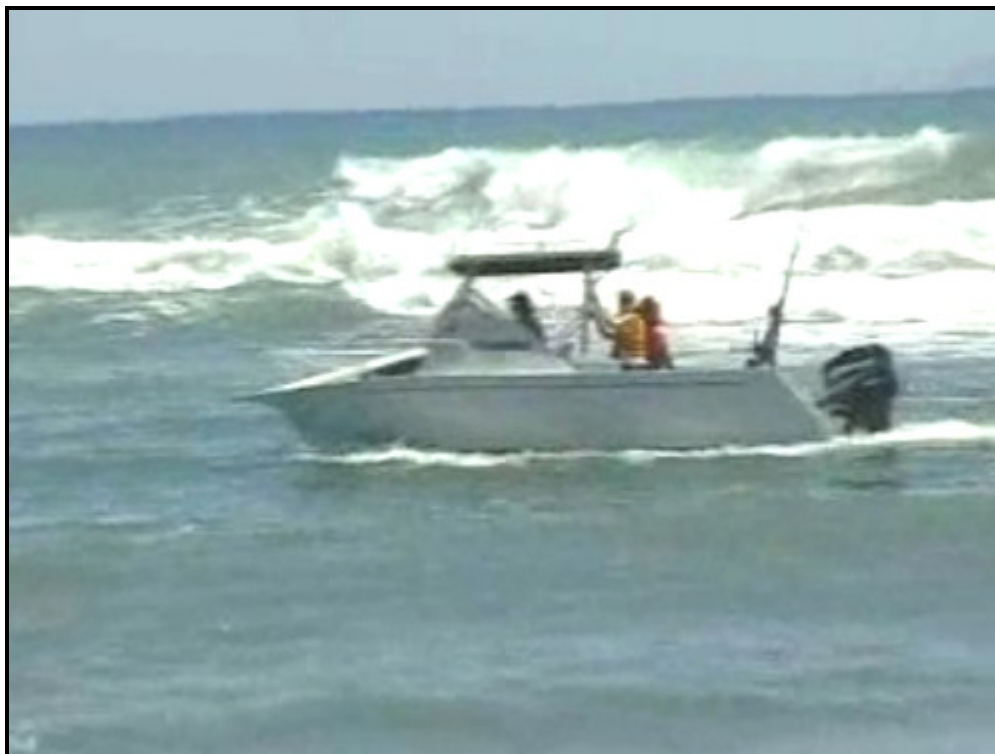
Photograph 1

Predator at Maraetai Bay while 3 boys circled awaiting owner.

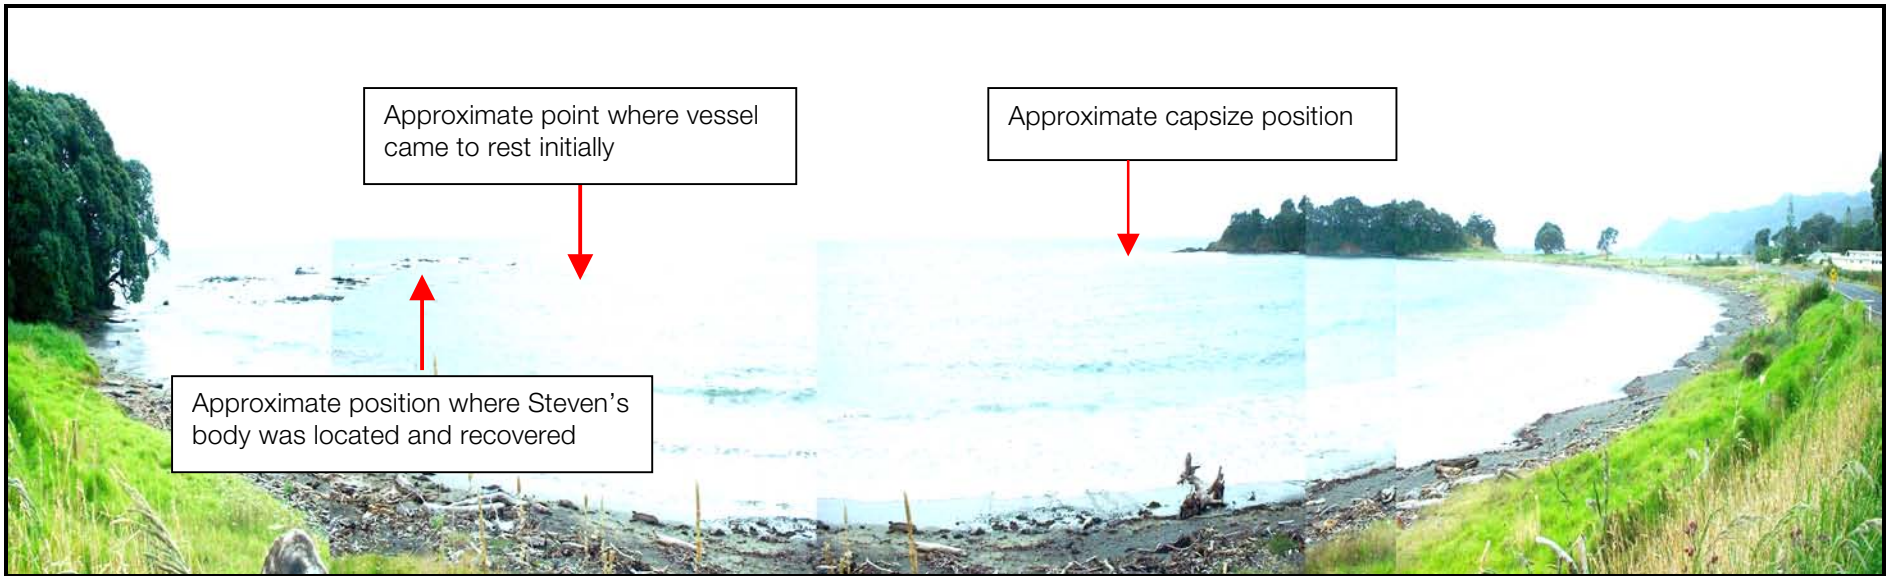
Photograph 3
Te Kaha (Maraetai Bay)

Maraetai Bay (See *Photograph 3*) has transit marks which are used as a guide to indicate the entrance of the main navigable channel. A second unmarked channel is situated to the west of the main channel.

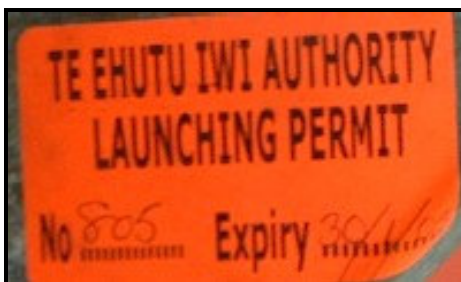
Photograph 6
Permit on the trailer of *Predator*

The Owner of the Park stated that he declined to sell permits during the morning of Saturday 29 January due to the rough sea condition at the entrance. He stated he had no “authority” to decline the sale of permits, but did so from a common sense perspective. He does not have vast boating experience and nor is he there to police permit use or abuse. There is an alternative launching area about 5 minutes drive away near the Te Kaha Hotel which does not require the use of a permit. He sold two permits to the Owner’s son that day, one for **Wavecrusher** and one for **Predator**. He assumed they would be used later that day if the sea conditions abated, or the next day as the permit was valid until Sunday 30 January.
