Accident Report  
COLLISION  
*Quickcat & Doctor Hook*  
04 January 2005  
Class A

**VESSEL NAME:                    *QUICKCAT***

**VESSEL NAME:                    *DOCTOR HOOK***

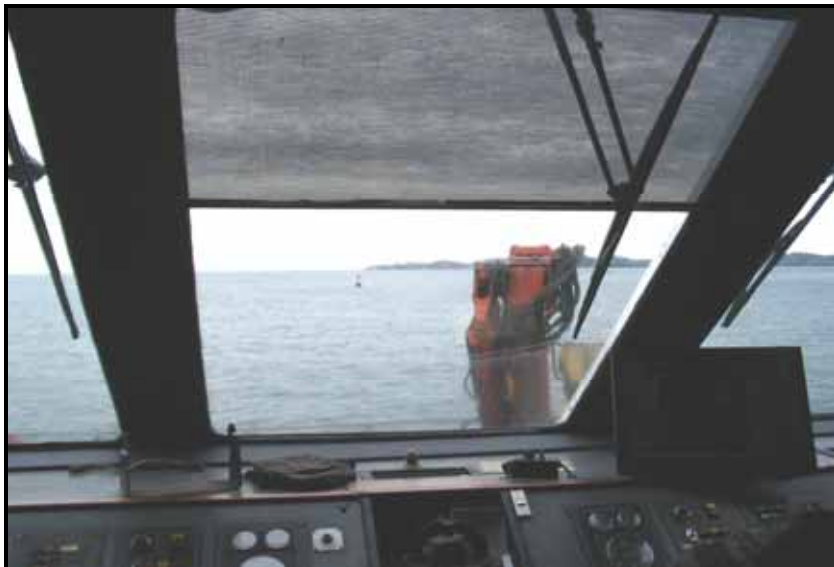
PHOTOGRAPH 1

The Master then returned to his seat and as *Quickcat* entered the channel he periodically moved his position at the helm position in an attempt to determine if any vessels were obscured behind the crane and window frames (See Photos 1, 2 & 3 – showing visibility from the helm position the day after the accident as *Quickcat* approached the northern most of the two port hand channel marks).
