Summary Report
Grounding
Rex
4 June 2006

REPORT NO.: 06 4100

VESSEL NAME: *REX*

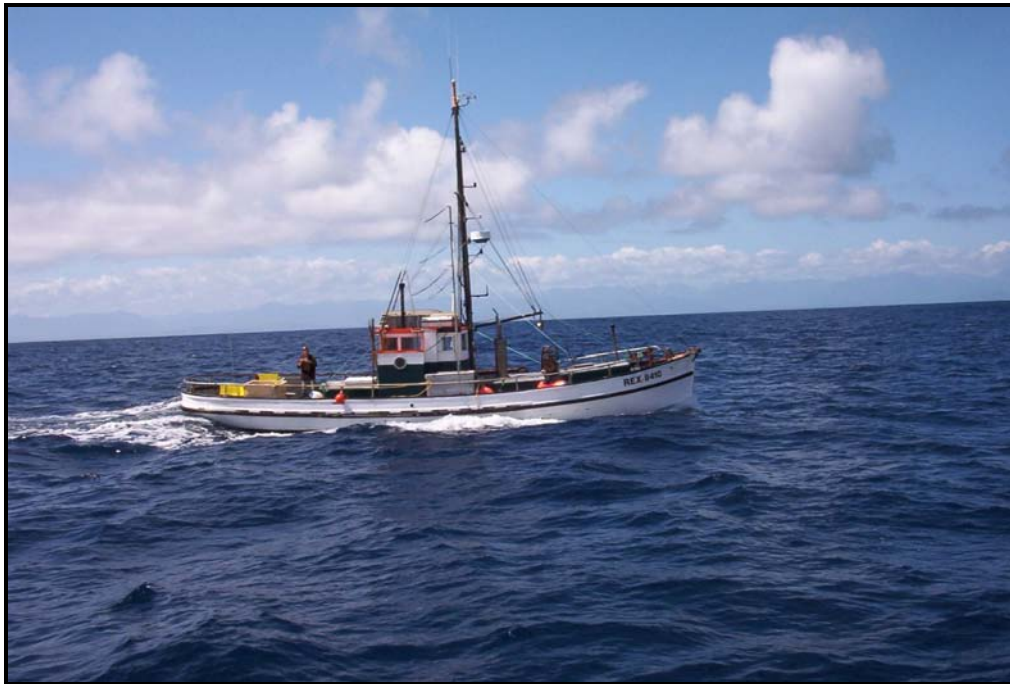
Photograph 1
Rex

Attempts to tow the vessel off the beach were unsuccessful and **Rex** remained hard aground. The Skipper and his friend left the vessel at about 0430 hours after all hope was lost. The vessel started breaking up in the 1 to 2 metre swell shortly afterwards. Over the next 24 hours the vessel was reduced to 'matchwood' and was a constructive total loss.
