Accident Report

Flooding

San Rakino

REPORT NO.: 05 3855

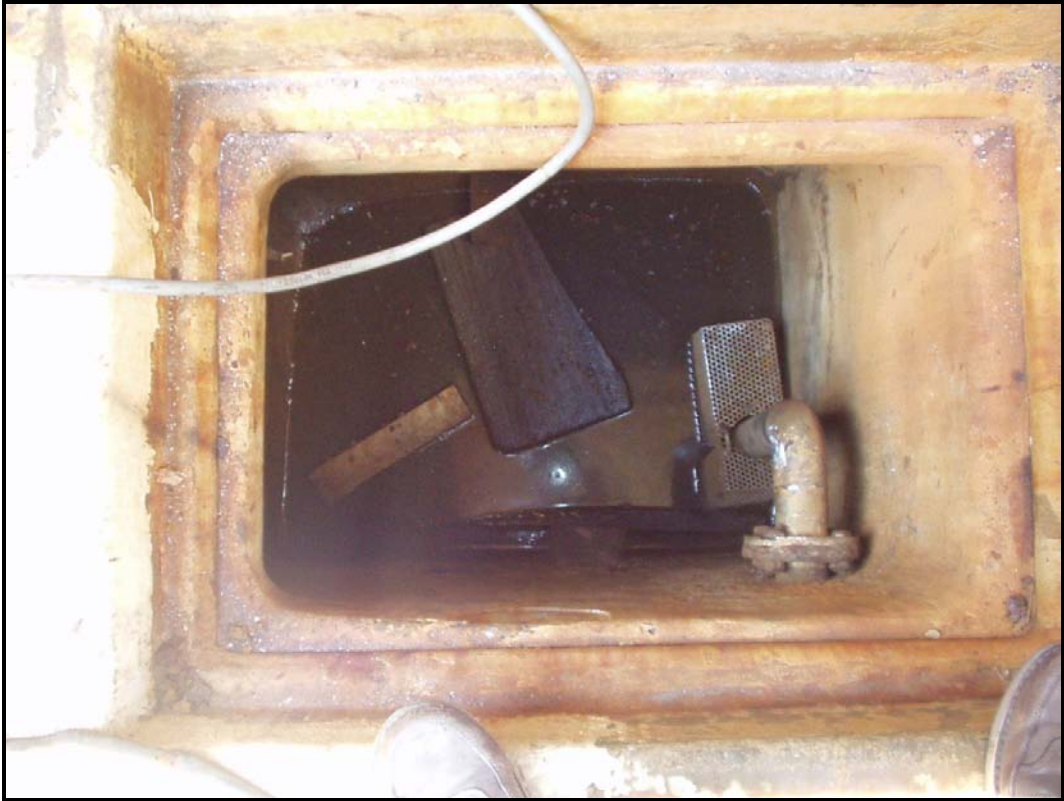
Photograph 2
Port Bilge Sump

San Rakino had a 3.5kW and a 7.5kW engine room pump draining the port fish room bilge sump. Both bilge sumps in the fish room were common with a 10 cm balance pipe running between the two. In addition, an electric pump on an automatic level switch operated from the port bilge sump. A submersible electric pump, that drained on to the deck, was also fitted on the vessel.
