Accident Report

San Rochelle

Fire & Sinking, 95.1 miles
Northwest of Cape Reinga
on 27 October 2004

REPORT NO.: 04 3590

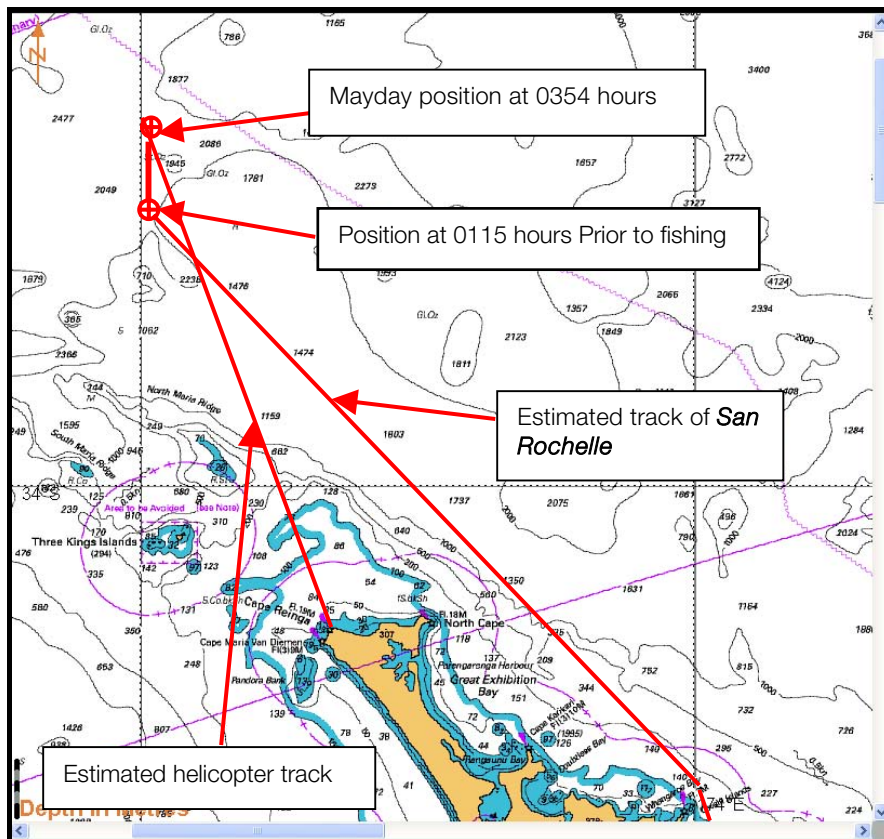
Figure 1 – Estimated Track of **San Rochelle** & Helicopter

At approximately 1230 hours on 24 October 2004, **San Rochelle** departed Auckland. The vessel stopped at Kawau Island to repair a stabilizer arm and proceeded directly towards her intended fishing grounds north of Cape Reinga. On board were the Skipper and two crew. The voyage north was uneventful. At approximately 1600 hours on 26 October, **San Rochelle** arrived at her fishing grounds. The main engine was turned off. Fishing gear was prepared and the crew relaxed. (See Figure 1 - NZ Chart 23 showing approximate track of vessel to fishing grounds and Mayday position).

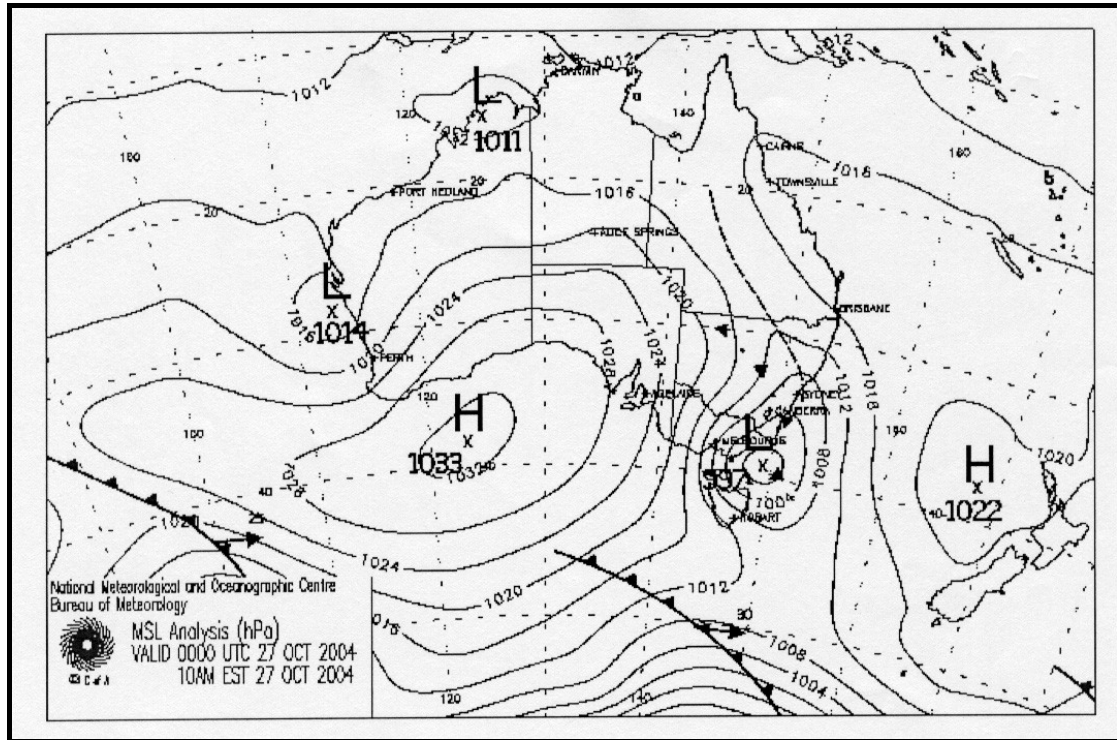
Figure 2 – Weather Situation

The Westpac rescue helicopter logged weather conditions as calm during the rescue. Winds were from the south at 10 knots with a one metre southerly swell (See Figure 2 - National Meteorological and Oceanographic Centre Bureau of Meteorology Weather Situation Valid 0000 UTC 27 October (1300 hours NZDT 2004))
