Accident Report

Grounding

Shangri-La

SHANGRI-LA GROUNDING

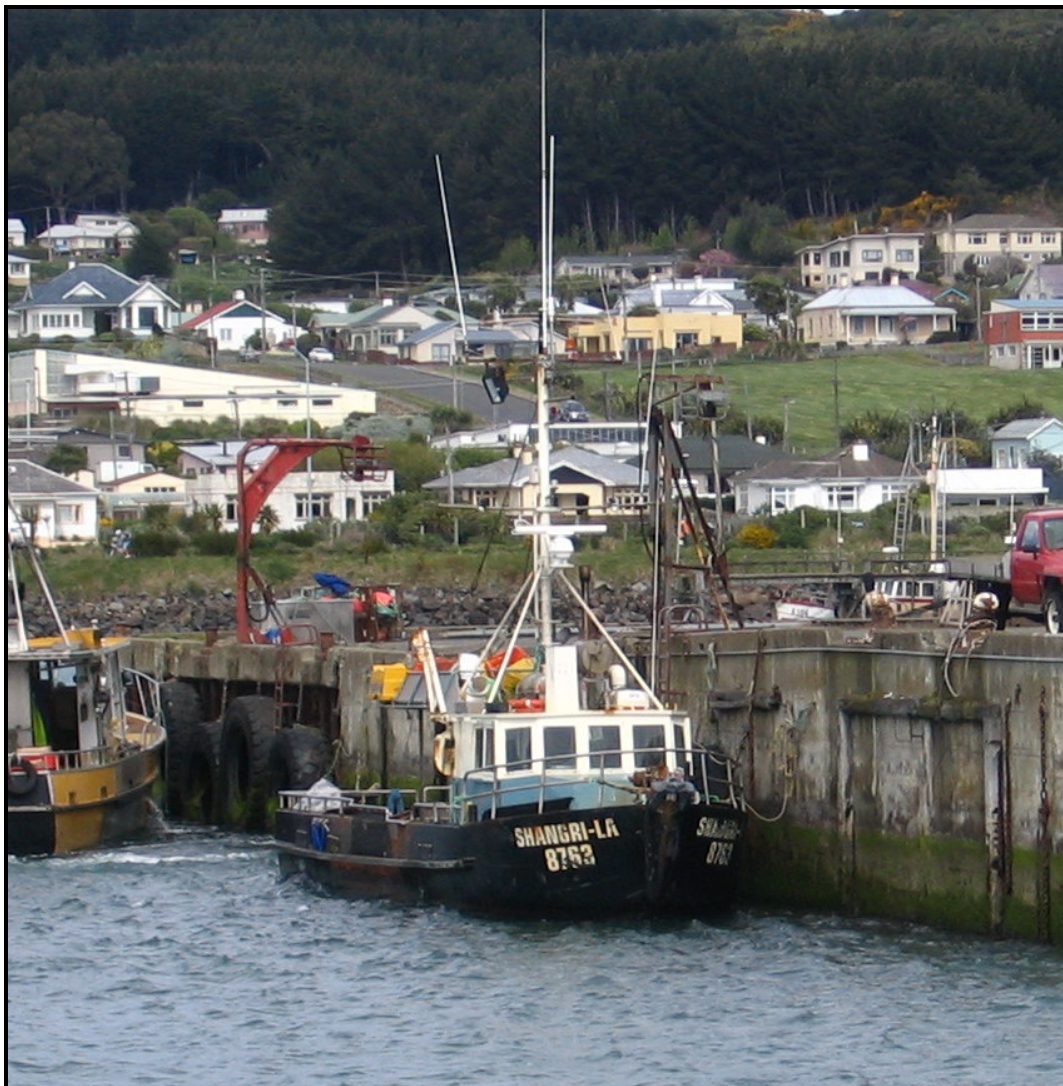
At approximately 0200 on 14 September 2005, the commercial fishing vessel **Shangri-La** grounded at Long Point after the watch keeper had fallen asleep more than two hours previously. The vessel suffered moderate damage, but fortunately there were no injuries to the crew.

The damage suffered by **Shangri-La** included a damaged propeller, which was replaced with a spare. A bent rudder shaft was replaced and a bent tail shaft was subsequently straightened. There was also minor damage to the hull in the vicinity of the transducer.
