Accident Report

Collision

Sinbad 7 & Stingray 1

23 October 2006

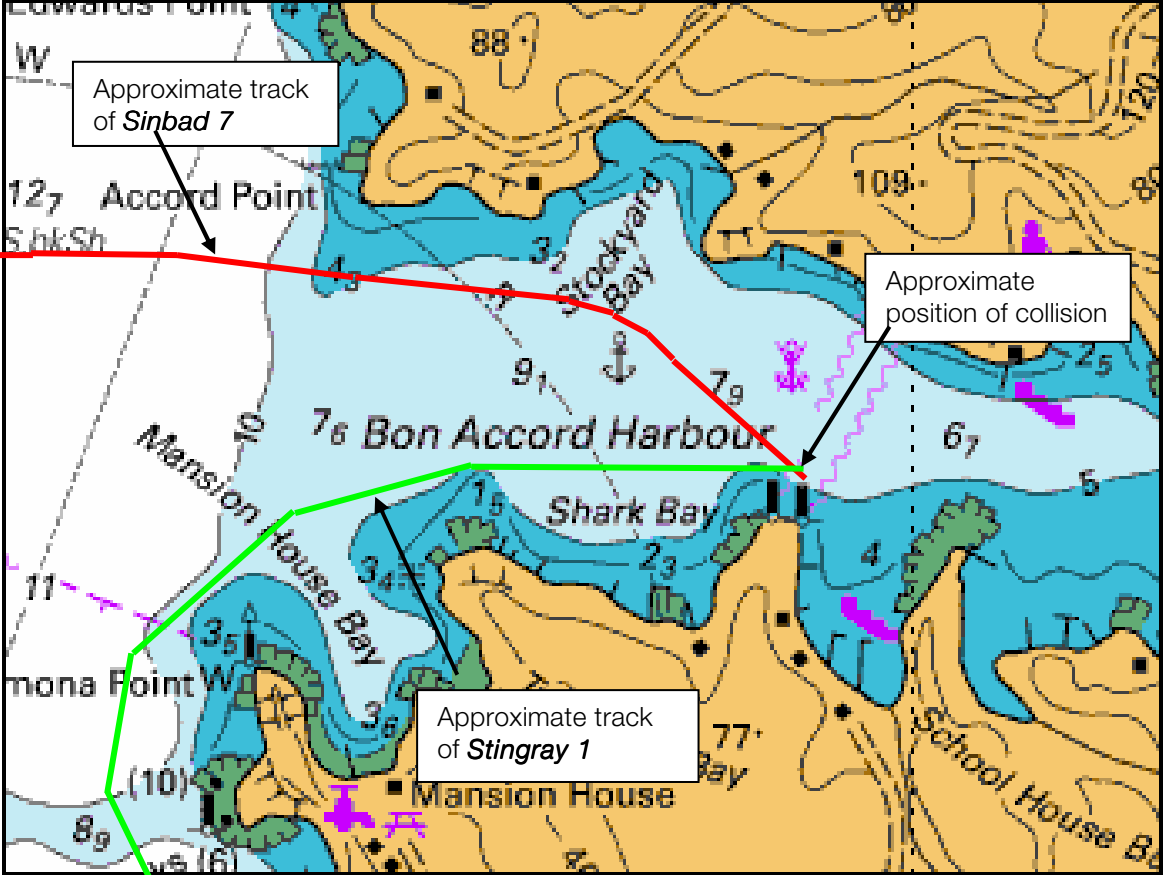
Figure 1
Extract From Chart NZ 5227

At approximately 1510 hours New Zealand Daylight Time (NZDT) on Monday 23 October 2006, the water taxi **Sinbad 7** was approaching Bon Accord Harbour on Kawau Island after a voyage from Sandspit. Based on the readout from the Global Positioning System receiver, **Sinbad 7** was travelling at a speed of 24 knots over the ground. It was bound for Schoolhouse Bay (See *Figure 1*), where the vessel was due to pick up eight passengers.

Sinbad 7 was navigated along the northern side of Bon Accord Harbour until it reached a position off Stockyard Bay (See *Figure 1*), when the Skipper altered course to head south east towards Schoolhouse Bay.
