# Accident Report

Failure of No. 2 Crane

*Tasman Mariner*

REPORT NO.: 05 3847

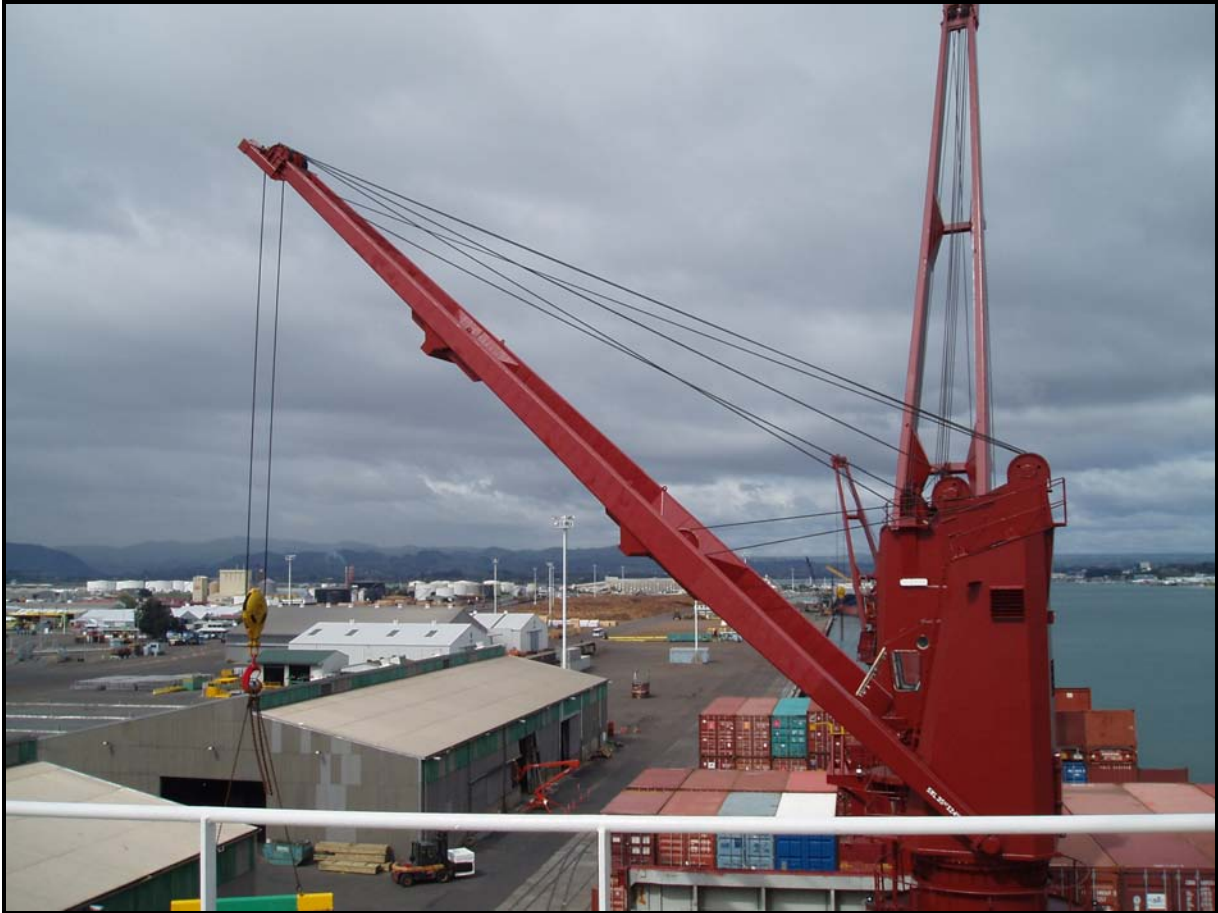
**Photograph 4**

No. 4 Crane (SWL 35 tonnes)

The rigging shown in *Photograph 4* is the same as for No. 2 crane. The topping lift wire rope was attached to the head of the crane, from where it was rove through the sheave fitted approximately four tenths of the length of the jib from its base. The wire rope then led back to a sheave at the crane head and from there to a sheave in the head of the jib. From the jib, it was led to another sheave at the crane head, then down through a guide to the topping winch.
