Investigation Report  
Grounding of *Te Ika*  
17 June 2010

**Maritime New Zealand**

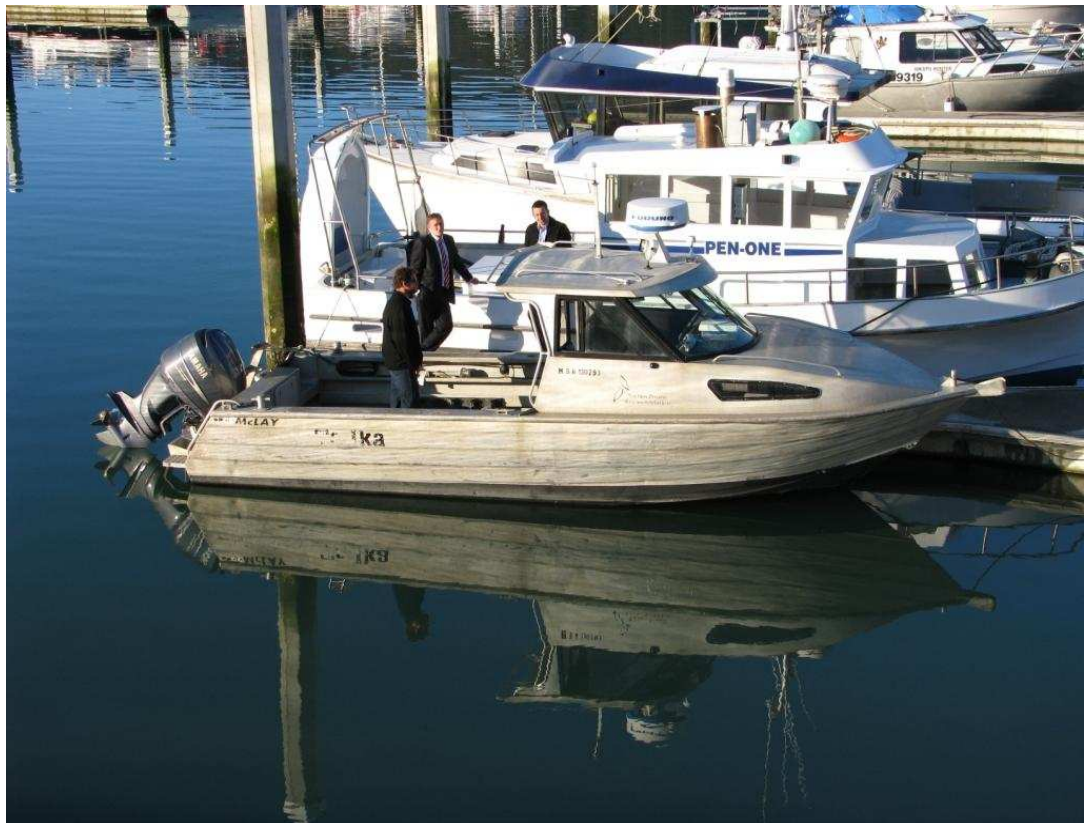
Figure 1 *Te Ika*

3. *Te Ika* is a 7.80 metre standard McLay designed aluminium mono hull, powered by a four stroke Yamaha outboard. The vessel is fitted with a Furuno Navnet which combines a Chart-plotter GPS and RADAR. The unit utilises Navtronics Gold © charting software. The vessel is not fitted with an echo sounder. The normal operating speed for the *Te Ika* is 28 knots. The vessel had a valid Safe Ship Management (SSM) certificate at the time of the grounding.

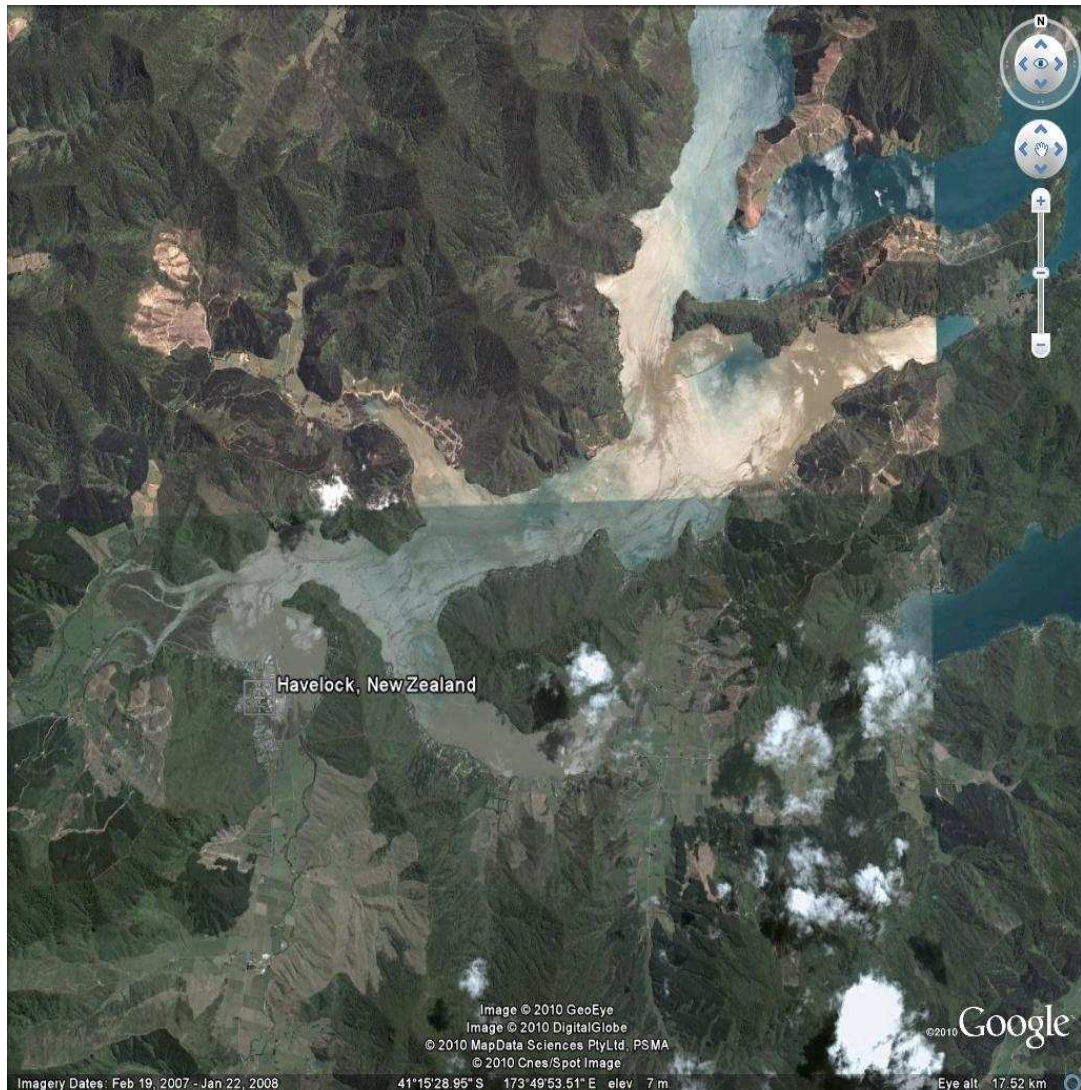
**Figure 4** Google Earth image of Havelock approaches

On 17 June 2010, the vessel *Te Ika* was involved in a grounding incident. The vessel grounded on a mud bank immediately south of Shag Point shortly after departing Havelock. The vessel was travelling at 15 knots (7.7m/s) whilst operating in the hours of darkness and in restricted visibility. The vessel did not sustain any damage nor were there any injuries sustained on board.
