Class A Accident Report

# Tiger III Grounding

At Cape Brett, on 18 December 2004

<b>REPORT NO:</b>	<b>04 3625</b>
<b>VESSEL NAME:</b>	<b>TIGER III</b>
<b>Ship Type:</b>	Restricted Passenger Ship
<b>Certified Operating Limit:</b>	Inshore: Northland, Auckland, Bay of Plenty.
<b>Port of Registry:</b>	Whangarei
<b>Flag:</b>	New Zealand
<b>IMO/MSA/Official No.:</b>	MSA 875120
<b>Built:</b>	1985
<b>Construction Material:</b>	Aluminium Alloy
<b>Length Overall (m):</b>	20.92
<b>Maximum Breadth (m):</b>	8.70
<b>Gross Tonnage:</b>	181
<b>Net Tonnage:</b>	135
<b>Registered Owner:</b>	Fullers Bay of Islands Ltd.
<b>Ship Operator/Manager:</b>	Fullers Bay of Islands Ltd.
<b>Classification Society/SSM Company:</b>	Maritime Management Services Ltd.
<b>Accident Investigator:</b>	Andrew Hayton

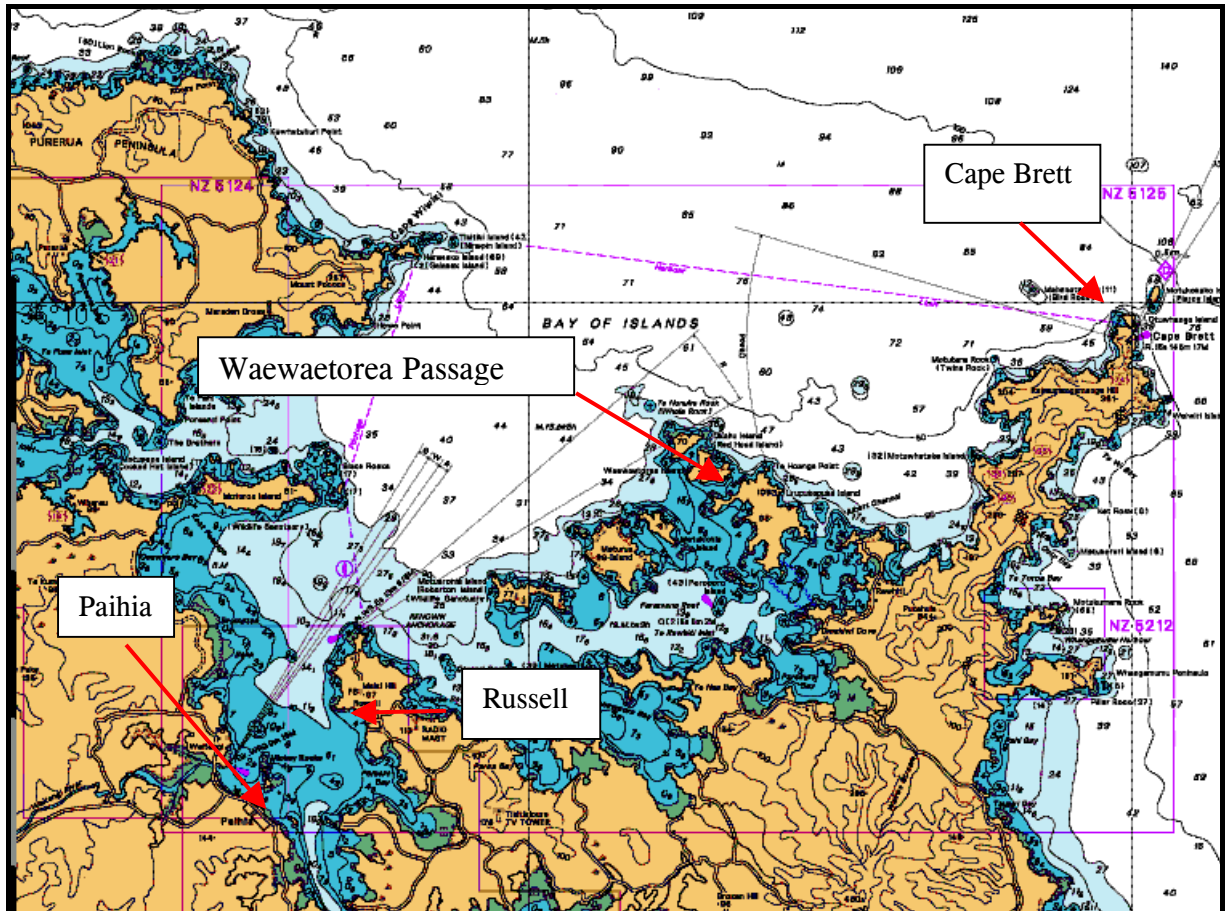
FIGURE 1 - EXTRACT FROM CHART 5125

*Tiger III* proceeded on its usual scenic cruise through the Bay of Islands via the Waewaetorea passage (See Figure 1). Shortly after transiting the passage, Deckhand (1) did his routine checks of the machinery spaces and opened the black water valves in order to commence discharging sewage from the vessels' holding tanks; he observed nothing out of the ordinary. When *Tiger III* arrived off Piercy Island (See Figure 2), the weather and sea conditions were such that the Skipper decided that it was too rough to pass through the 'Hole in the Rock' (a natural tunnel which passes through Piercy Island). Instead, the Skipper made a 360° turn off the southern entrance to the Hole to enable all the vessel's passengers to have a good view. The

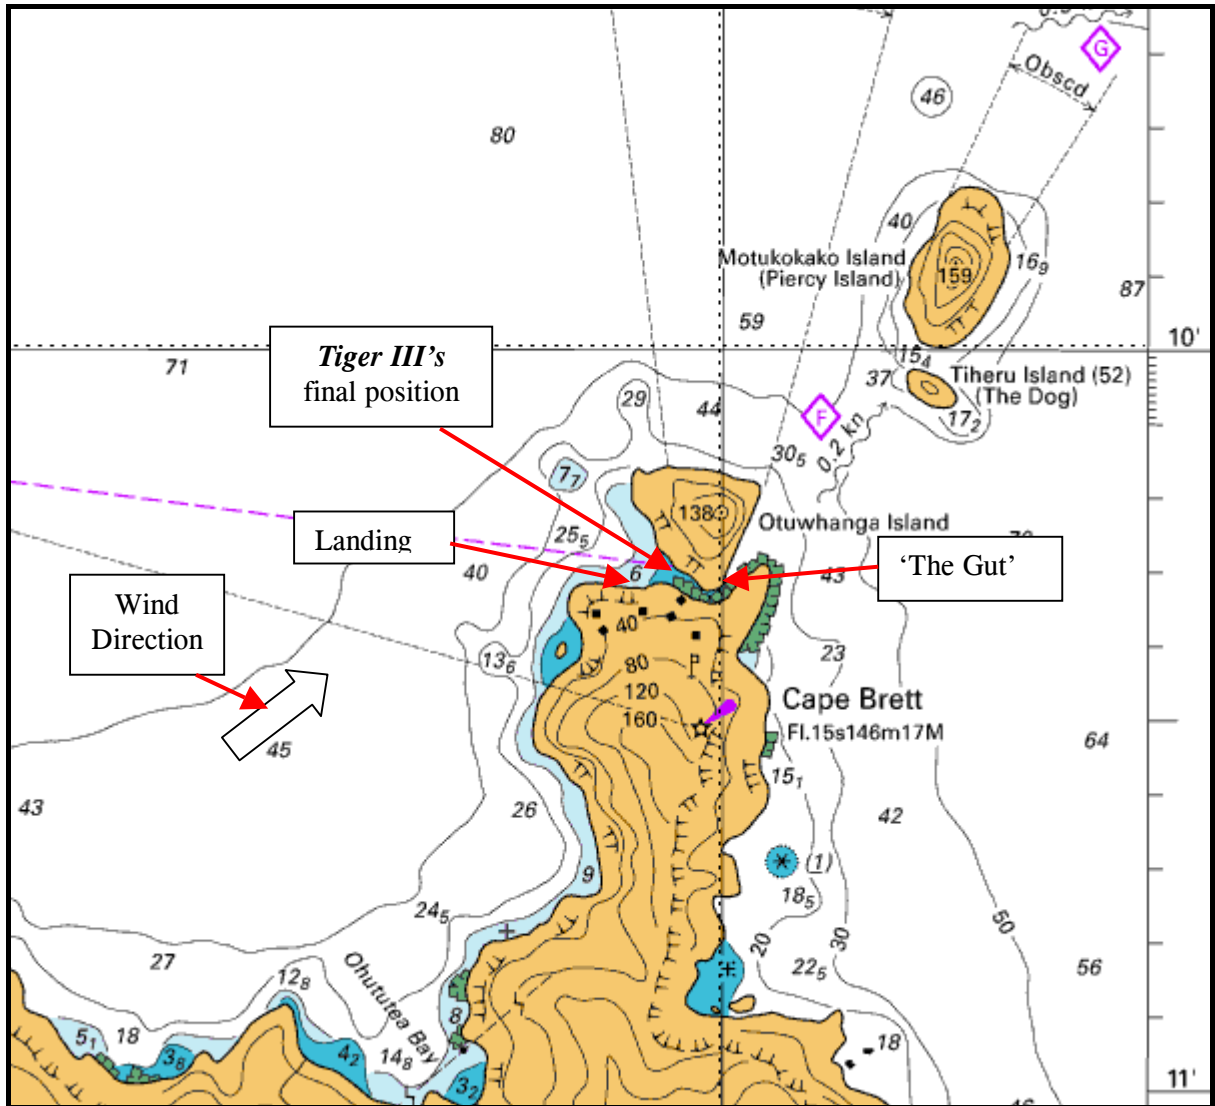
FIGURE 2 - EXPANDED CHART EXTRACT FROM NZ 5125

After spending several minutes in the vicinity of Piercy Island, *Tiger III* then proceeded around the west coast of Otuwanga Island towards the landing below Cape Brett Lighthouse (See Figure 2).

The Skipper wanted to try and get the wind on the port quarter of the vessel and by going astern on the starboard engine hoped to be able to keep the wind on the port quarter and 'walk' the vessel astern out of the cove. He put the helm hard to port and went ahead on the starboard engine. The engine was stopped before hitting the rocks on Otuwanga Island and the vessel was set towards the 'Gut' (See Figure 2 & Figure 3 - Position 'C').
