Accident Report

Capsize

Time to Burn

31 August 2008

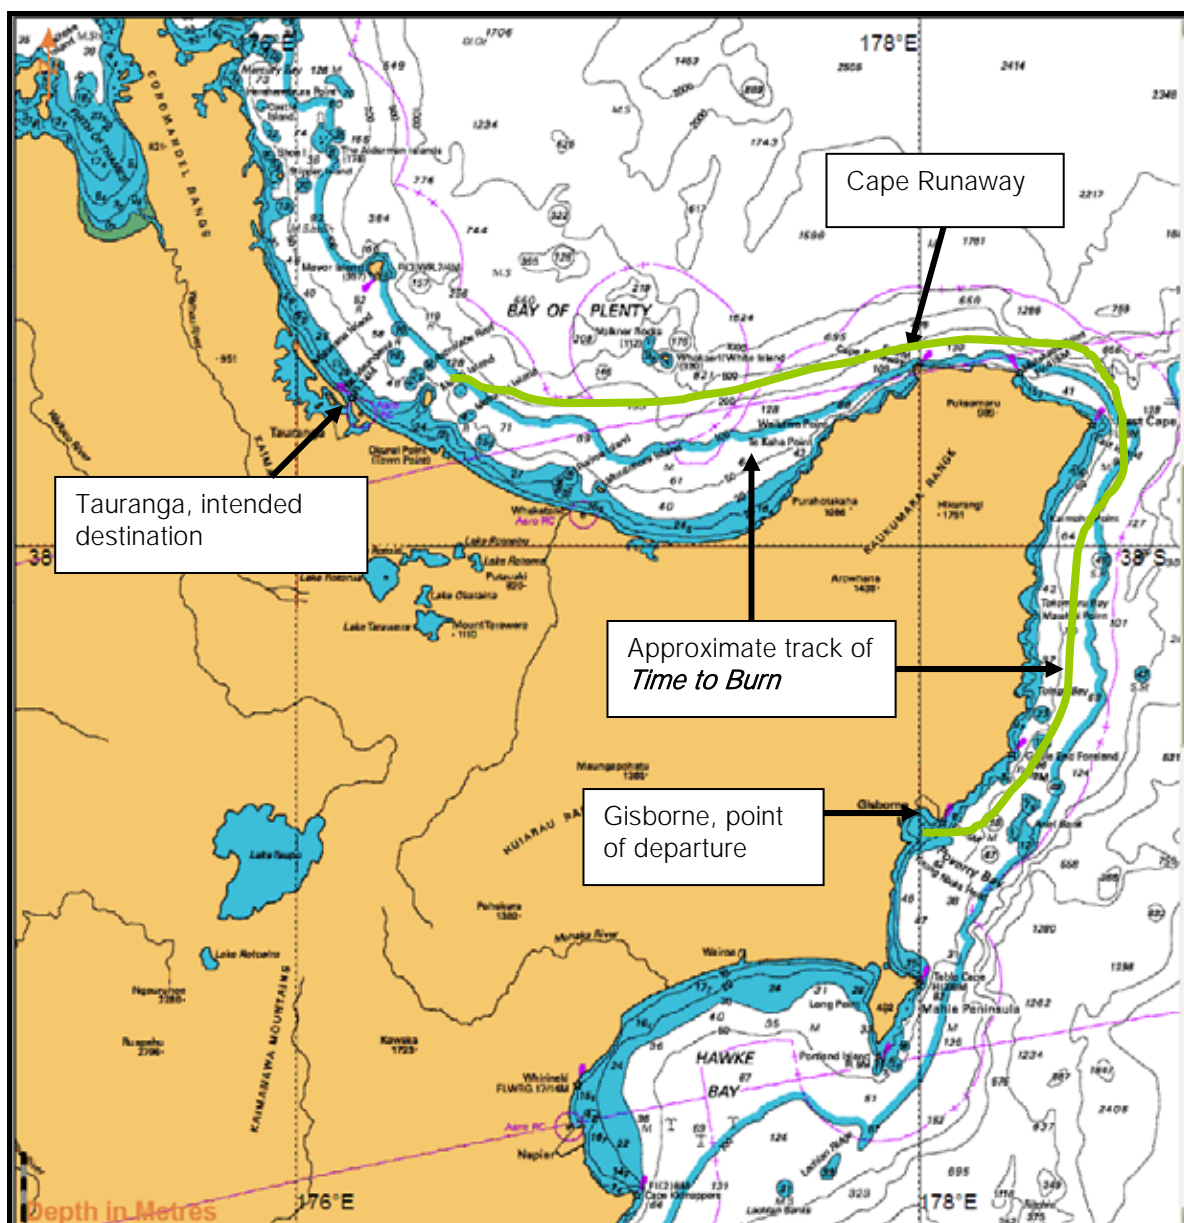
Figure 1
 Extract of chart NZ23 New Zealand North Island, showing the approximate track of *Time to Burn* from Gisborne. (See figure 2 for detail on the vessel position off Tauranga.)

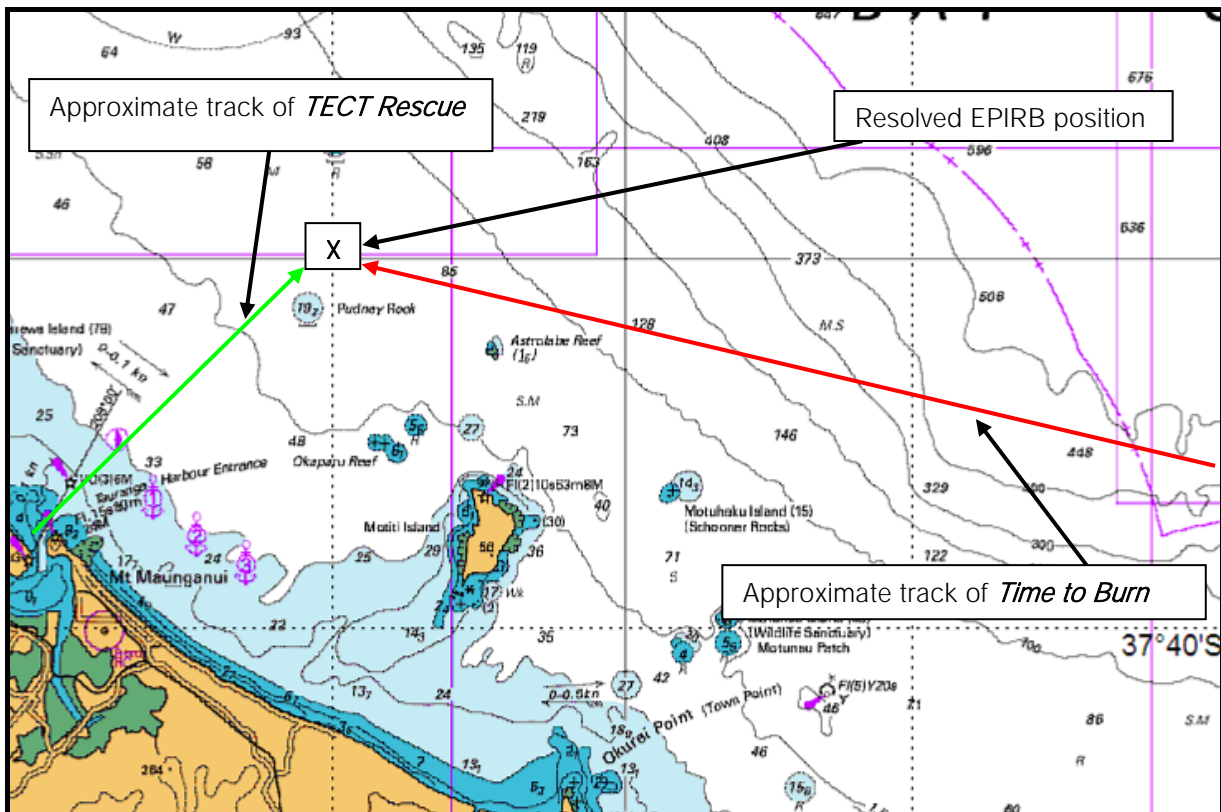
Figure 2
Extract of chart NZ54, showing approximate track of *Time to Burn*, *TECT Rescue* and resolved EPIRB position.

0636 hours – The next satellite pass occurred and generated a second alert from the 406 MHz EPIRB transmissions. This alert gave a location for the distress at the position 37° 30'S 176° .20'E. RCCNZ gave this position to the aircraft, helicopter and Coastguard vessel. This was the first time that the agencies involved had a definite position to work with. (See figure 2 for resolved EPIRB position.)

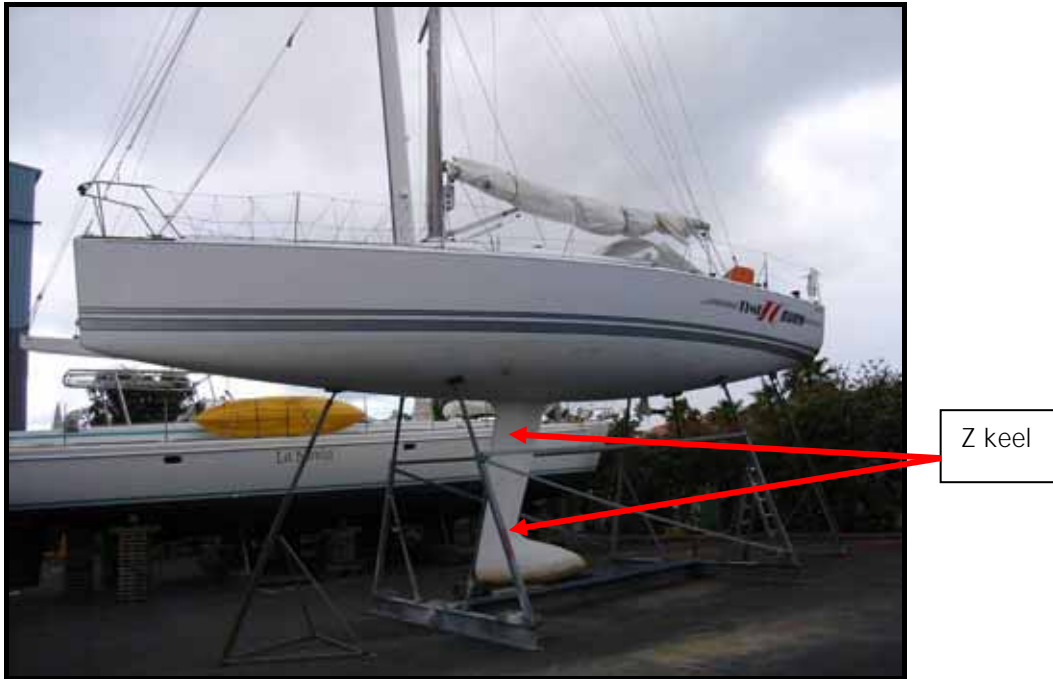
Photograph 3

(Courtesy of Hunter Marine Surveying Ltd) *Time to Burn* on a traditional cradle.

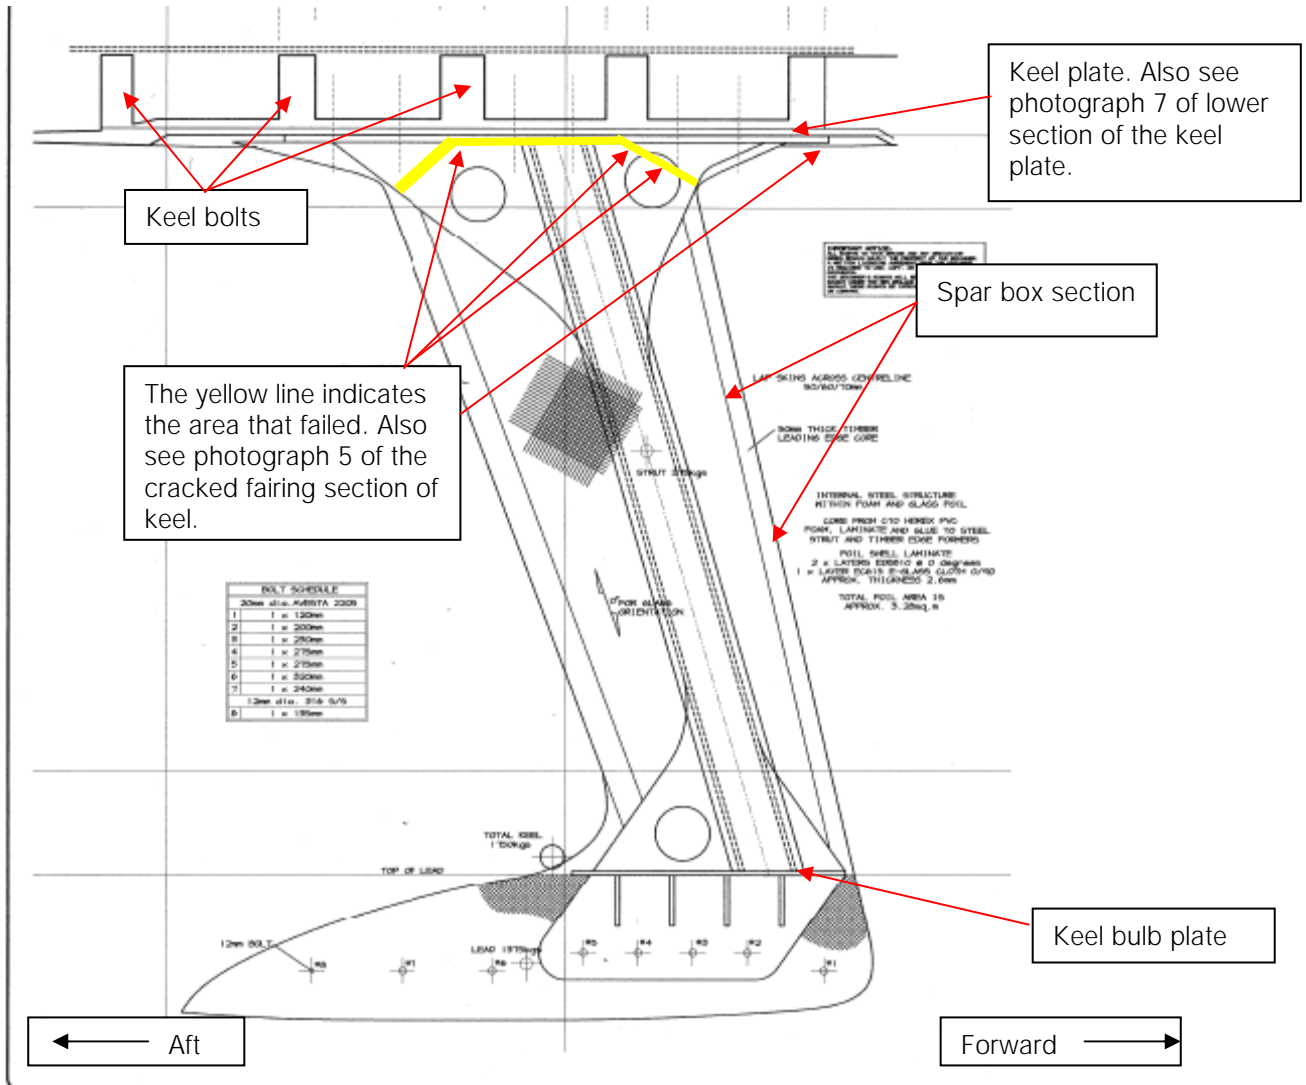
- 3.35 In simple terms, *Time to Burn's* keel plate, on which the keel structure was welded, was secured to the vessel's hull by bolting it to the hull. The keel plate was held in place by steel bolts. (See figures 3 and 4 and photograph 6 showing keel bolts.)
- 3.36 The keel comprised three basic parts: the keel plate (the part that bolts to the hull), the rectangular hollow section spar (the part that is fixed to the keel plate), and the bulb (the bulb is fixed to the hollow spar forming the bottom of the keel). The rectangular hollow section spar was connected to the keel plate by welding it to the plate.

3.37 The transverse loading (left and right) of the keel was distributed across a relatively small area that measured 11 cm between the points where the spar was welded to the keel plate. The vertical web plates of 12 mm steel provided only fore and aft support. (See photograph 8 showing the weld failure where the spar was welded to the keel plate.)

Figure 3
A plan drawing of *Time to Burn's* keel.

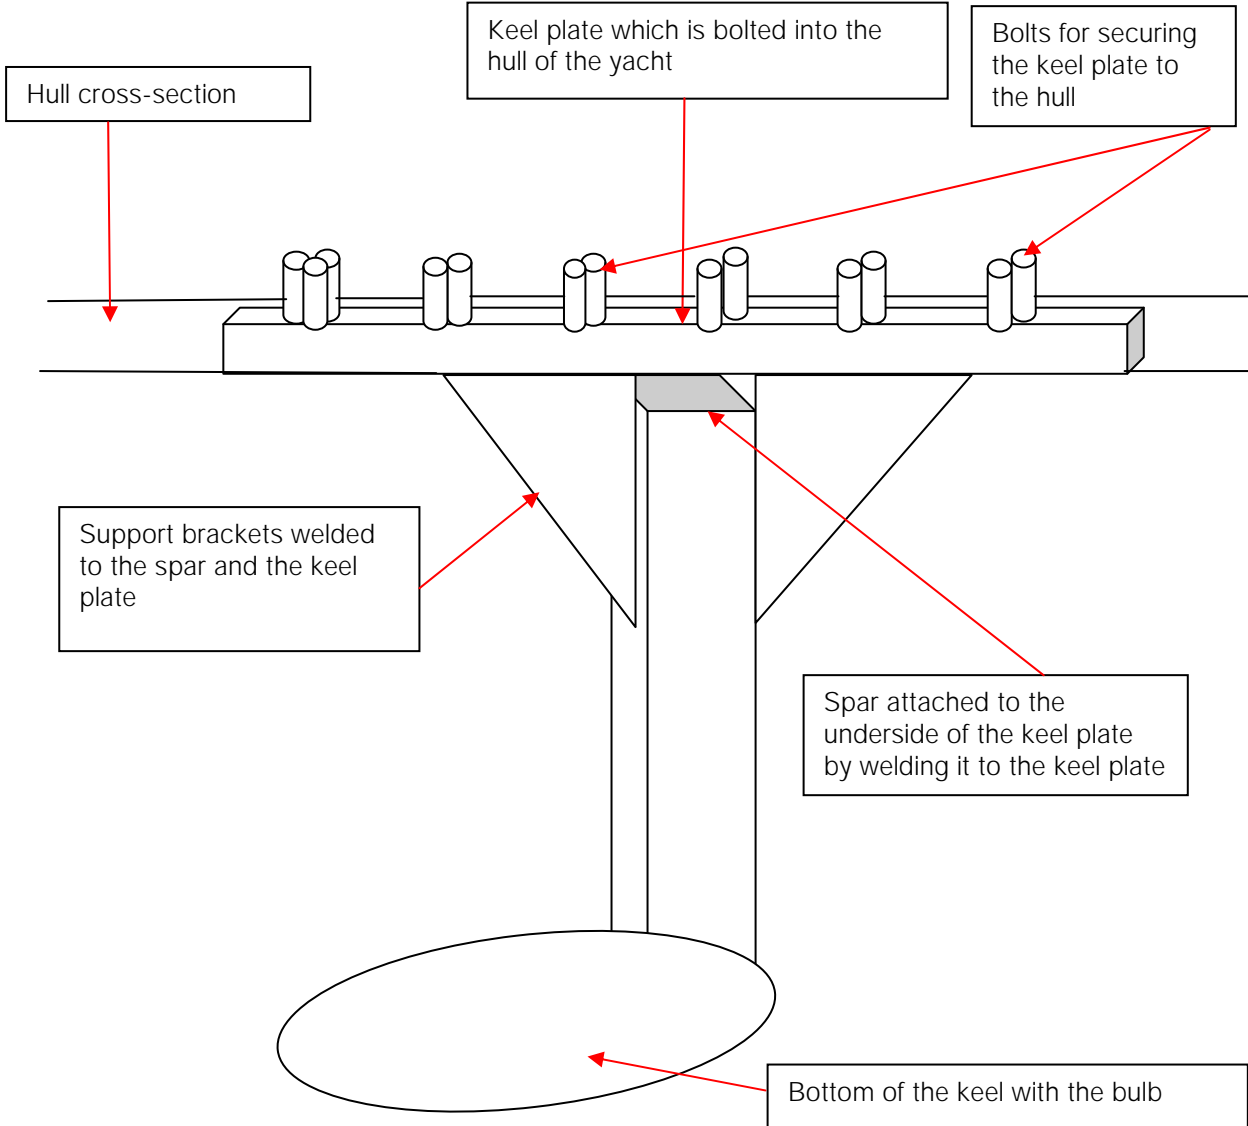
Figure 4
Visualisation of keel structure.

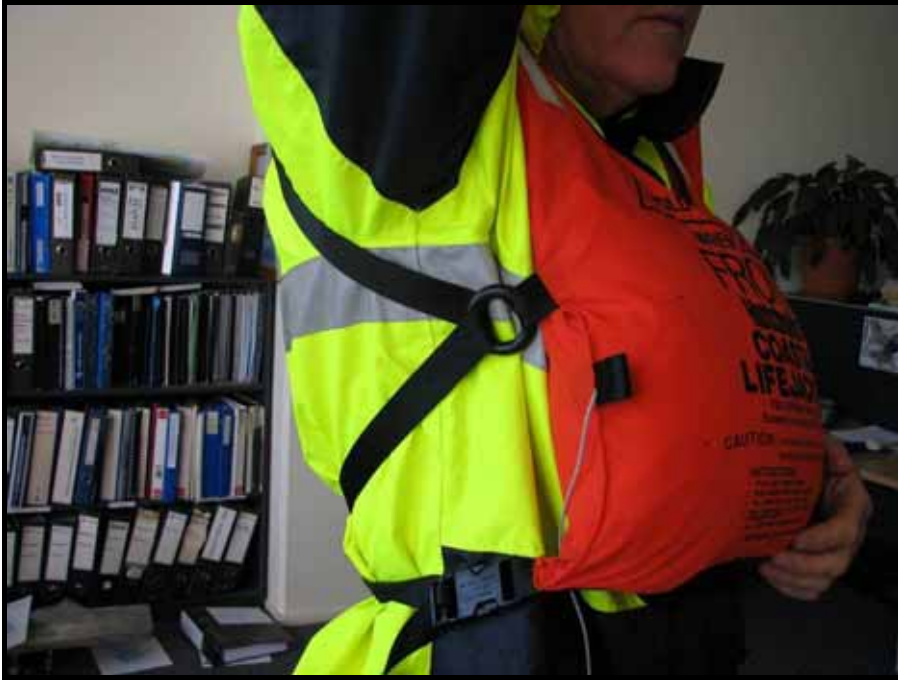
- 3.75 A properly fitted lifejacket is vital in situations where people in the water become tired, hypothermic or lose consciousness. (See photographs 10 and 11 of correctly and incorrectly fastened lifejackets.)

Photograph 10
Correctly fitted lifejacket.

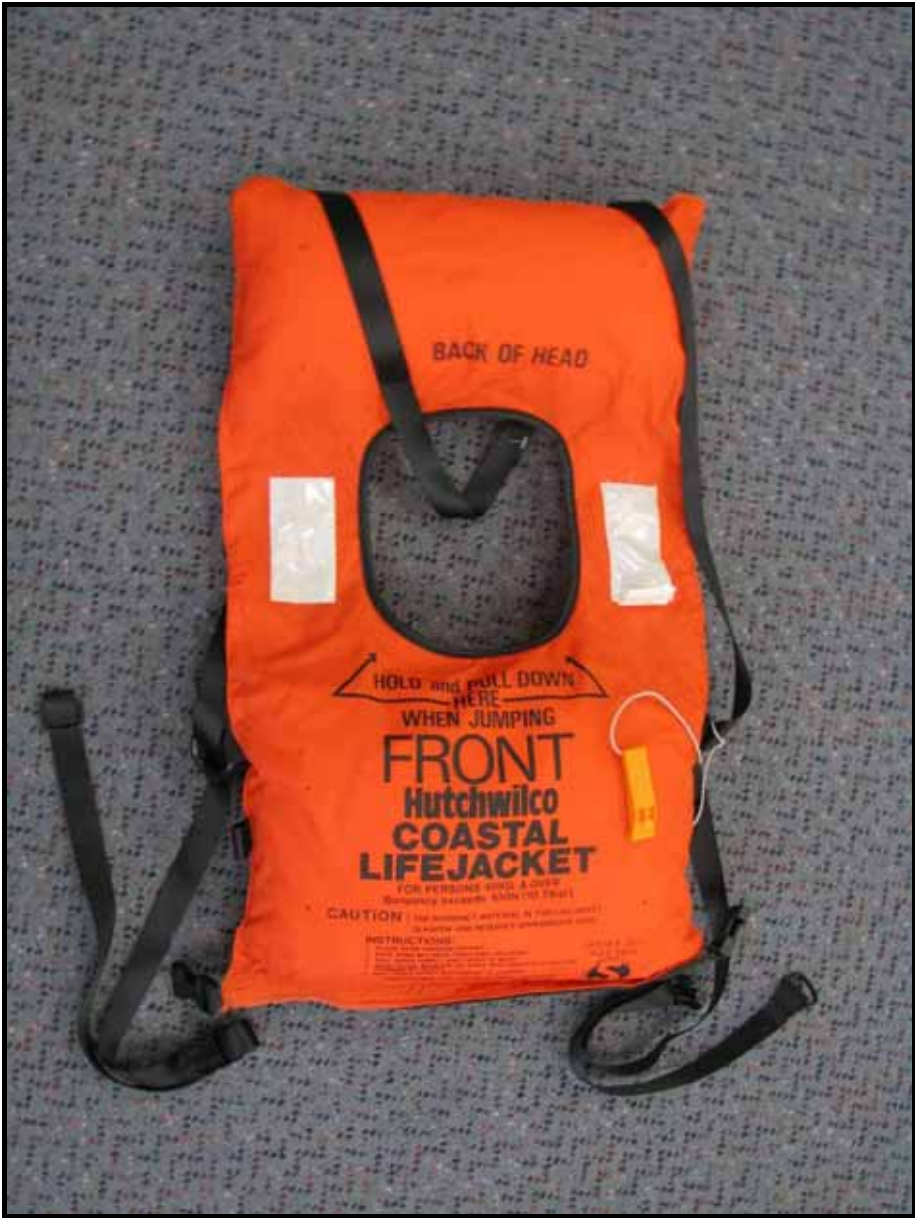
- 3.66 The crew opted to wear the 401 offshore lifejackets after previously experiencing failures with inflatable lifejackets. The offshore lifejackets are described as suitable for persons 40 kg and over with buoyancy exceeding 100 newtons¹³. The lifejackets were approved to NZS 5823. (See photographs 12 and 13 of the coastal lifejackets.)

Photograph 12
One of the coastal lifejackets worn by the crew.

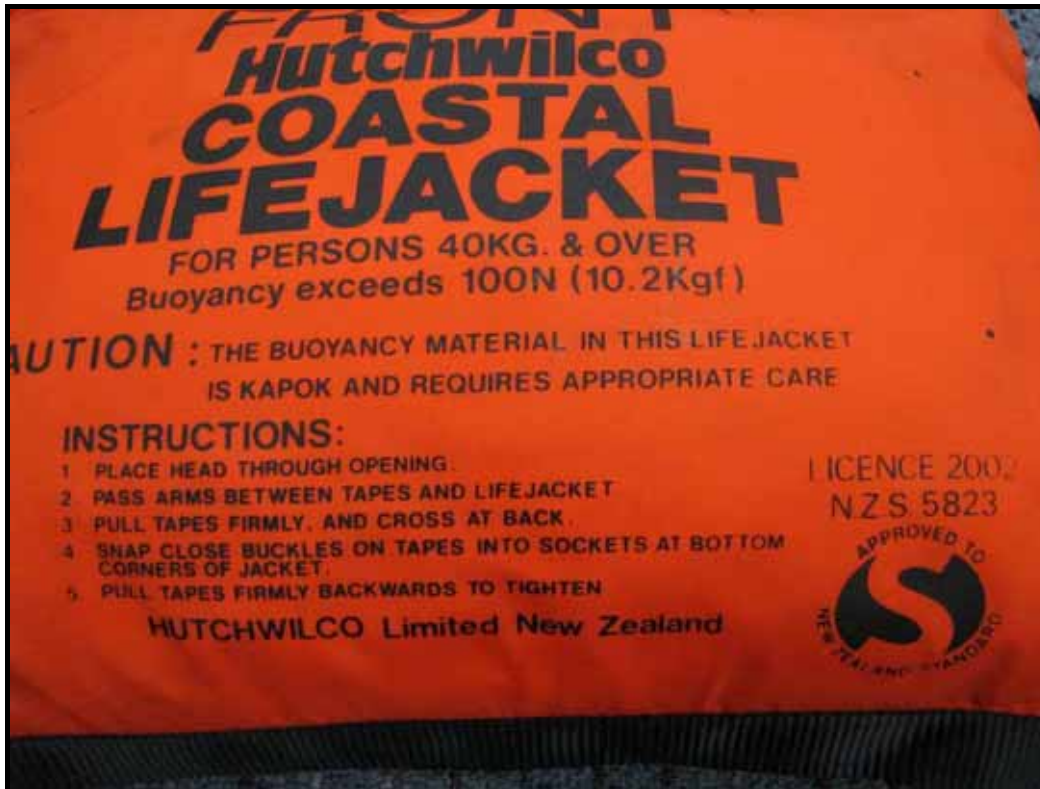
Photograph 13

Information on one of the coastal lifejackets worn by the crew.
