Accident Report
Fatality
Unnamed Canadian Canoe
23 May 2008

Maritime New Zealand

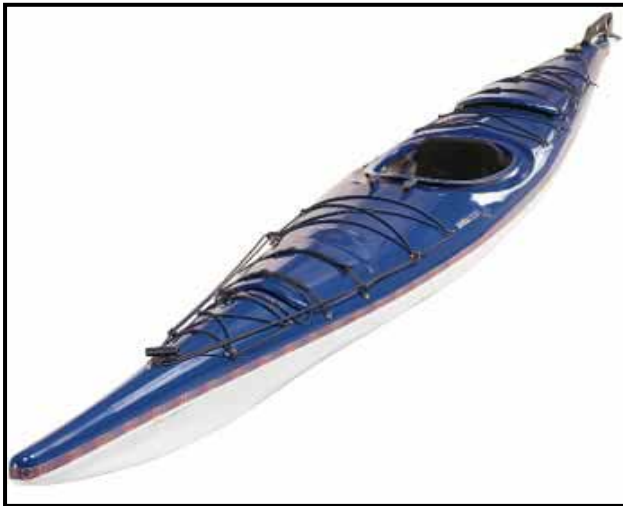
Figure 1
Closed top kayak

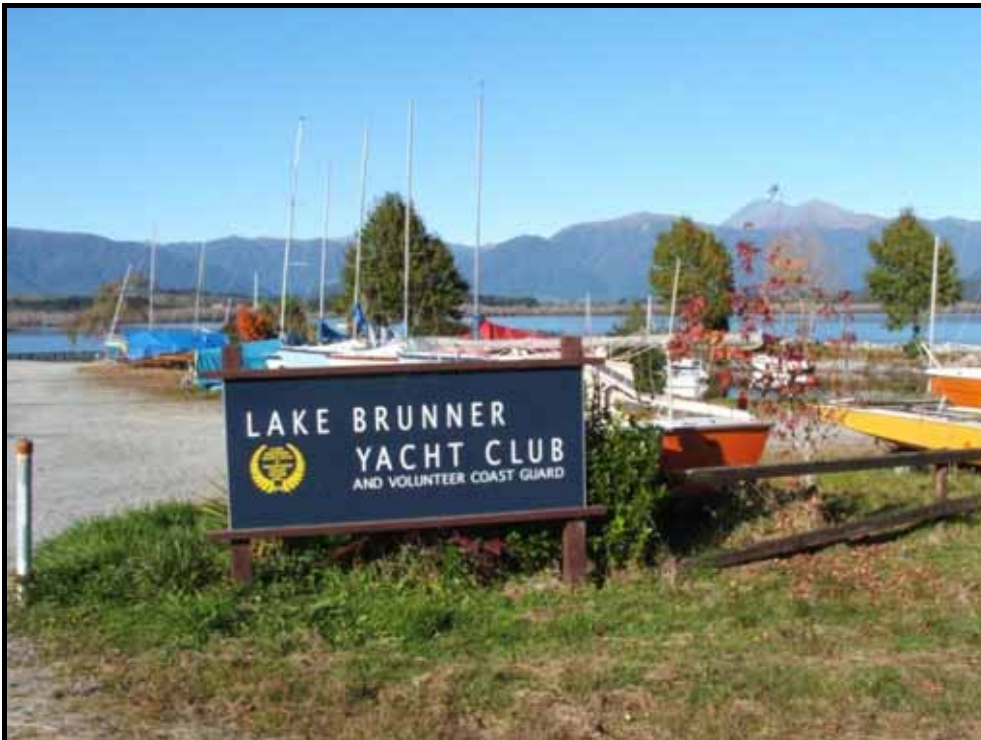
Figure 4
The Lake Brunner Yacht Club where Mr Hill left his vehicle.
Ref: DSCF0358 - Photograph taken on 27 May 2008 at 1256

Lake Brunner was calm at the time Mr Hill left his vehicle there and a local resident who was a witness, stated that it was similar to the conditions shown in this photograph.
