Accident Report

Fatality

Unnamed Jetboat

11 August 2005

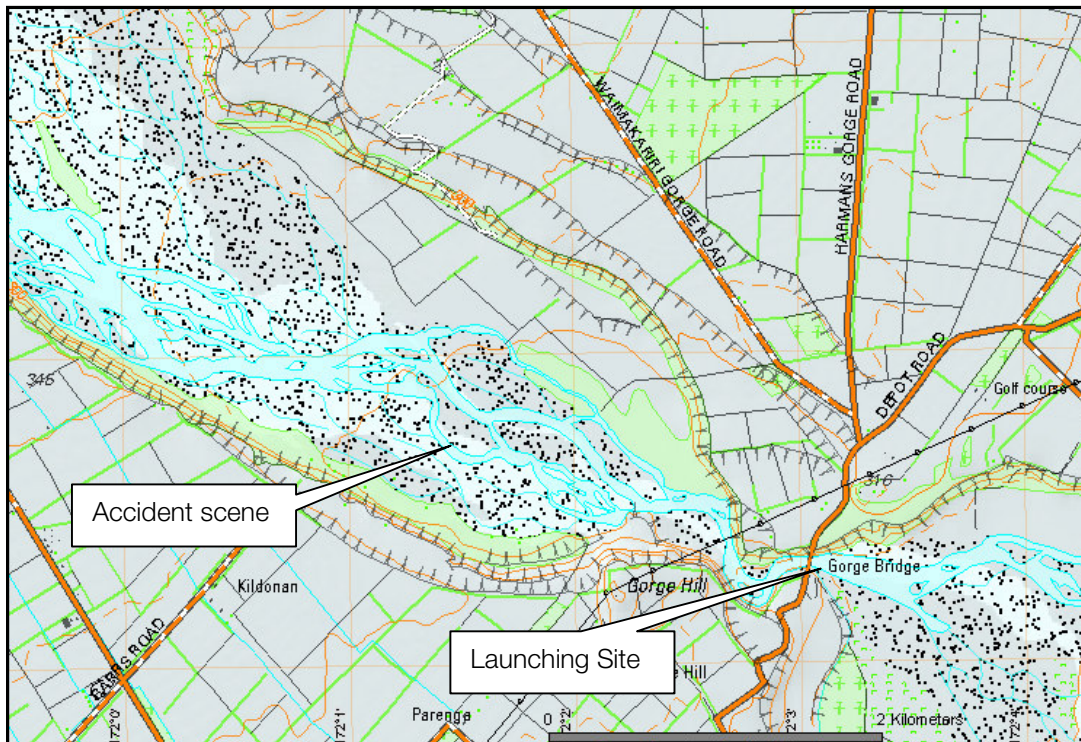
Figure 2

Mr Burrows then continued trying to get the vessel down the river leaving Friend Two behind. Later, Friend Two noticed the boat had stopped but there was no sign of Mr Burrows (See *Figure 3*). The vessel was estimated to be travelling at about 56-60 kph judging by the impact on the rocks.

Extract from Land Information New Zealand Topo Online – Approximate position of accident. *The river braids shown above change regularly due to the nature of the river.*

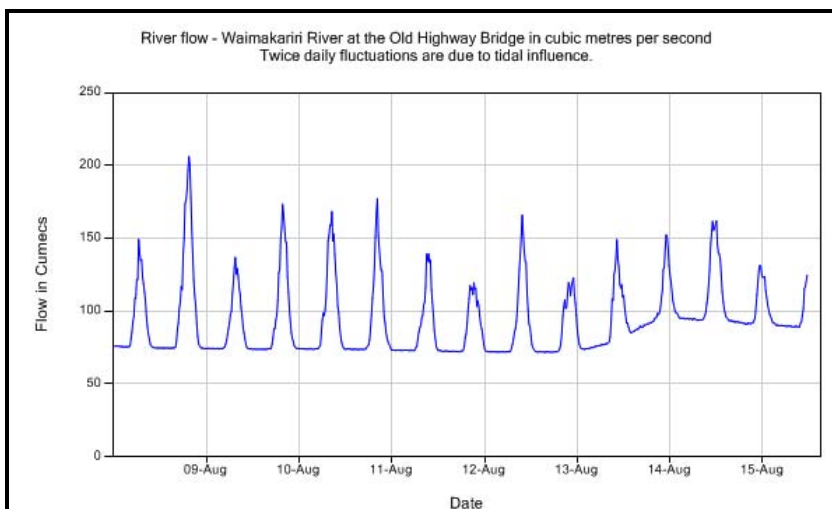
Figure 4
River Flow at the Old Highway Bridge – Waimakariri River

The stage height at the Waimakariri River Gorge Bridge was 1.4 metres on both the day of the accident and the day after during the accident scene investigation. This height is considered a normal stage height for the Waimakariri River.
