Accident Report  
Capsize Resulting in 1 Fatality  
*Kayak*  
11 March 2005  
Class A

REPORT NO.: 05 1185

Vessel Type:	Minnow Kayak
Construction Material:	Plastic
Accident Investigators:	Ian Logie & Andrew Hayton

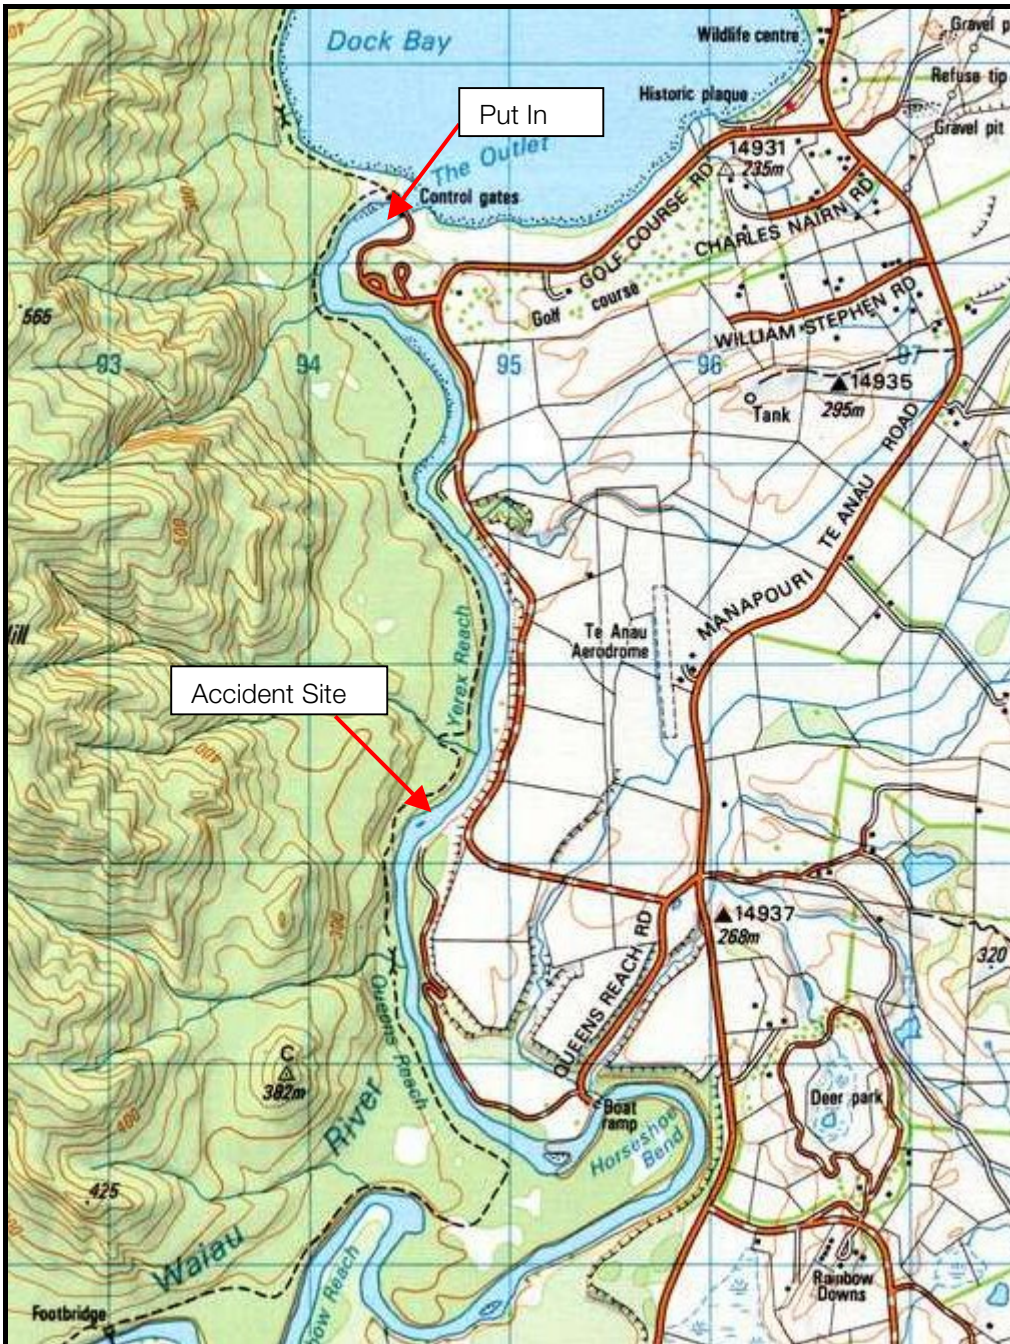
Figure 1

Grid Reference NZMS 260: D43 – Showing Put In Position & Accident Site

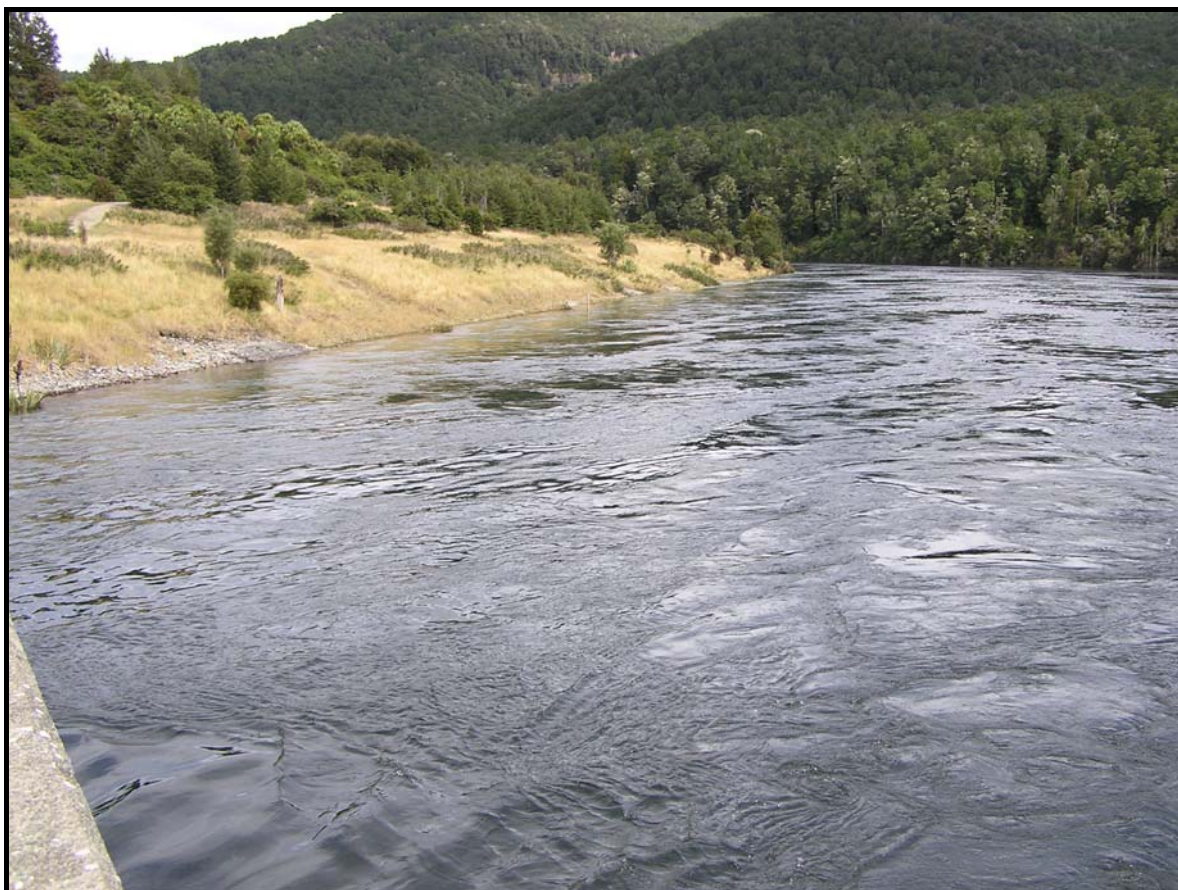
The Kayakers had a wholemeal loaf and muffins for lunch and decided to go paddling despite their initial decision not to – with only one PFD. Kayaker 2 wore the PFD that they did have because she fitted it and Kayaker 1 did not. They put on the river at approximately 1600. This was in the eddy on river right directly beneath the Lake Te Anau control gates (See *Figure 1 – Grid Reference NZMS D43 945132 & Photograph 4 – View of eddy at Put In [river left]*).

View of eddy at Put In (river left)

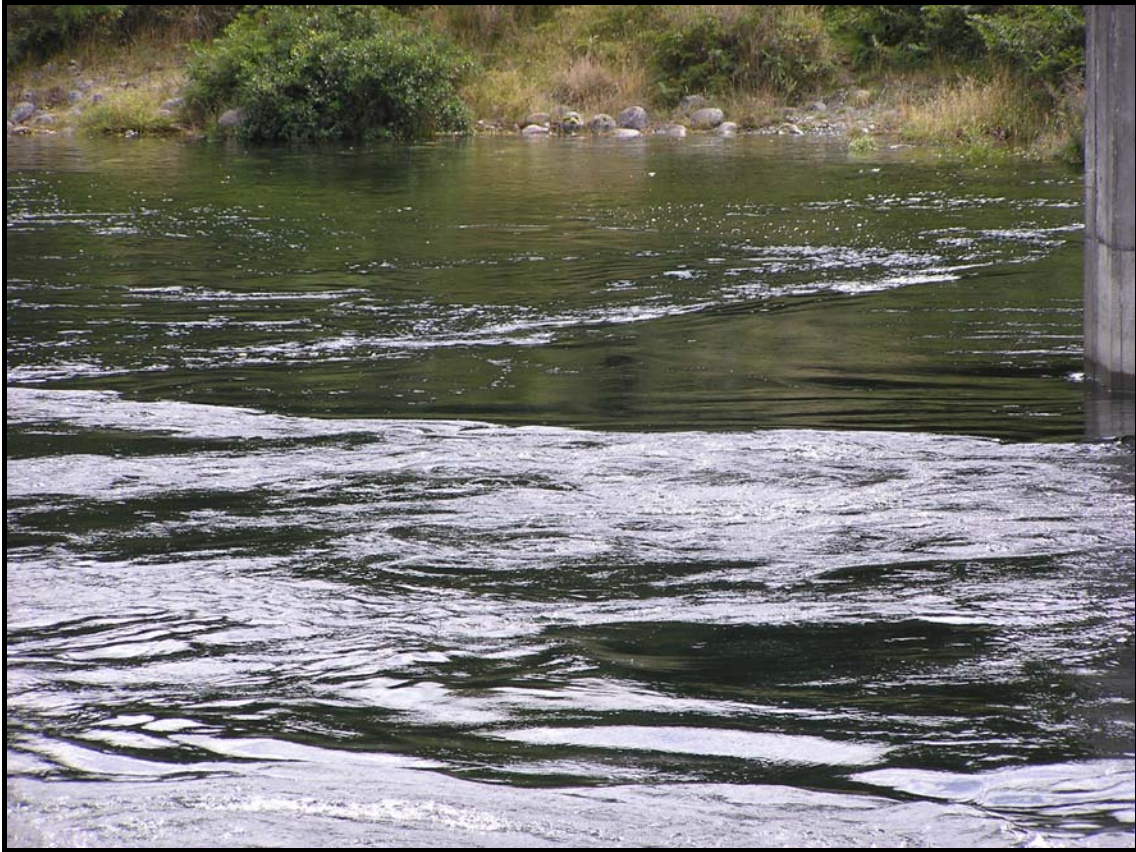
### Photograph 5

They ferry glided across the river “a couple of times” (See *Photograph 5 – View of Eddy river right at Put In*) and were in control, paddling straight lines, and making the eddy turns the way they wanted to. They continued their discussions about whether to continue on down river or not as it was “50/50” on should they go or should they not. Factors that they considered included:

View of Eddy river right at Put In
