Accident Report
Foundering resulting in 2 fatalities
Viper 1
16 March 2009

Maritime New Zealand

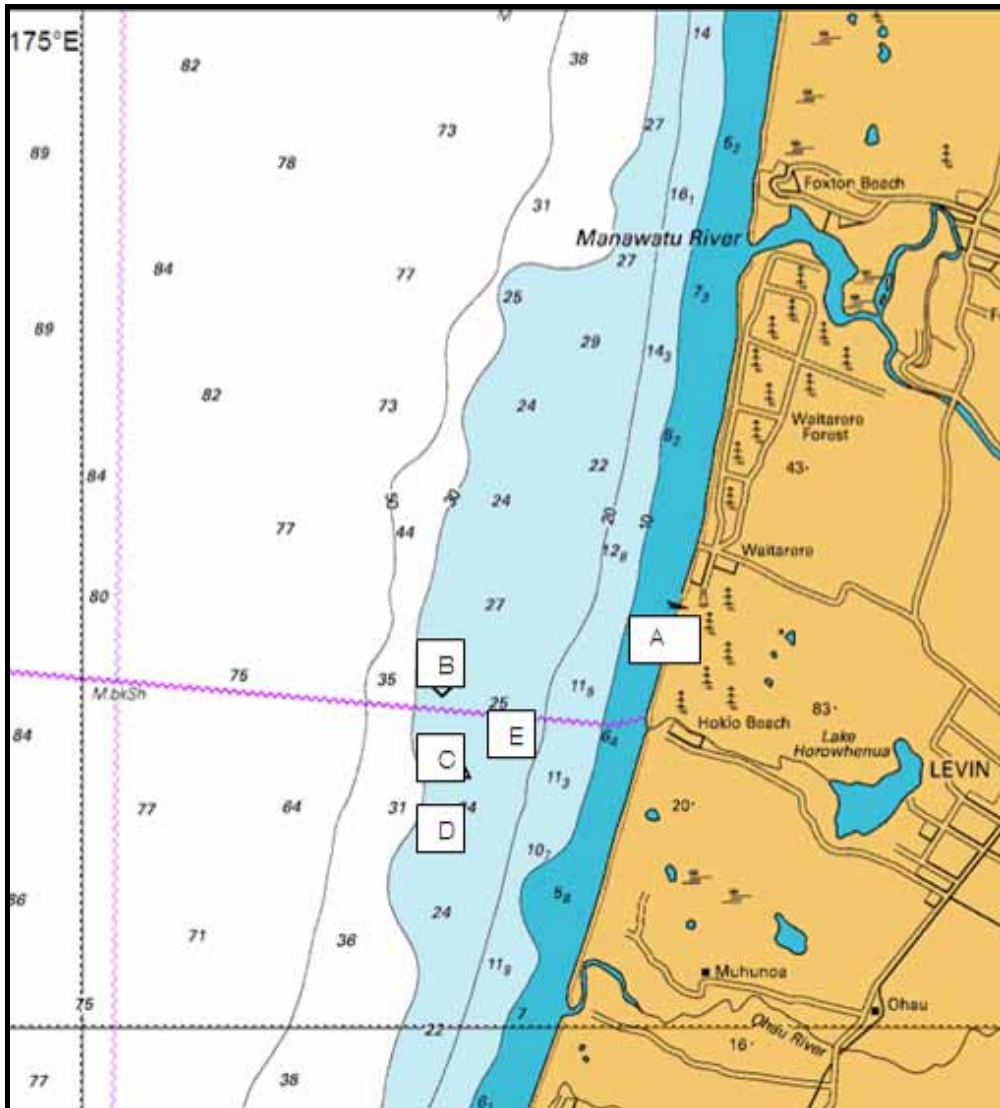
Figure 1
Image taken from Chart NZ46.

The above chart shows the following locations:

- A location of trailer and general area of launching
- B *Viper 1* found by Coastguard
- C passenger located
- D skipper located
- E anchor located.

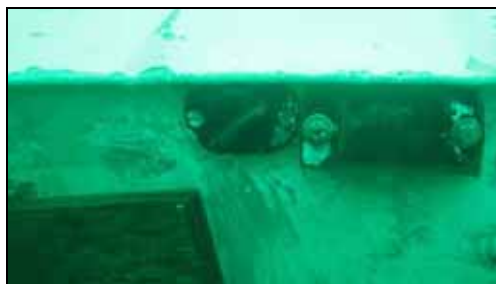
Photograph 16

3.28 *Viper 1* was fitted with a non-automatic bilge pump, and was known to leak to the extent that the fuel tank would sometimes begin floating. To rectify this, the skipper was known to usually turn the bilge pump on when returning to shore, however, the bilge pump was known to be unreliable.
