Accident Report  
Fatality  
*Unnamed Canadian Canoe*  
23 May 2008

## **Maritime New Zealand**

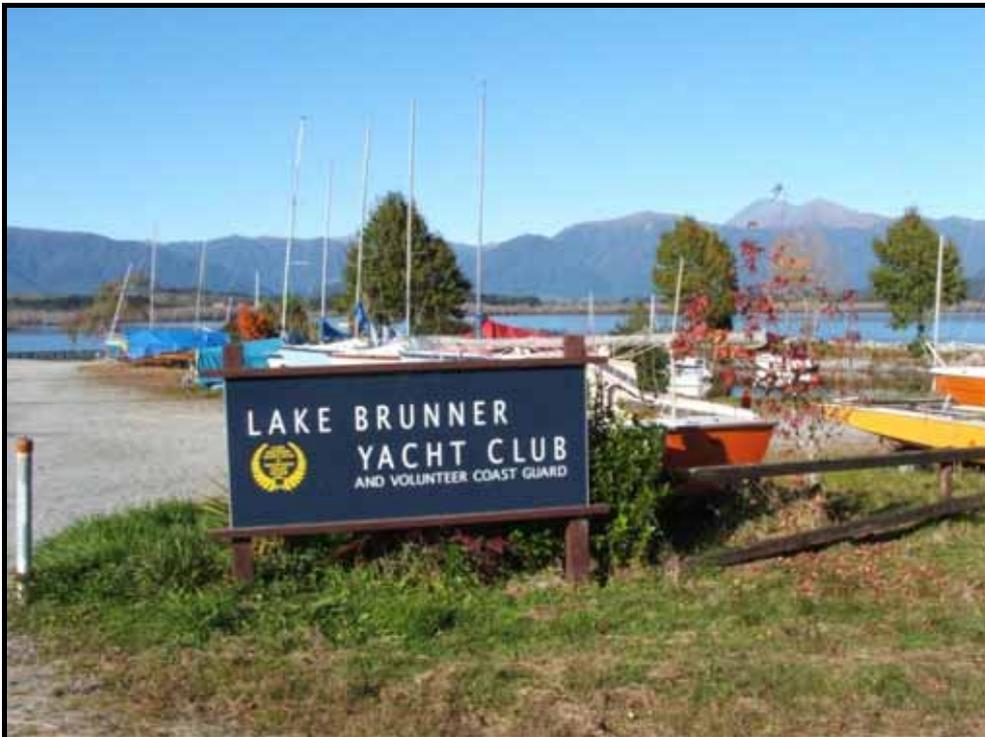
**Figure 4**  
The Lake Brunner Yacht Club where Mr Hill left his vehicle.  
Ref: DSCF0358 - Photograph taken on 27 May 2008 at 1256

Lake Brunner was calm at the time Mr Hill left his vehicle there and a local resident who was a witness, stated that it was similar to the conditions shown in this photograph.
