# Accident Report

*Aquilo*

Person Overboard/Fatality

REPORT NO.: 04 1155

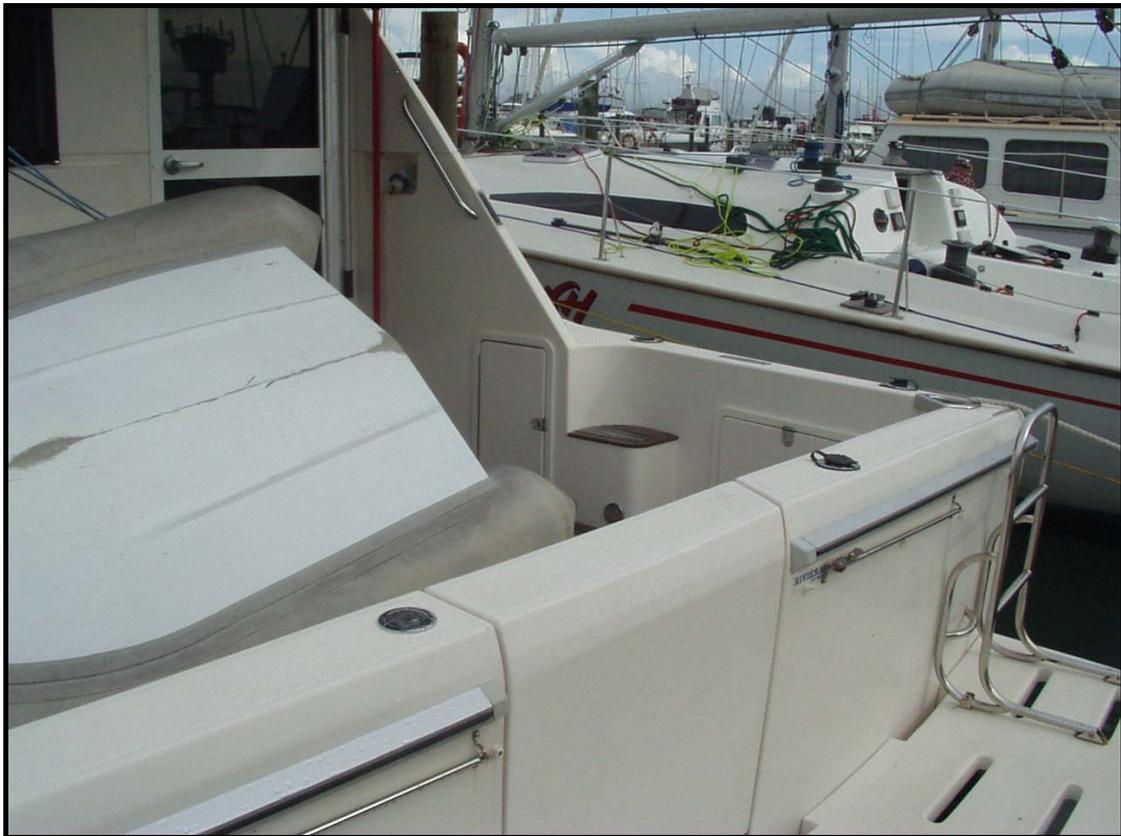
At about 1700 hours **Aquilo** moved further into the bay and anchored in the area with about 10 other vessels, including the yachts **Redeeder** and **Entourage** (See Figure 1). There was a light northwest wind.
