Accident Report  
*Arahura*  
Mechanical Failure in Tory  
Channel on 14 December 2004  
Class B

## REPORT NO.: 04 3626

# ARAHURA – MECHANICAL FAILURE

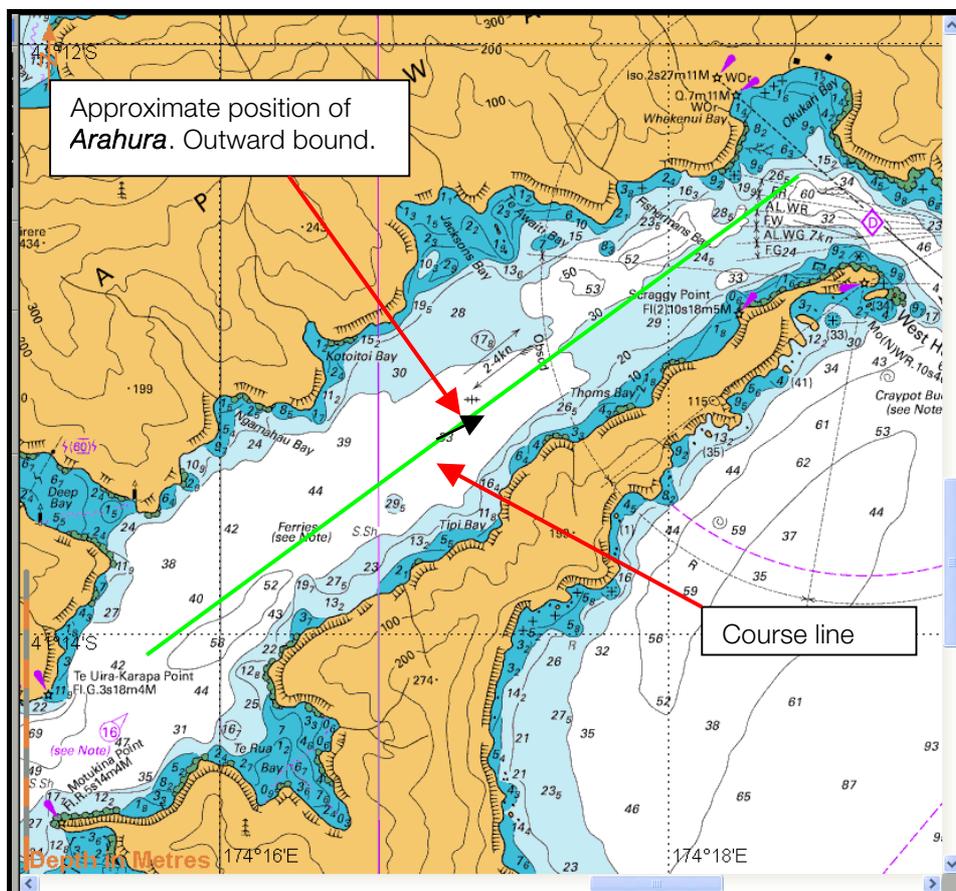
Figure 1

Whilst *Arahura* was transiting Tory Channel (Figure 1), a shore based Electrical Contractor was tracing/eliminating earth faults in the vessel's main engine room. These faults had been the cause of previous spurious alarms on the CSI alarm and monitoring system. The function of the system was to monitor the sensor outputs from the four diesel driven alternators (PE's – Figure 2 ). The PE's provided electrical power to four electric propulsion motors (PM's – Figure 2 ).
