Accident Report
Serious Harm Injury to Passenger
aboard Dolphin Discovery V
4 January 2010

Maritime New Zealand

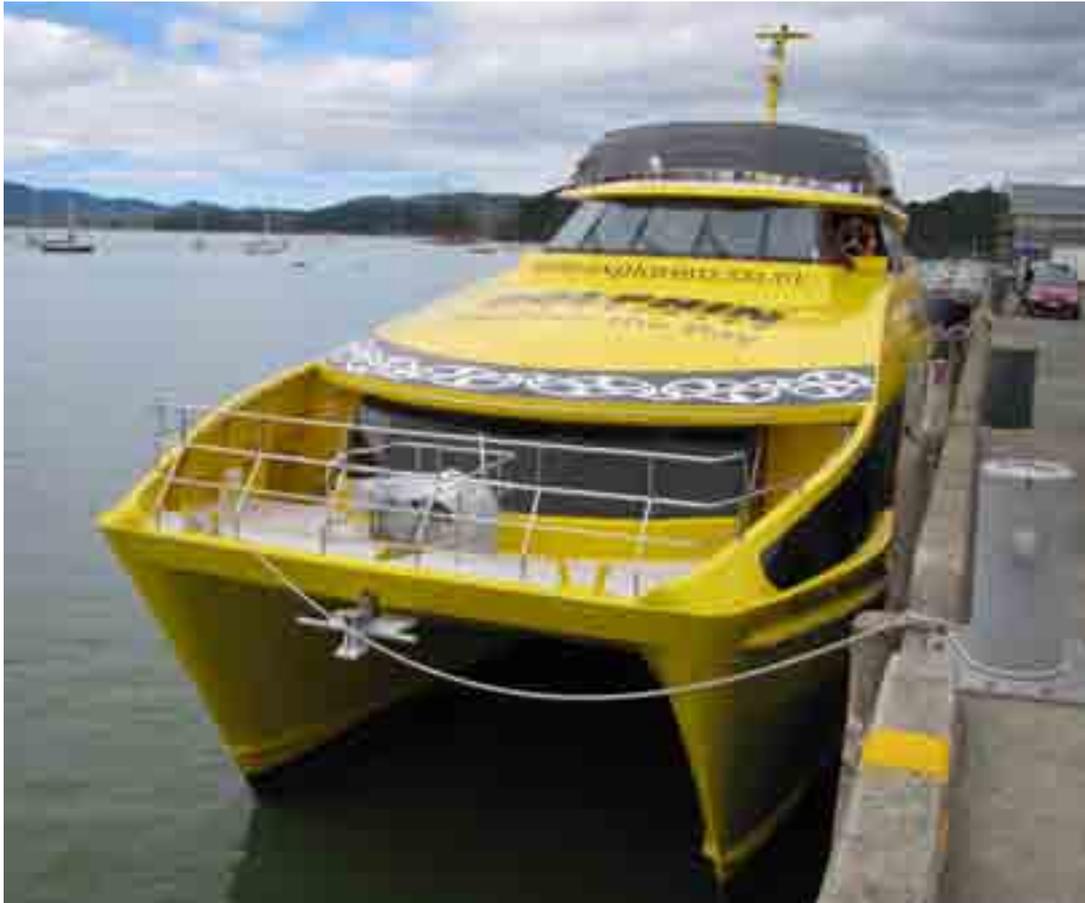
Figure 1 *Dolphin Discovery V*

1. A passenger sustained a serious harm injury whilst on the 24 metre vessel ***Dolphin Discovery V***. The trip departed Paihia in the Bay of Islands and was bound for an area near Cape Brett called “the hole in the rock. After viewing this area the vessel then headed back towards the more sheltered area of the trip. The weather conditions near the hole in the rock were poorer than those found further inshore. As a result of the weather and swell conditions the vessels bow started to rise and fall. There were several passengers situated on the bow deck at this time, one of which was thrown to the deck as a result of the movement where she suffered a serious harm injury.
