Accident Report

Man Overboard/Fatality

East Ocean

REPORT NO.: 04 3589

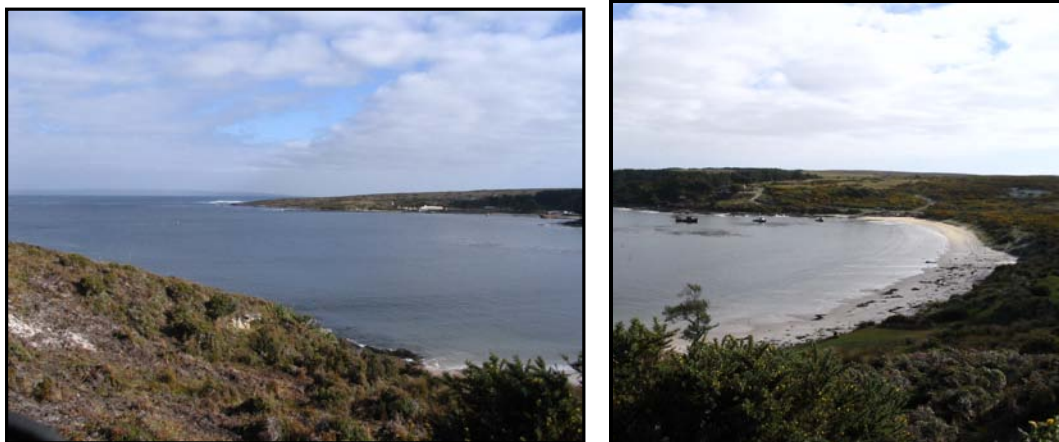
Photograph 3
Overall View of Port Hutt

East Ocean was anchored in a position where the charted depth is approximately 9 metres. The vessel had between 80 and 100 metres of anchor cable and wire set.
