Investigation report  
*Foveaux Express* and  
*Southern Express*  
close quarters situation  
**19 January 2010**

## **Maritime New Zealand**

Published December 2010

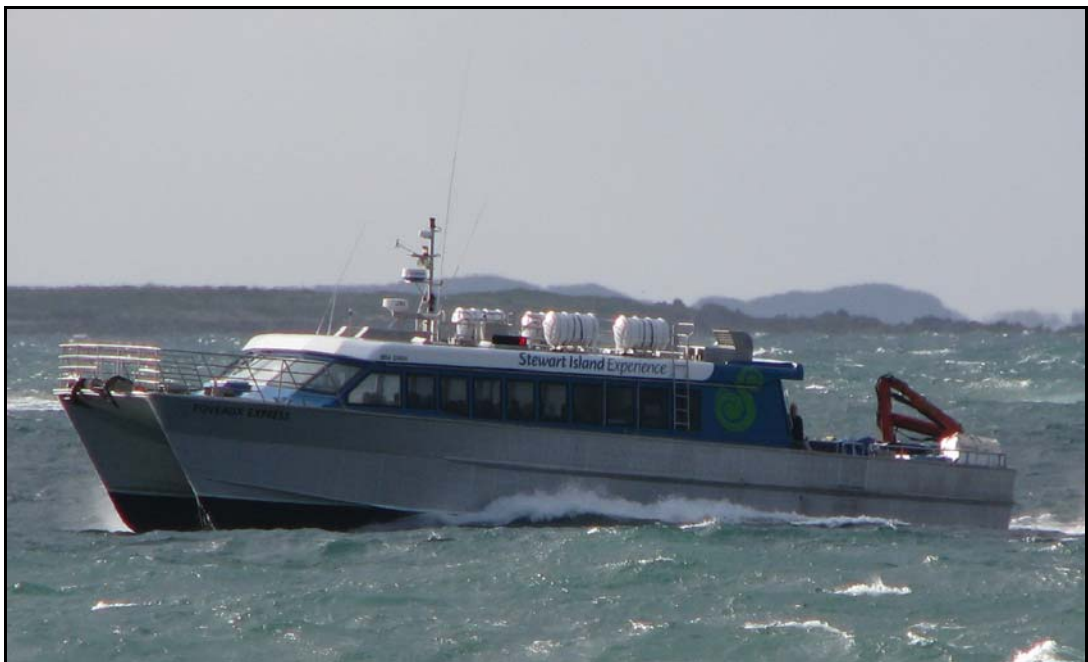
Figure 1 **Foveaux Express**

3. **Foveaux Express** is a 21-metre aluminium catamaran, powered by two V12 VTU engines, each engine producing 1,000 horsepower. It is fitted with two radar sets, a VHF marine band radio and a cellphone. The radar fitout includes one dedicated JRC JMA-2253 Rastar Scan radar and one Furuno Navnet 1933C, combined chart plotter, radar and GPS, with a Furuno RDP-139 display unit using C-Map NT charting software. The normal operating speed for **Foveaux Express** is approximately 22 knots.

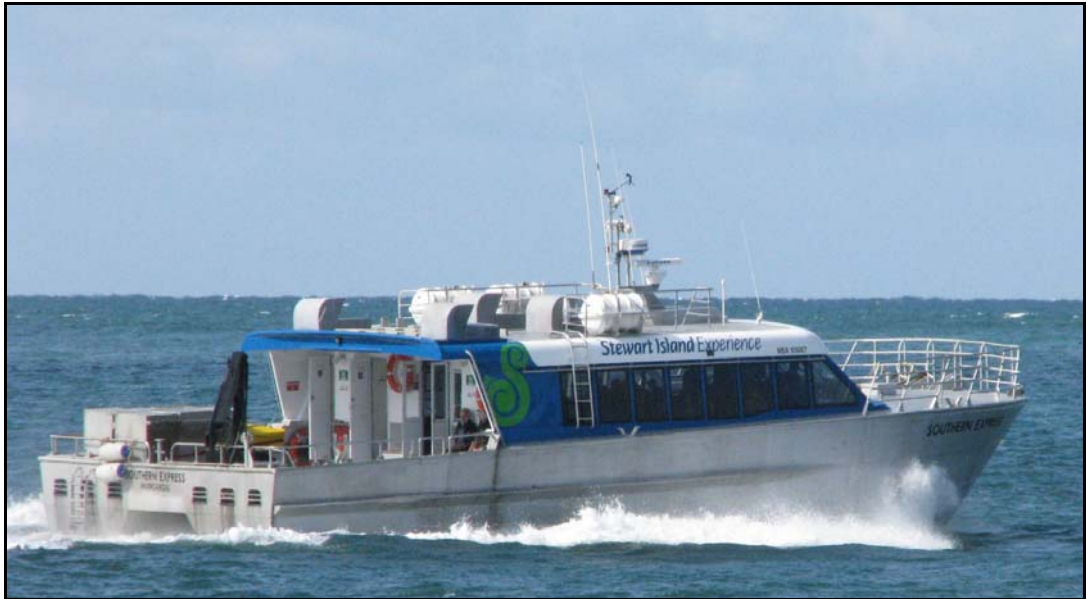
**Figure 2 Southern Express**

4. **Southern Express** is a 19-metre aluminium catamaran, which is also powered by two V12 VTU engines, each producing 1,000 horsepower. This vessel is also fitted with two radar sets, a VHF marine band radio and a cellphone. The radar fitout for this vessel includes one JRC JMA-2253 Raster Scan radar and one Furuno 1941 Mark II combined chart plotter, radar and GPS unit with a Furuno RDP 104 display using Navionics Gold V2 charting software. The normal operating speed for **Southern Express** is also approximately 22 knots.
