Investigation report

***Ady Gil and
Shonan Maru No.2***

Collision on 6 January 2010

Maritime New Zealand

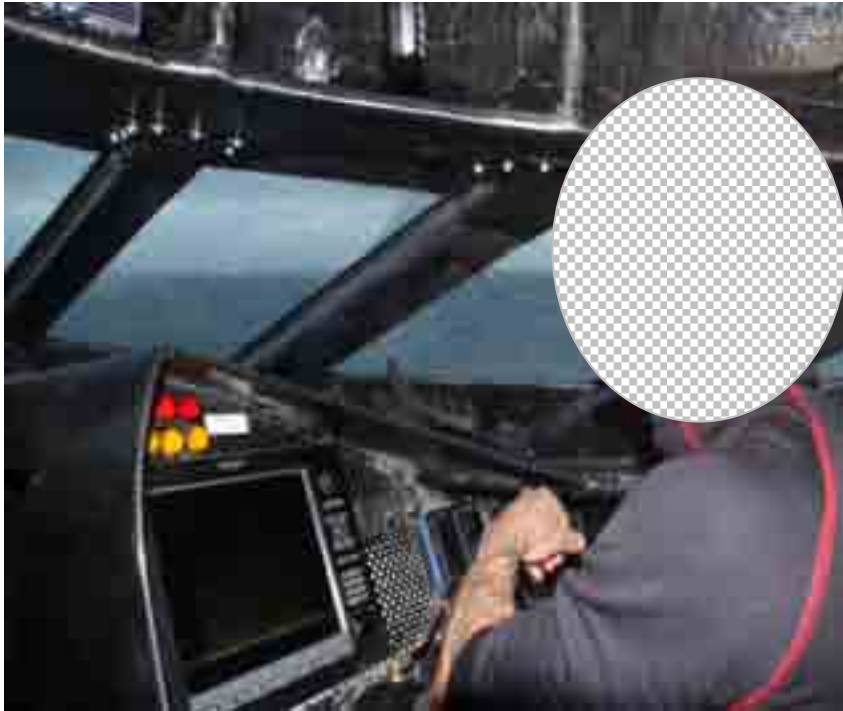
62. A few days prior to the collision, the manual steering helm was found to have minor problems and the vessel was reportedly being steered under auto helm, which involves controlling the rudder with a dial control or buttons. This is a longer process than simply turning a wheel. This manner of steering is not as effective at low speeds or in conditions of moderate sea or swell.

Figure 6 View forward and starboard from **Ady Gil**'s helm
(Photograph courtesy of SSCS)

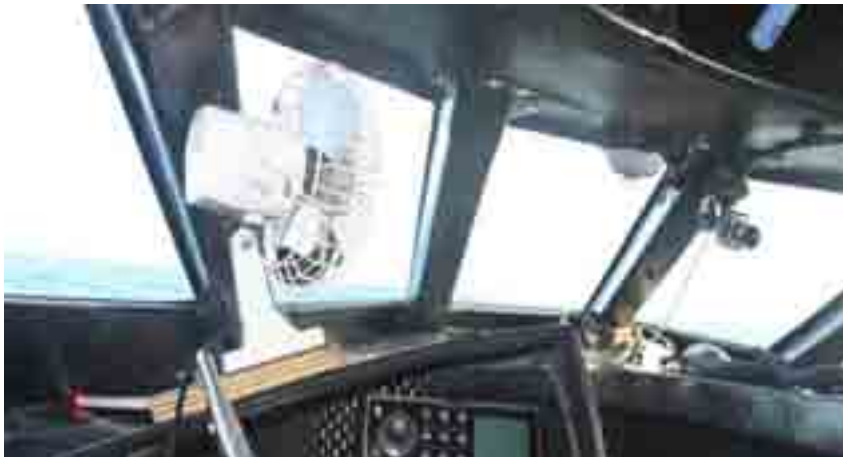
Figure 7 View forward from port side of **Ady Gil**
(Photograph courtesy of SSCS)

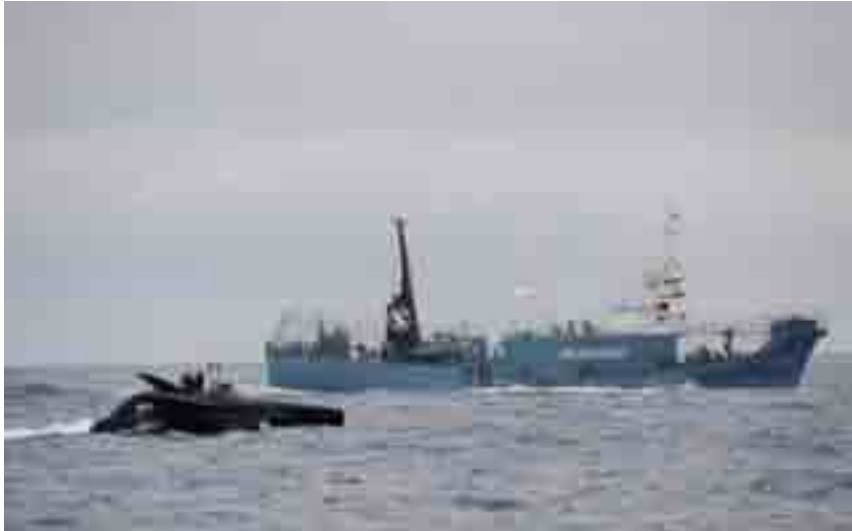
Figure 9 *Yushin Maru No. 3* and *Ady Gil*, photographed from on board *Bob Barker*
(Photograph courtesy of SSCS)

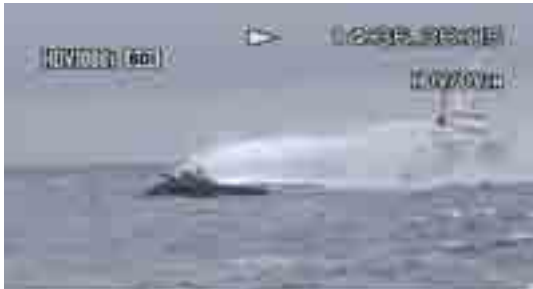
94. The following screenshots show the final seconds prior to the collision. Note that *Shonan Maru No. 2* appears to be yawing, which resulted in the vessel's heading continually changing.

Figure 11 *Shonan Maru No. 2* approaching *Ady Gil*
(Video courtesy of Lizard Productions)

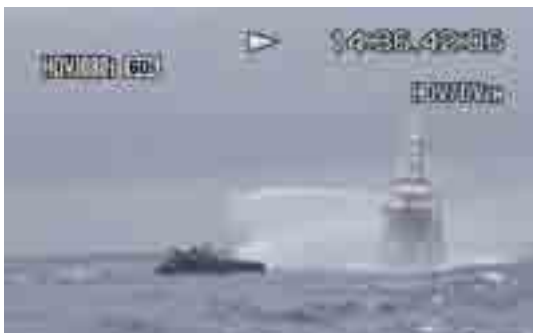
93. The information available suggests that, when **Shonan Maru No. 2** was approximately 130 metres away from **Ady Gil**, **Shonan Maru No. 2** steered so as to alter her track line some 13° degrees starboard (that is, from about 350°(T) to 014°(T). This alteration of course by **Shonan Maru No. 2** rendered a close quarters situation inevitable in the absence of either a further change of course by **Shonan Maru No. 2** or a change of course by **Ady Gil**. (Refer to Appendix 4 from Point D onwards, and to Appendix 5)

Figure 13 *Shonan Maru No. 2* and *Ady Gil*
(Video courtesy of Lizard Productions)

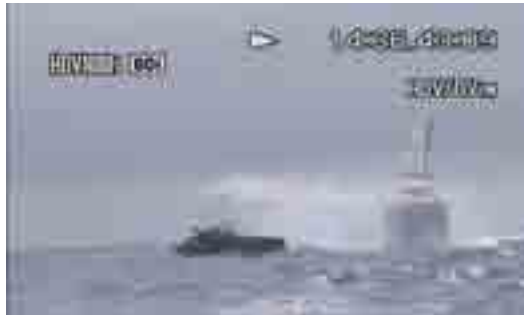
Figure 14 **Shonan Maru No. 2** and **Ady Gil**
(Video courtesy of Lizard Productions)

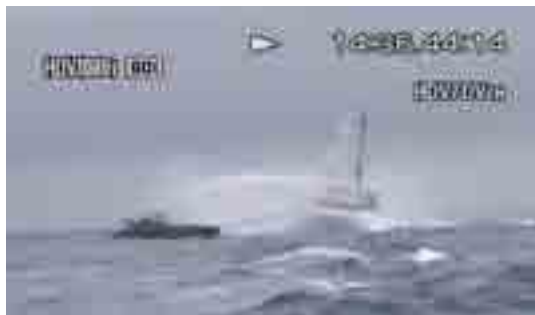
Figure 15 **Shonan Maru No. 2** and **Ady Gil**
(Video courtesy of Lizard Productions)

95. Shortly after the change of heading took effect, **Shonan Maru No. 2** came close enough for its water monitors to reach **Ady Gil**.
96. Although the exact timing cannot be determined, it was in the moments preceding the apparent alteration of course that the **Ady Gil** helmsman, alerted by the LRAD sounding, became fully aware of the situation developing. Prior to this his attention had been on other things and he had not been monitoring **Ady Gil**'s radar. He moved from his seat at the helm and looked astern out of the port cockpit window. He describes what he saw and did as follows:
