Class B Accident Report

# **Lady Kawhia**

# **Mechanical Failure**

## **REPORT No: 04 3604**

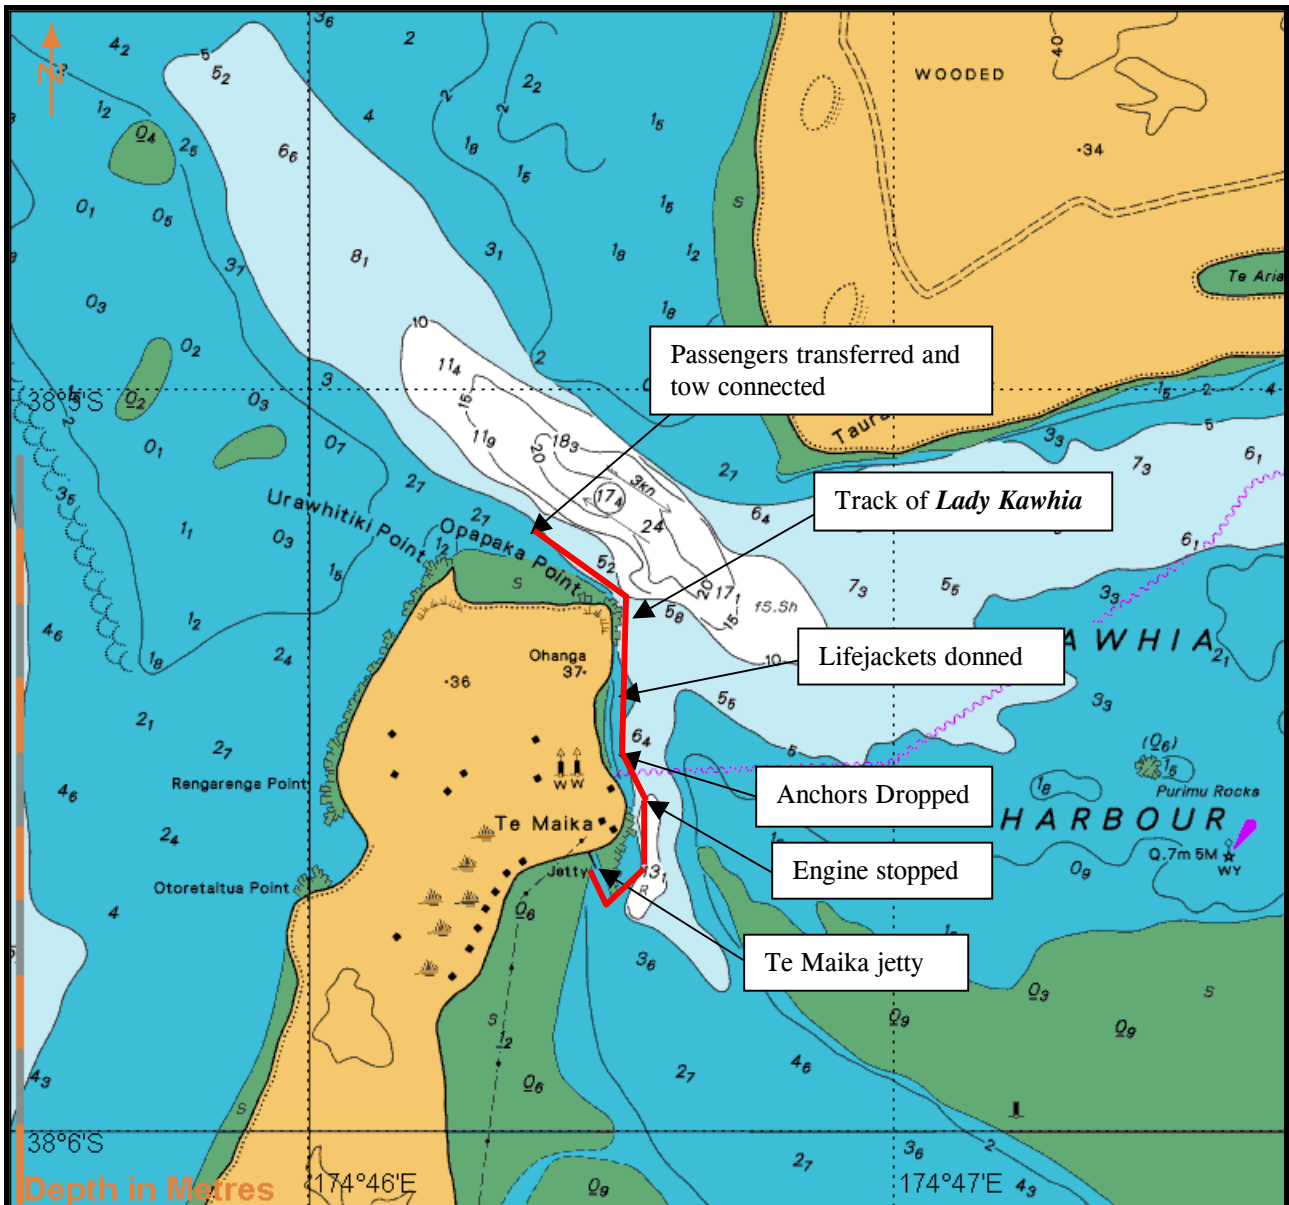
After the passengers embarked, *Lady Kawhia* departed Te Maika pier at approximately 1500 hours. Shortly afterwards, *Lady Kawhia's* engine failed. The engineer went to the engine room and soon discovered the fuel filters and fuel lines to be blocked, thus starving the engine of fuel.

Since the incident, the fuel lines have been unblocked and the filters replaced. The fuel in the tanks has been discarded and the tanks have been cleaned out. The engine has been run for approximately 30 hours without incident and there have been no further signs of fuel contamination.
