Class B Accident Report

NZL41

Injury to Passenger

Auckland 27 November 2004

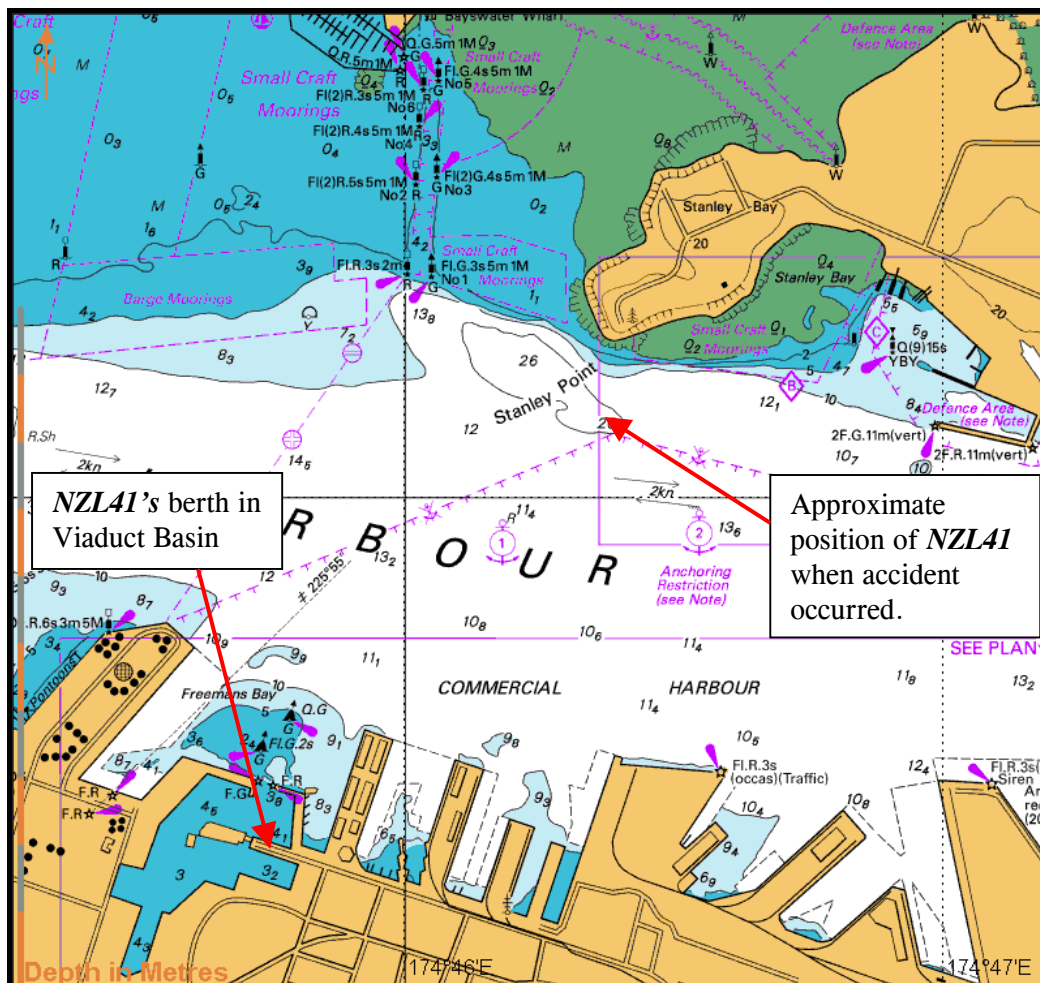
The vessel hoisted sail when leaving the Viaduct Harbour and sailed east towards the Rangitoto channel.

The vessel eventually turned around and commenced tacking back towards the harbour bridge. At approximately 1530 hours, whilst on a port tack approximately 300 metres south of Stanley Point, the vessel tacked to starboard. The victims' husband stumbled over a deck stiffener and fell. The victim, who was sitting on the port side of the vessel, attempted to move across to the starboard side but had nothing substantial to hold on to. In moving, she held onto the mainsheet line. At that moment, the mainsheet moved along the traveller. The passenger's right hand entered the mainsheet block thumb first. This resulted in the right thumb being amputated and other injuries to her right hand.
