Accident Report

Pacific Way

26 November 2005

Pacific Way – Injury

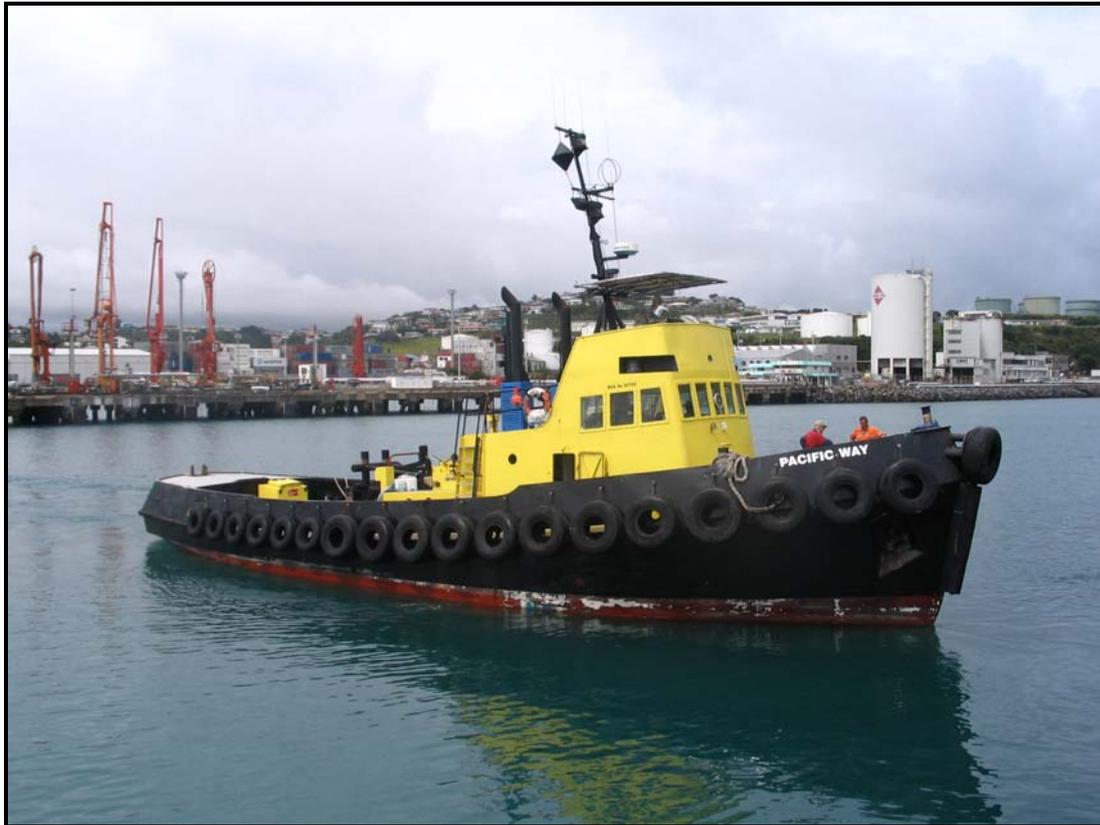
Photograph 1
Pacific Way

A crewmember suffered an injury to his wrist when the handle connected to the manually powered windlass that he was using counter-rotated due to a heavy weight coming onto the anchor cable in the prevailing swell conditions.

After one shackle had been heaved on deck, **Pacific Way** lifted on a two metre swell wave bringing considerable weight onto the cable. This caused the anchor to suddenly run out and the winding handles to counter-rotate. The starboard handle stuck a crewmember on the left wrist.

The injured crewmember suffered a fracture to a bone in his left wrist.

At the time of the accident, the operation of retrieving an anchor had not been identified as a hazard in the vessel's hazard register, which was otherwise found to be robust.

1. It is recommended that the owners of ***Pacific Way*** install an alternative (mechanical, hydraulic or electrical) means of operating the windlass as soon as possible. Also, as the anchoring equipment is used infrequently, it is recommended that a planned maintenance regime be implemented for the windlass.
2. It is recommended that the owners of ***Pacific Way*** immediately ensure that crew training records be kept up to date and all relevant paperwork onboard ***Pacific Way*** is brought up to the required standard.
3. It is recommended that the owners of ***Pacific Way*** immediately issue written procedures to the Masters of their vessels reaffirming the need to inform Maritime New Zealand directly of any accident, incident or mishap involving serious harm, as soon as practicable.
