Summary Report

Serious Harm Injury

Patea Explorer

21 September 2006

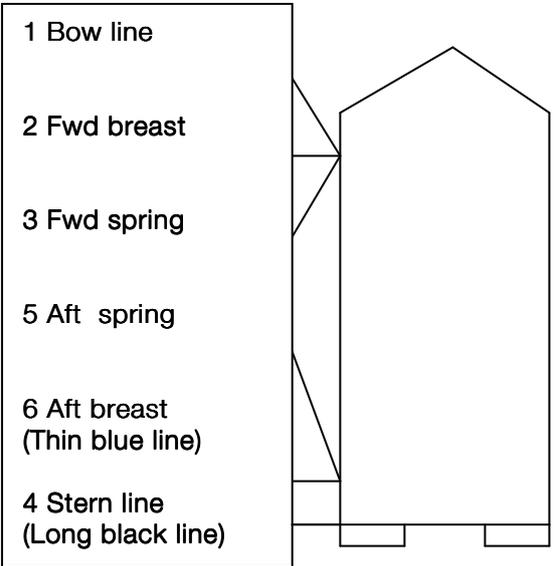
In the meantime the mooring procedures for this vessel have been re-assessed and the new procedure is as follows:

Real Journeys are currently reassessing the mooring arrangements of *Patea Explorer*. They have approached Incat Crowther in Australia, the builders of the vessel, to prepare drawings for the modification of the mooring bits at the stern and the fitment of a single Samson post at the bow on the outside of the coaming about a metre above the deck to allow easier and safer mooring/unmooring.

All work areas are to be cordoned off when crew are working with the lines.
