Final Draft Accident Report

Poseidon

Grounding

North of the Manukau Bar on 15 April
2004

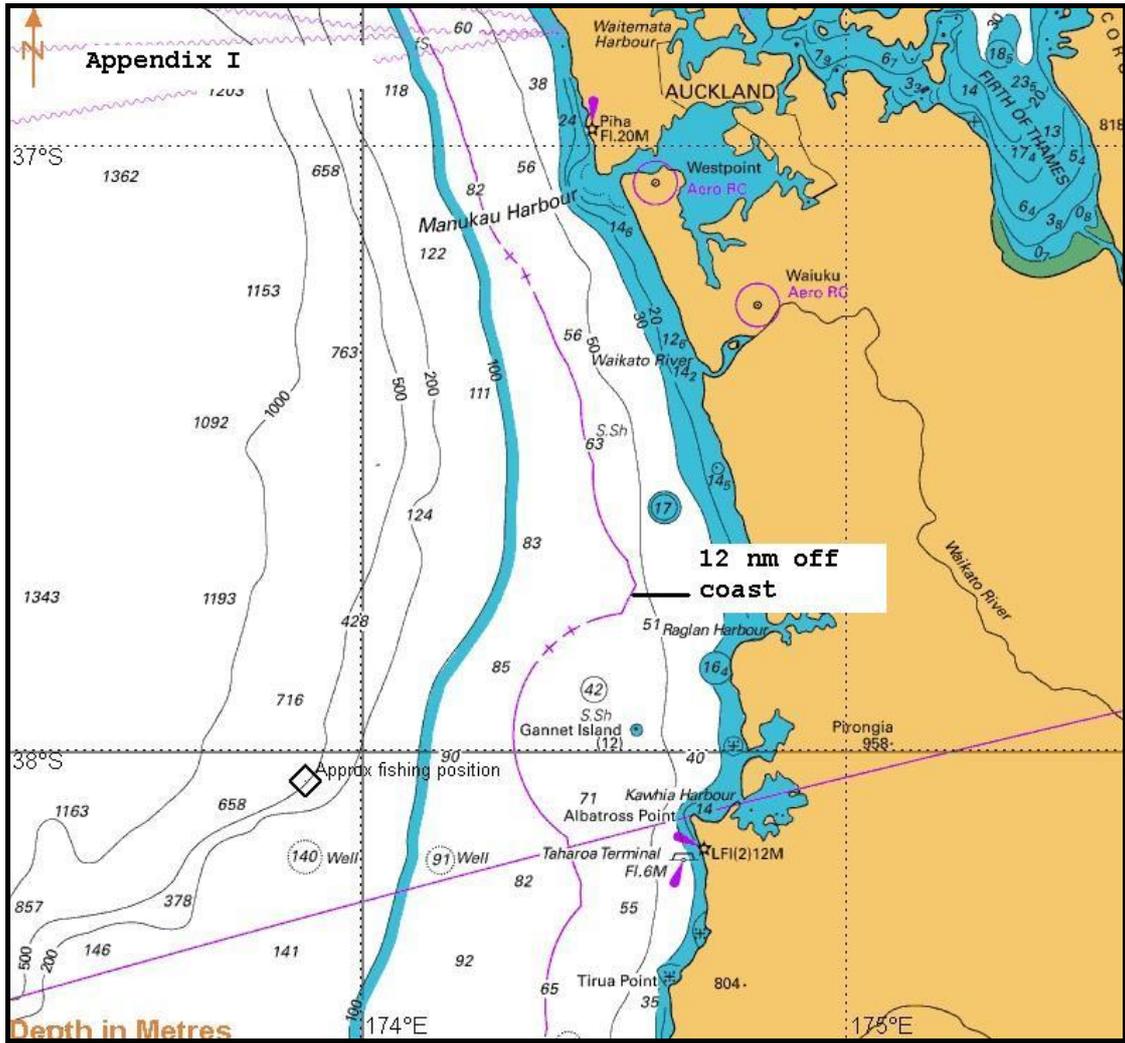
APPENDIX I

- 1.2** The vessel was bound for fishing grounds approximately 40 nautical miles (nm) west of Kawhia Harbour, (*See Appendix I - Position A, Fishing Area*).
