Accident Report  
*Sinbad & Unnamed Dinghy*  
Collision at Bon Accord Harbour  
on 26 March 2005  
Class B

REPORT NO.: 05 3701

## *SINBAD & DINGHY – COLLISION*

Whilst on passage from Hokimai Bay to Sandspit, *Sinbad* was in a collision with an *Unnamed Dinghy* whilst in Bon Accord Harbour.

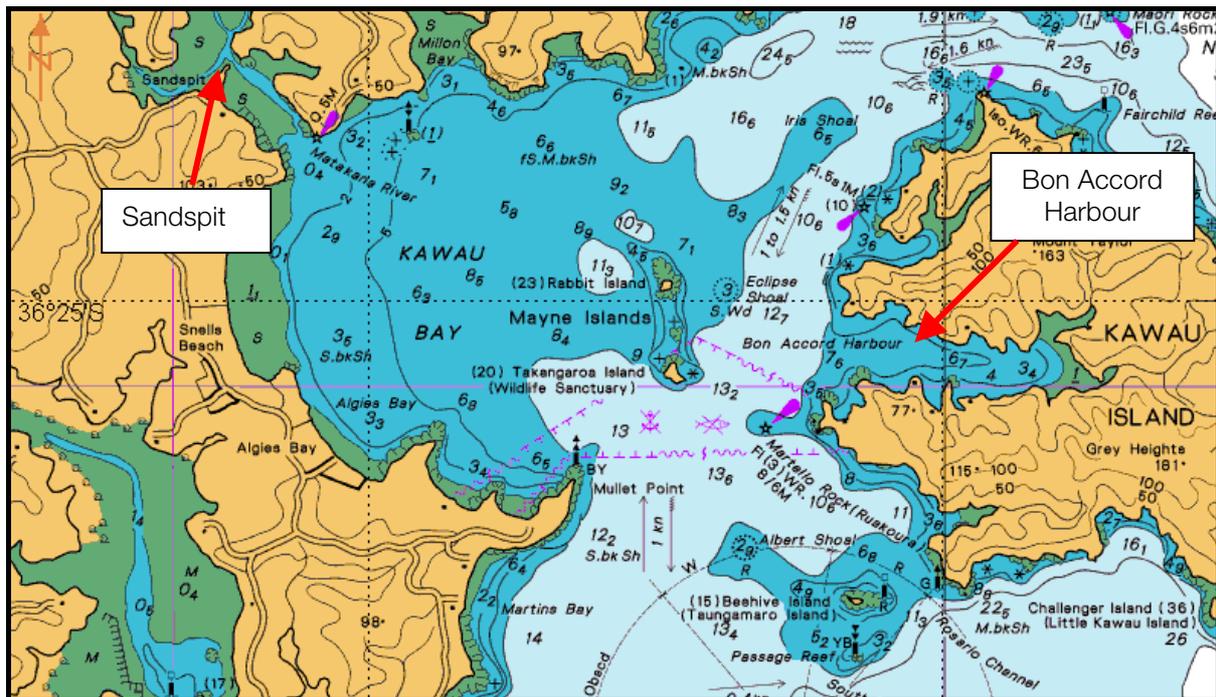
Figure 1

On Saturday 26 March 2005, at approximately 2000 hours New Zealand Standard Time (NZST), an unnamed dinghy was launched from the shore into Schoolhouse Bay, Bon Accord Harbour, Kawau Island (See Figure 2). The two crewmembers had borrowed the dinghy from its owner. The dinghy was rowed a short distance until the water became deep enough to use the outboard engine.

At approximately 2010 hours, *Sinbad* departed Hokimai Bay, Bon Accord Harbour (See Figure 2), bound for Sandspit. In addition to the Skipper, there were two adults and two children passengers onboard. *Sinbad* proceeded out of the Harbour at a speed of approximately 7 knots.

Upon passing south of the Yacht Squadron clubhouse, on the northern shoreline of Bon Accord Harbour (See Figure 2), *Sinbad* passed to port of *Lion New Zealand*, which was anchored south of the clubhouse, and the Skipper of *Sinbad* increased the engine revolutions to 3000 RPM (revolutions per minute) to give a speed of approximately 20 knots.

- The Skipper states that the barge was moored inside the heads of School House Bay. The position of the barge on *Figure 2* is representative of the position of the barge on the chartlet drawn by and signed by the Skipper of the dinghy. The owner of the dinghy states that the barge was moored inside the heads of Schoolhouse Bay
