Accident Report
Tamure & Unnamed Ramco
Collision - Pelorus Sound on
24 March 2005
Class B

REPORT NO.: 05 3700

TAMURE & UNNAMED RAMCO – COLLISION

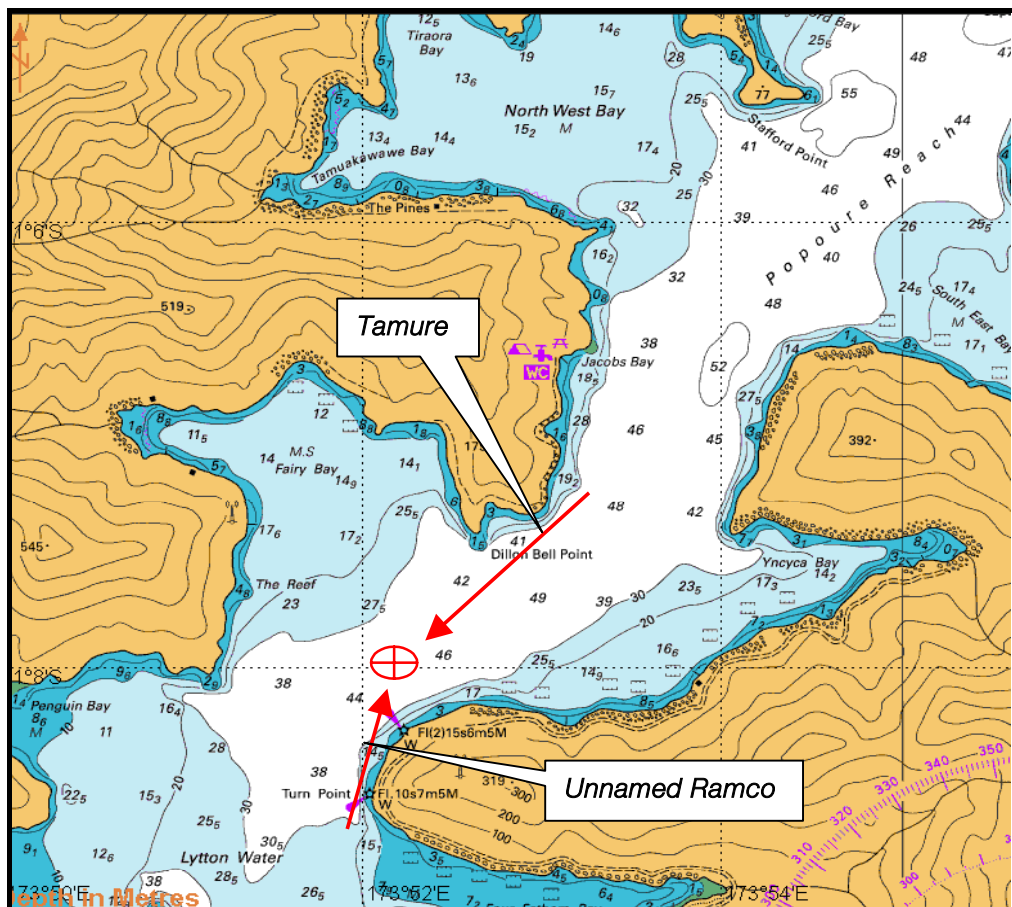
Figure 1

At about 1900 hours, in the area of Turn Point, both vessels sighted each other's lights through the rain. The Skipper of *Tamure* altered to starboard and the Skipper of the *Unnamed* vessel altered to port. A short while later the vessels collided. The bow of the *Unnamed* vessel pierced the port side of *Tamure* amidships.
