Class B Non Serious Harm Accident Report

Bledisloe No. 1 North Wharf, Auckland
on 2 July 2004

REPORT NO: 96 294

TANIWHI – INJURY TO STEVEDORE

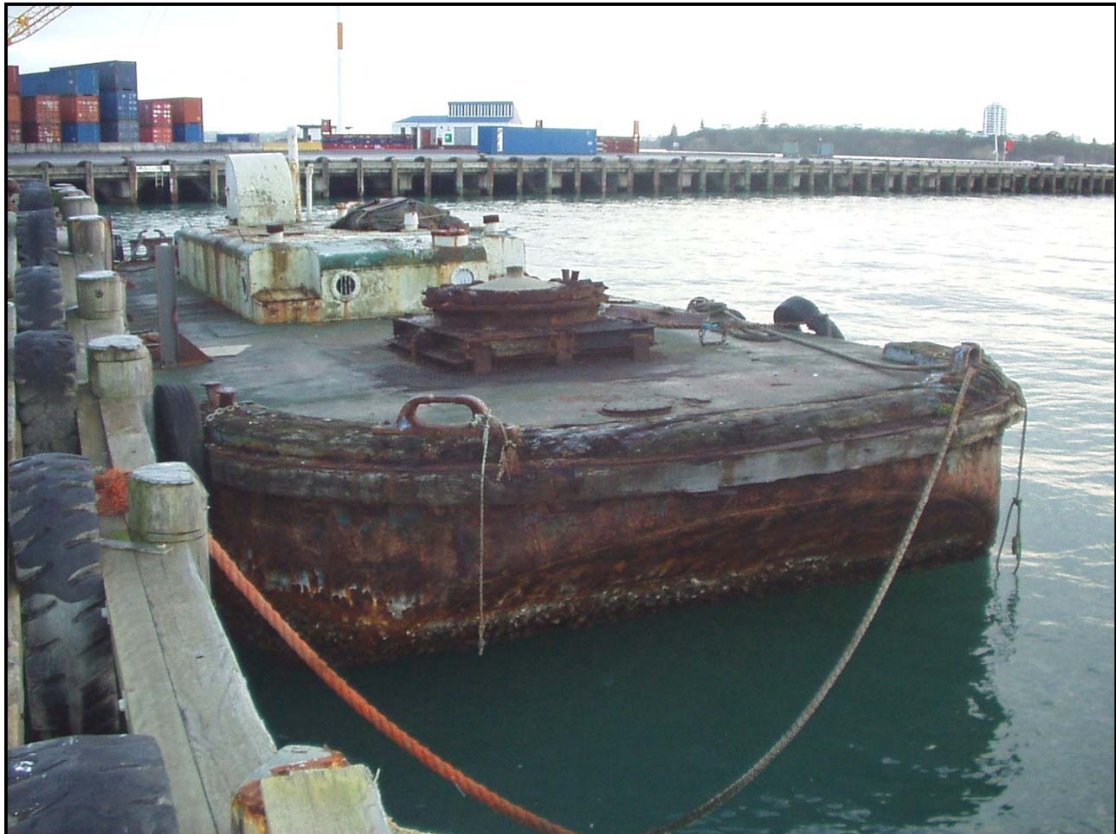
The welder was lying flat on the deck of the barge, welding stanchions to *Taniwhi*, whilst it was made fast alongside an open pile wharf. Whilst his left foot was touching one of the piles, a passing vessel caused the barge to move suddenly, crushing the welder's foot between the barge and the pile.

The welder sustained broken bones to his foot. To date, he has undergone two operations. It is anticipated he will be off work for some months.

The company hazard register did not identify the above scenario as a potential hazard. This was in breach of the following sections of the HSEA, namely:

- The hazard is minimised by the provision of adequate sized fenders of sufficient quantity between the barge and adjacent wharves/other fixed or floating object to protect employees, or
- The danger to employees is eliminated by repositioning the barge so that the side on which employees are working does not abut a fixed or floating object.

- The procedure for provision of safe working areas on floating plant has been added to the Operations Manual, incorporating the provision of adequate sized fenders between adjacent wharves/other fixed or floating objects and the positioning of the floating plant such that the work area is away from adjacent wharves/other fixed or floating objects.
- The hazard – sudden movement of the vessel against wharf plies has been added to our hazard register.
- The hazard has been brought to the attention of employees as an item on the agenda at our staff toolbox meeting and by notice on the staff noticeboard.
