Accident Report

Target & Unnamed Dinghy Collision

North of Urupukapuka Island, Bay of
Islands on 26 September 2004

REPORT NO: 04 3560

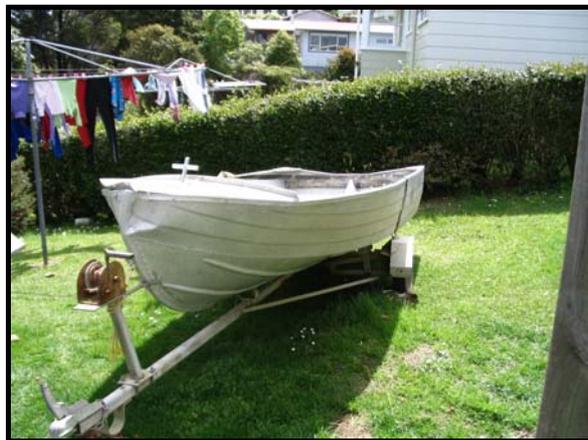
UNNAMED DINGHY

2.2.10 The damage to the dinghy consisted of a crumpled starboard bow (*See Appendix 1 – Photo 1*). The engine was also swamped and required repairs.
