Class B Accident Report

***Tokerau & Kawau Kat***  
**Collision**

At Auckland on 11 December 2004

**REPORT NO: 04 3624**

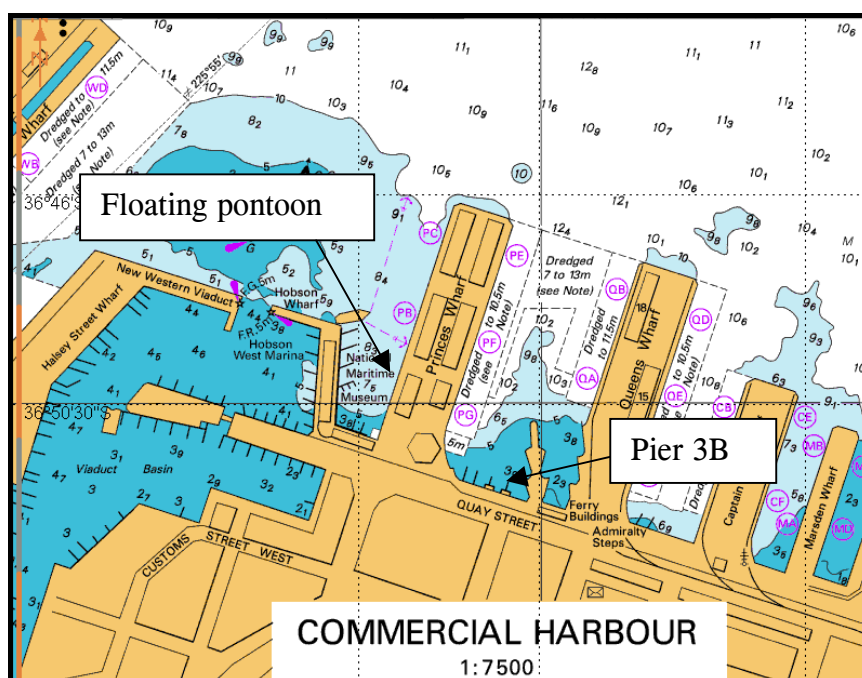
FIGURE 1

On Saturday 11 December 2004, at approximately 1640 hours NZDT (New Zealand Daylight Time), *Tokerau* departed Bayswater marina. It proceeded across Waitemata Harbour towards the Auckland Ferry Terminal. After some difficulty manoeuvring, due to the wind conditions, it berthed port side alongside to the western face of Pier 3B (See Figure 1). The vessel was longer than the floating pontoon and its stern overhung the pontoon. The vessel was made fast with a spring line forward and a spring line aft.

Shortly after berthing, passengers commenced embarking. The passengers were employees and friends of the vessel's owner. *Tokerau* was to take them to the Riverhead Hotel for a Christmas function.
