Class B Accident Report

Hamilton 141

REPORT NO: 04 1141

UNNAMED – GROUNDING RESULTING IN A FATALITY

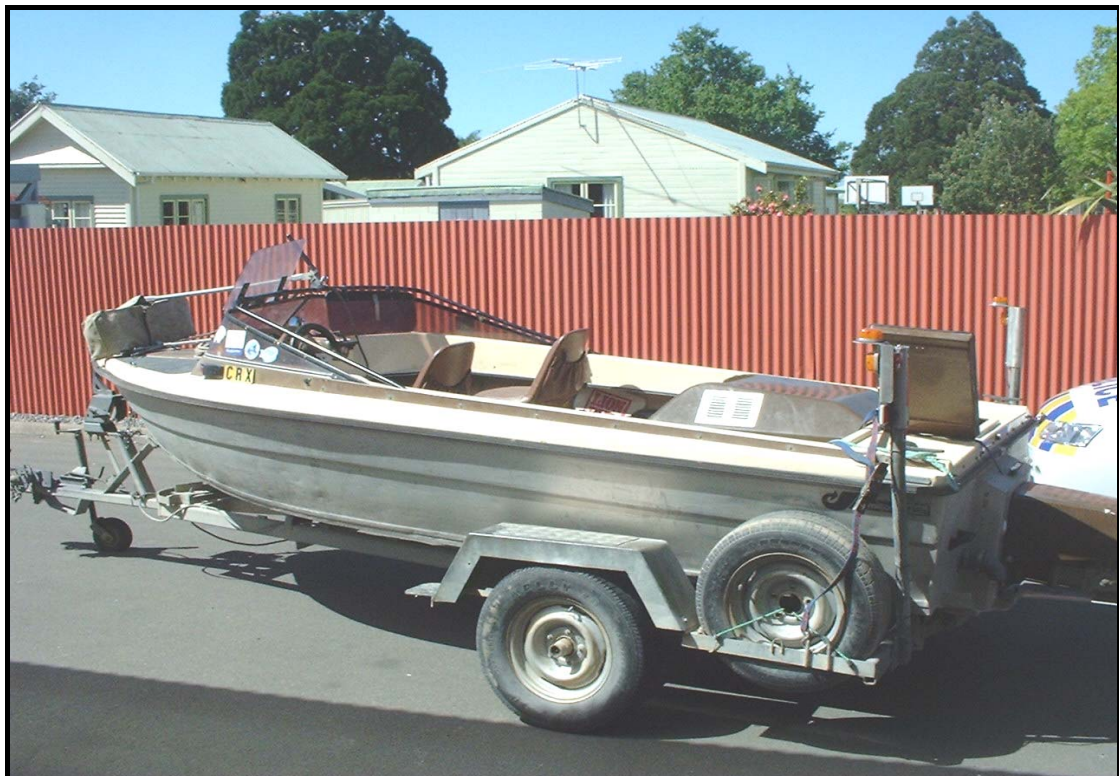
After two days hunting in the upper Waimakariri River area, two hunters and the Owner/Driver of the jet boat were returning down stream to the launching area. When they reached the drop off area the Skipper decided the river had dropped too much to stop in that particular position. He turned the vessel back out into the main flow where the steering jammed. The vessel then drifted at speed down river and came into contact with the rocky river's edge three times before the crew were able to beach the vessel. During this time the Skipper suffered a heart attack and died after being helicopter evacuated from the area.
