Class B Non Serious Harm Accident Report

Waima

Back Injury

Fulljames Rapid, Waikato River on 21
November 2004

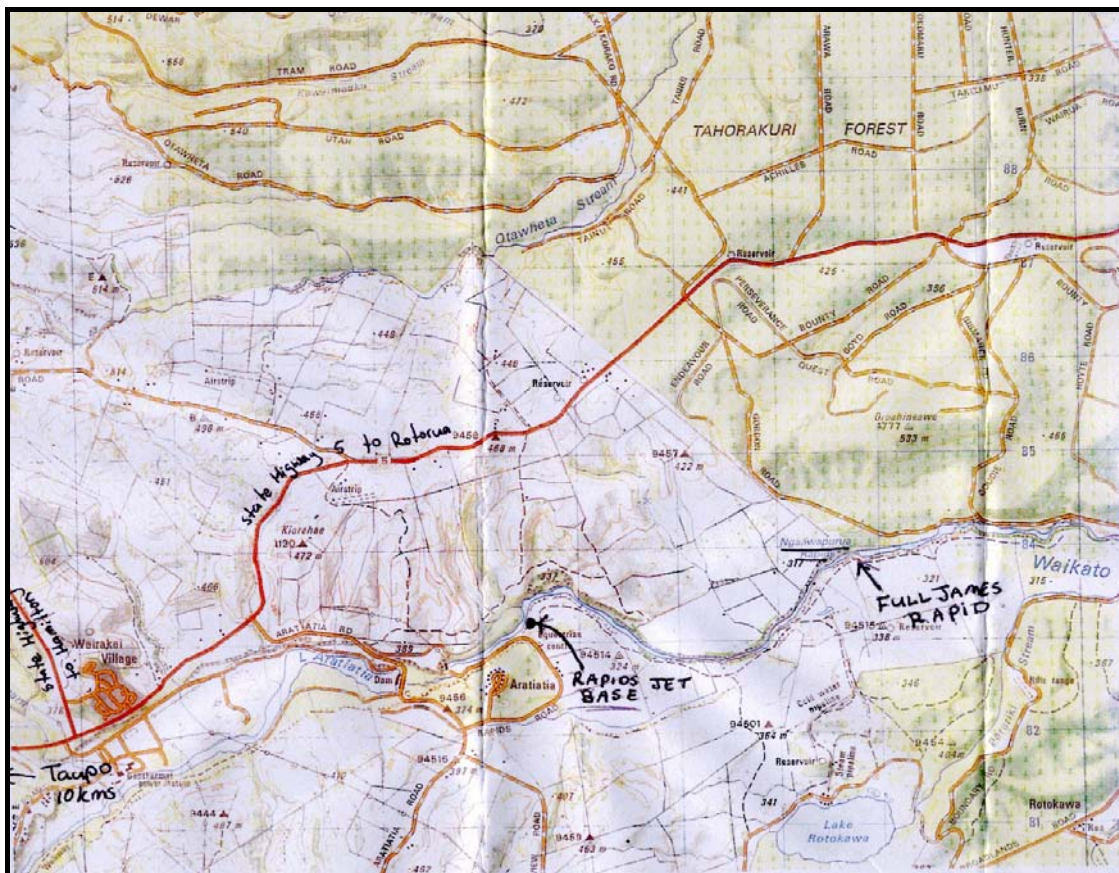
The weather conditions at the time of the injury was warm and cloudy.

Pressure waves are caused by the narrowing of the river at the Fulljames Rapid. The height of these waves will depend on the flow rate of the river.
