LESSONS LEARNT
BY ACCIDENT

LOOKOUT!

SEPTEMBER 2007 ISSUE SIX

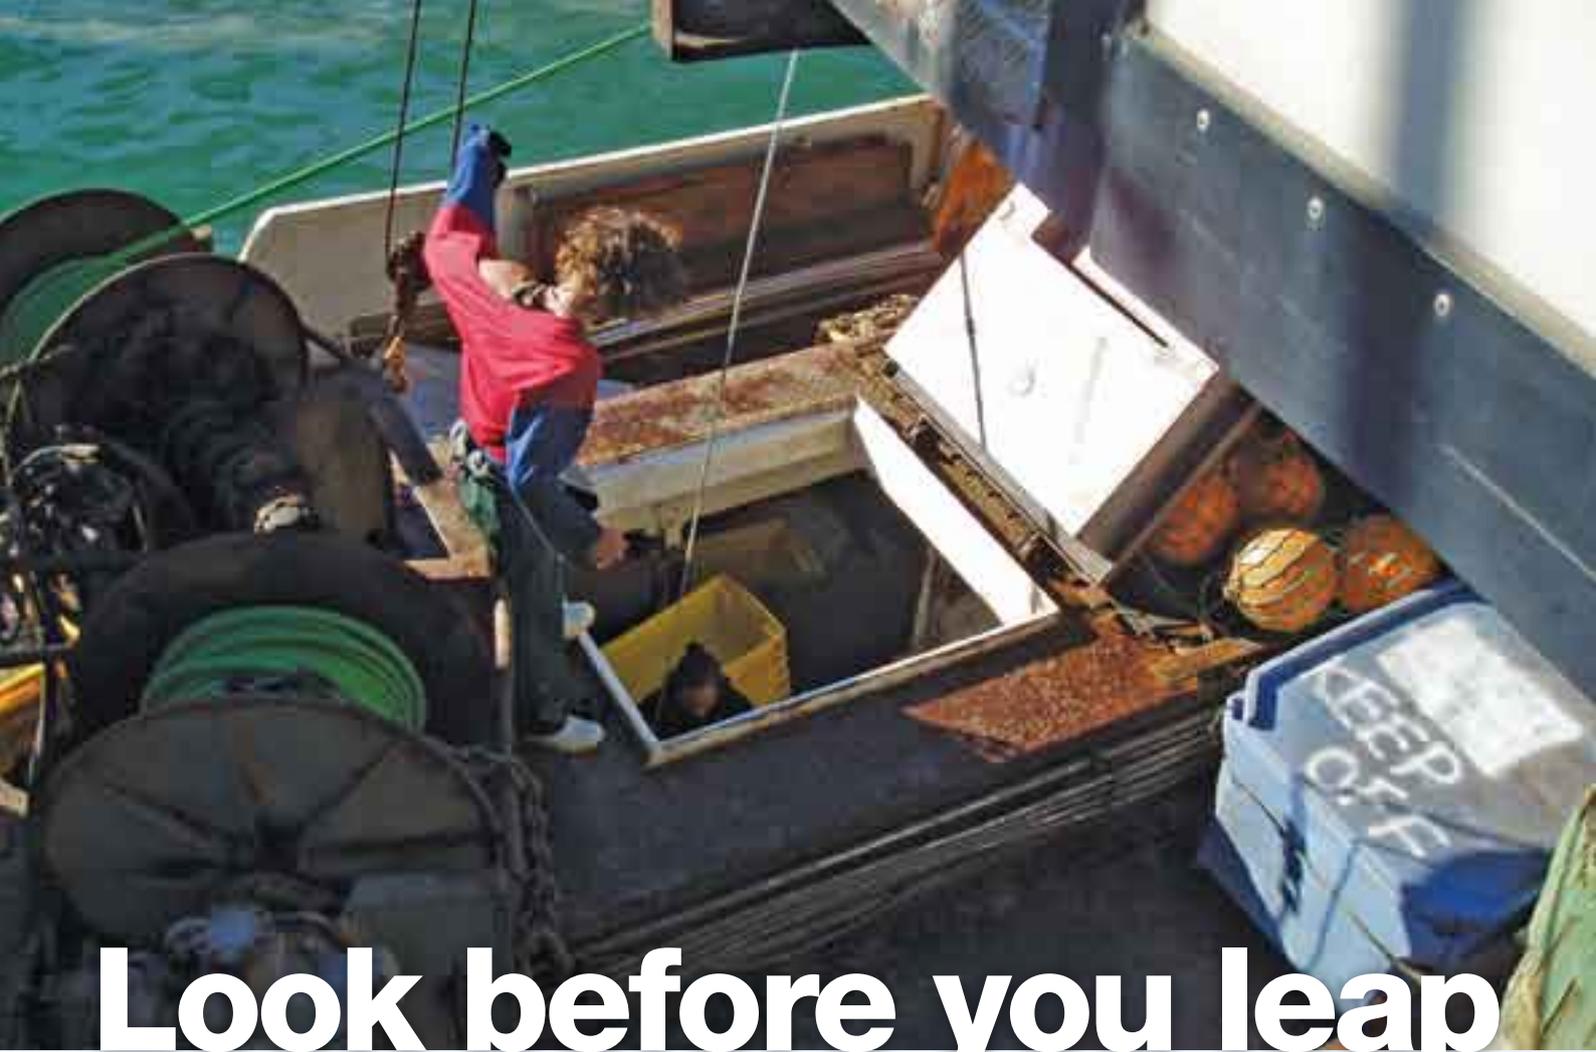
Look before you leap

A deckhand continued working with a fractured back and broken tail bone for 10 days after landing heavily on to fish bins in a hold.

After the accident, the deckhand climbed out of the fish hold and lay down for about half an hour to rest his sore tail bone before resuming work. Over the following 10 days the injury did not improve, and was eventually diagnosed by x-ray as a fracture to the sacrum and a broken tip of the coccyx.

2. The vessel always berths on its port side for unloading, and the freezer truck crane always operates into the port side of the fish hold. The skipper should instruct crew to enter and exit only via the starboard side of the fish hold to minimise the likelihood of obstructions below and unloading hazards above.

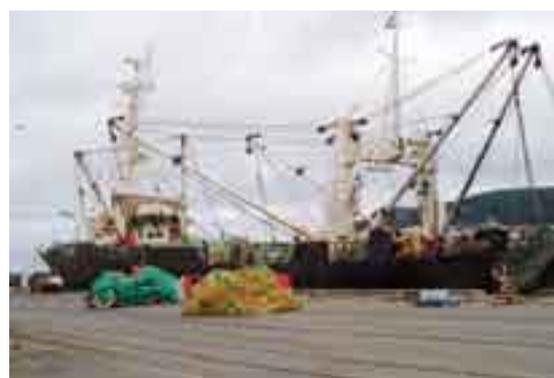
▲ THE CHIEF, 1ST AND 2ND ENGINEERS WERE UNDERTAKING REPAIRS TO SOME HYDRAULIC PIPING ON DECK, AT THE PORT QUARTER OF THE VESSEL, ADJACENT TO THE TRAWL RAMP AND GATE.
▶ THE FISHING VESSEL.

“ AN EXPLOSIVE FIRE BROKE OUT, TRAPPING THE TWO INJURED MEN ON THE PORT QUARTER OF THE VESSEL. ”

1. High usage of the oxygen/acetylene equipment could have caused physical damage to the hoses resulting in leakages. Gas could also have escaped from leaking couplings connecting the tail ends of the main hoses. It is possible that unburnt gases could have formed an explosive pocket underneath the plating above the deck and been ignited by a spark or the cutting torch flame. Also, leaking oxygen may have reacted with grease or oil in this vicinity.

3. Leaking oxygen can be highly explosive if mixed with any grease or oil. Acetylene, being heavier than air, can form explosive "pockets" which would be ignited by a spark or contact with a hot surface. Also remember that acetylene is absorbed by cotton.

remembered that to safely control the ignition of these gases, the cutting equipment must be properly maintained, and hoses should be checked for any wear and tear that could lead to leaks.

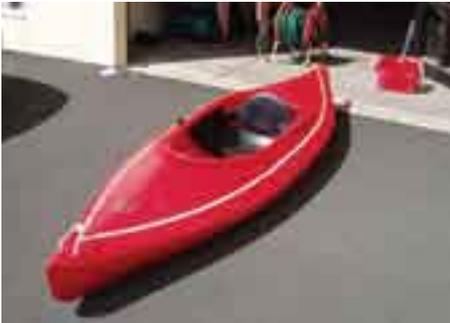
THE FISHERMAN AND HIS COMPANION BORROWED THE KAYAK.

A fisherman drowned after using a kayak to string a long fishing line out from shore for about 1 km. The body was recovered and the blood toxicology report identified enough methamphetamine to have contributed to the accident.

No-one saw the accident occur, but the drug may have caused mental confusion, exhaustion or muscle cramps.

1. The use of kayaks to set fishing lines from beaches is becoming increasingly common. Always ensure the craft used is suitable in design and construction for the conditions.

4. Carry safety equipment, such as a life jacket and waterproof clothing. To reboard a swamped kayak would require a spray skirt, paddle float and pump. Always ensure you have the skills to reboard in the conditions you are likely

6. Never use drugs or alcohol when operating any type of craft as this will impair your judgement and ability to respond to difficulties.

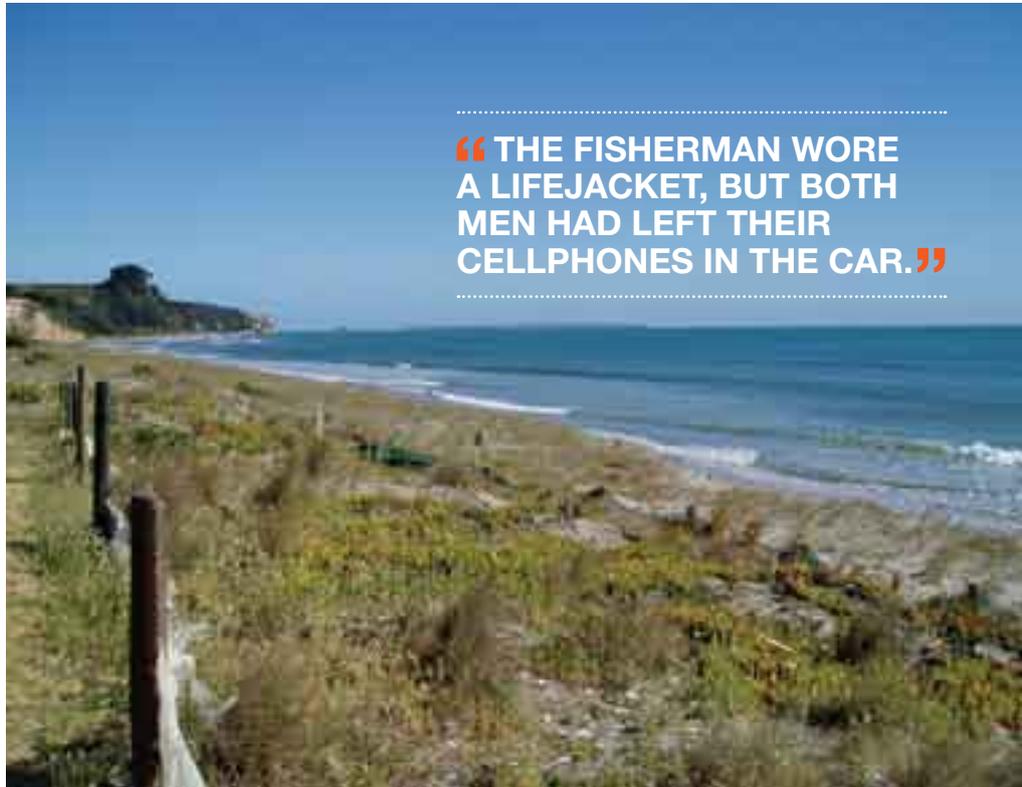
THE SEA CONDITIONS WERE GOOD.

away that his companion on the shore could make out only a small patch of colour where the kayak was. A passerby also reported seeing the fisherman paddling away. The sea conditions were good.

fisherman's body was found, his head was being kept above water by his life jacket, but he had already drowned. His face was towards the wind and waves were lapping into his mouth. The kayak was found to be about two-thirds full of water.

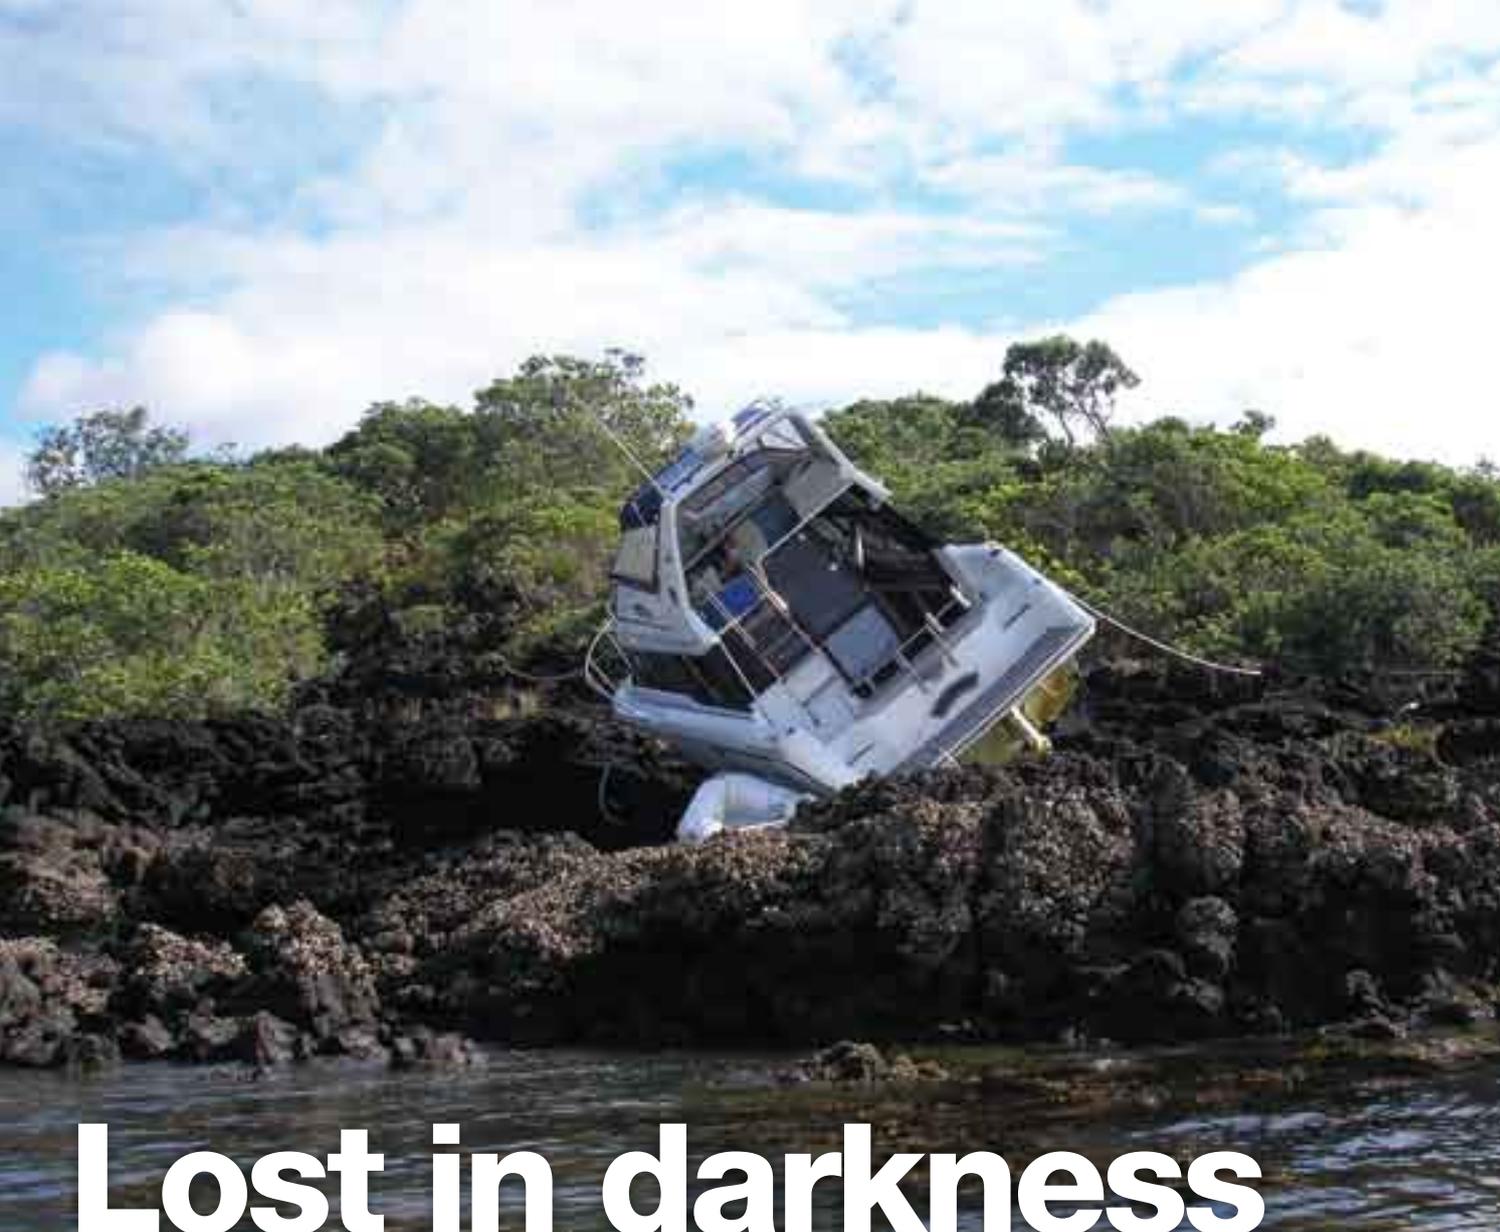
Lost in darkness

A skipper drove a 10 m motor launch straight onto rocks after losing situational awareness in darkness.

1. The skipper was engrossed in resetting the chart plotter, and was distracted from keeping a proper lookout. In a low visibility situation, such as this, the skipper should have slowed or stopped the vessel until he was certain of its position.

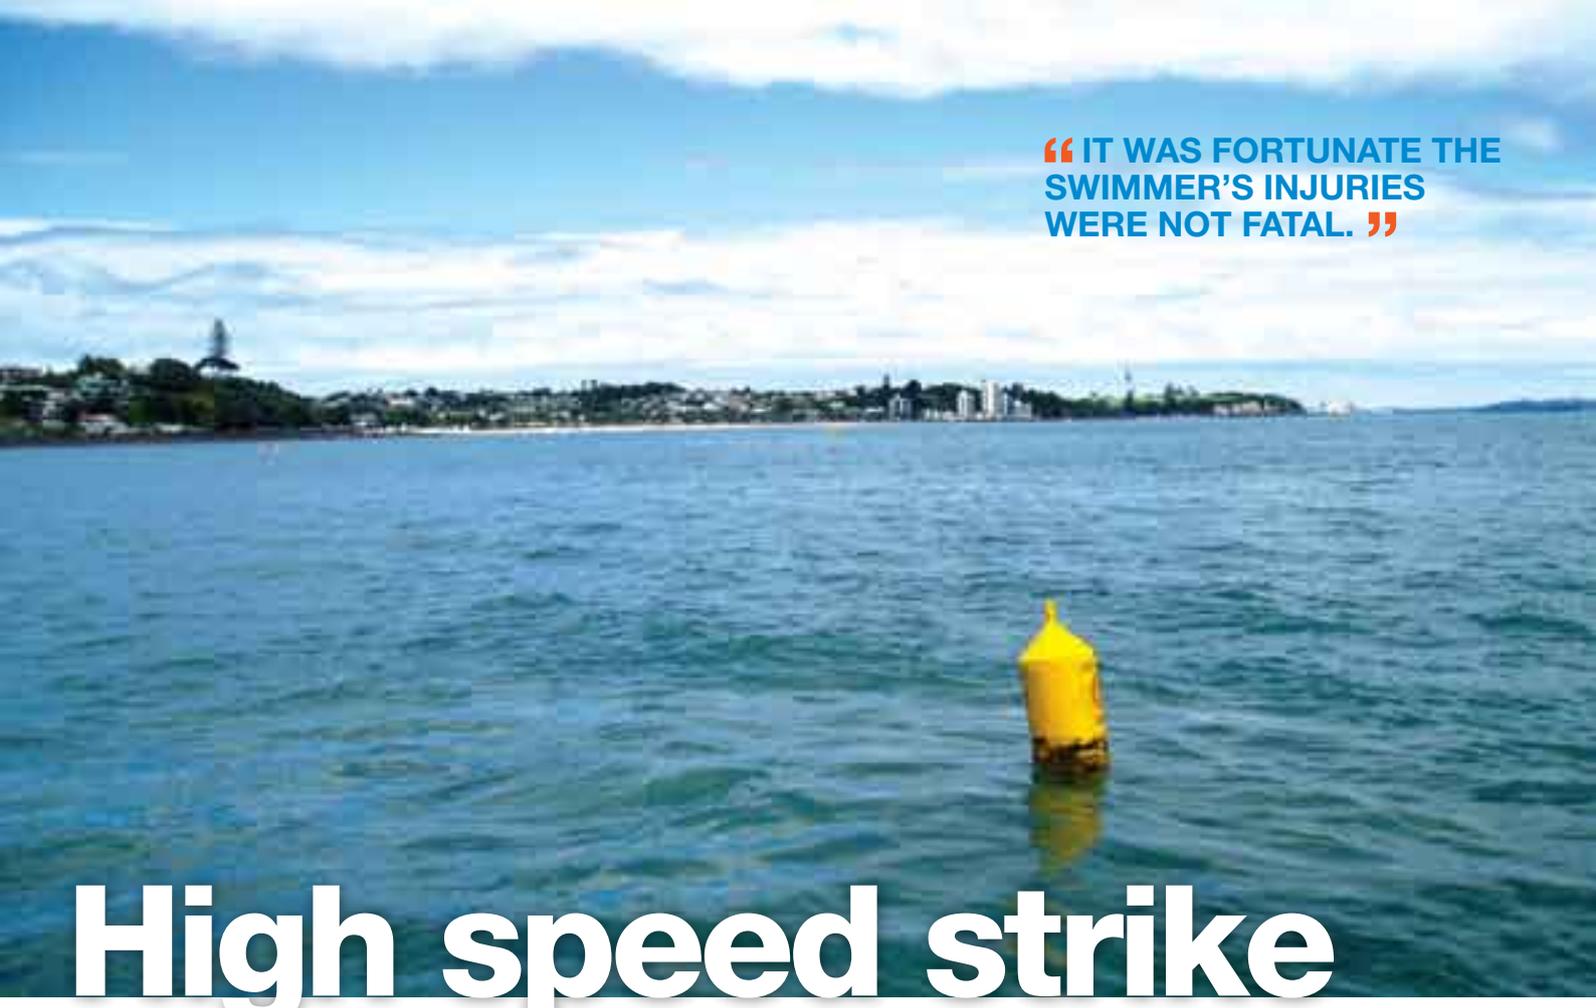
High speed strike

A PWC (personal water craft like a jet ski) struck a swimmer at a popular beach, breaking his shoulder blade and knocking him semi-unconscious.

The skipper of the PWC immediately circled back to the swimmer who was floating face down in the water and dived in to assist. Coastguard vessels arrived on the scene and took the swimmer to the beach. He was taken to hospital by ambulance and discharged after 2 days with a fractured right scapula and three fractured ribs.

Skippers of all vessels have an obligation to keep a proper lookout for swimmers and other vessels and to operate at a safe speed at all times regardless of where they are. It was fortunate the swimmer’s injuries were not fatal.

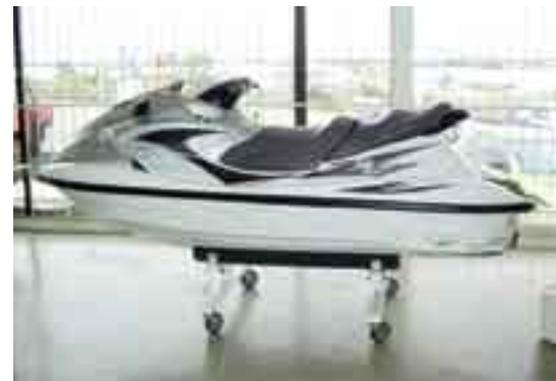
▲ PERSONAL WATER CRAFTS ARE OFTEN REFERRED TO AS JET SKIS.
▲▲ THE BEACH IS A POPULAR SWIMMING BEACH WHERE YELLOW BUOYS MARK THE DESIGNATED 200 M LINE. THESE ARE CLEARLY VISIBLE TO VESSELS, SWIMMERS AND PEOPLE ON THE BEACH.
